SPDT Effects on Surface Quality & Subsurface Damage in Ceramics

Deepak Ravindra & John Patten
*(Manufacturing Research Center-
Western Michigan University)*

Jun Qu
(Oak Ridge National Laboratory)

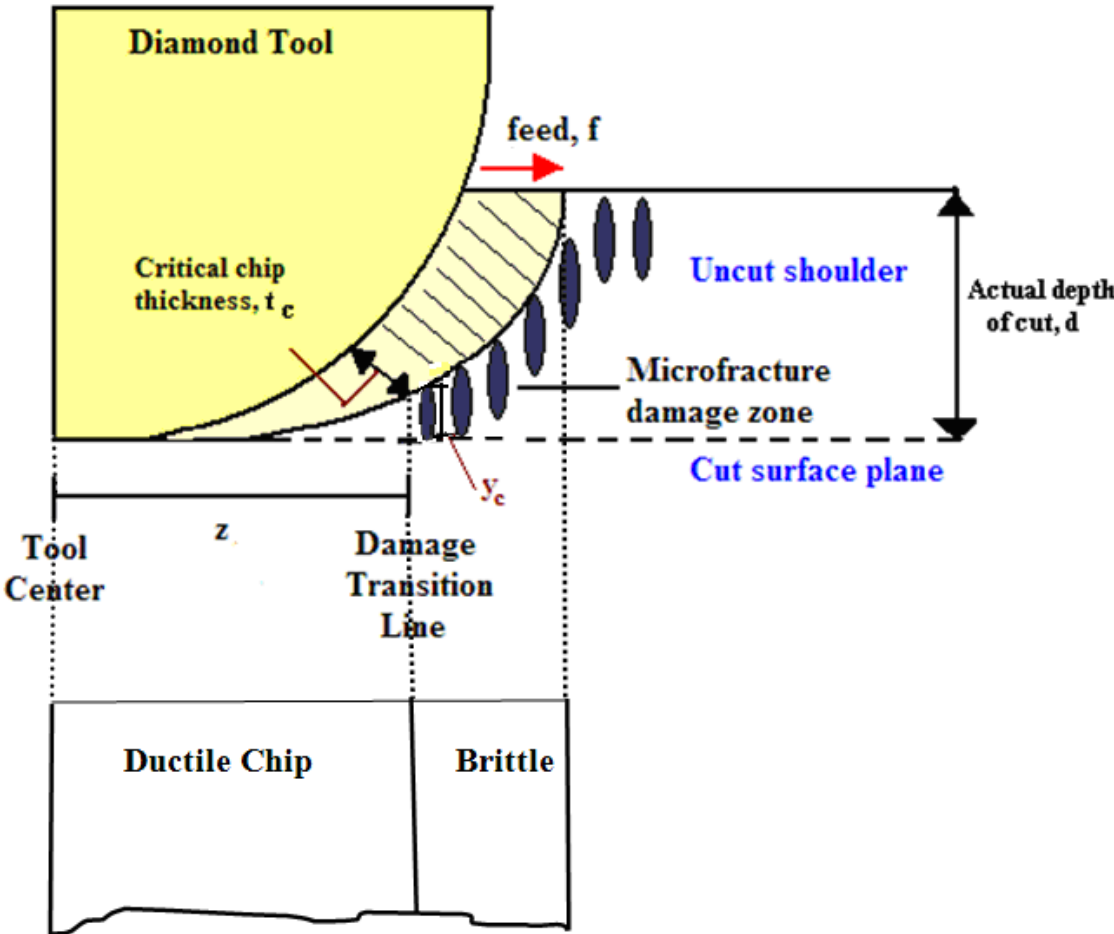
Ductile Regime Machining of Ceramics

Model proposed by Blake & Scattergood

- DBT is calculated based on material properties
- Depth exceeding critical depth will result in brittle machining
- Micro-cracks / surface damage depth, y_c should not extend beyond the cut surface plane

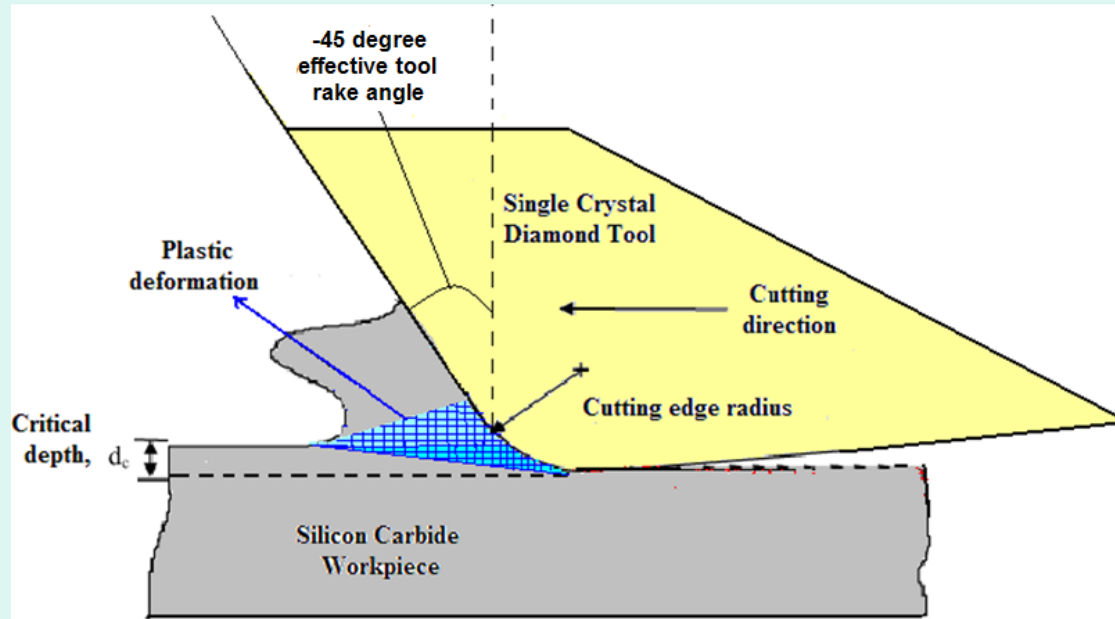
Critical Depth of Cut (d_c)

- Griffith fracture propagation criteria:

$$d_c \sim 0.15 \cdot (E / H) \cdot (K_c / H)^2$$

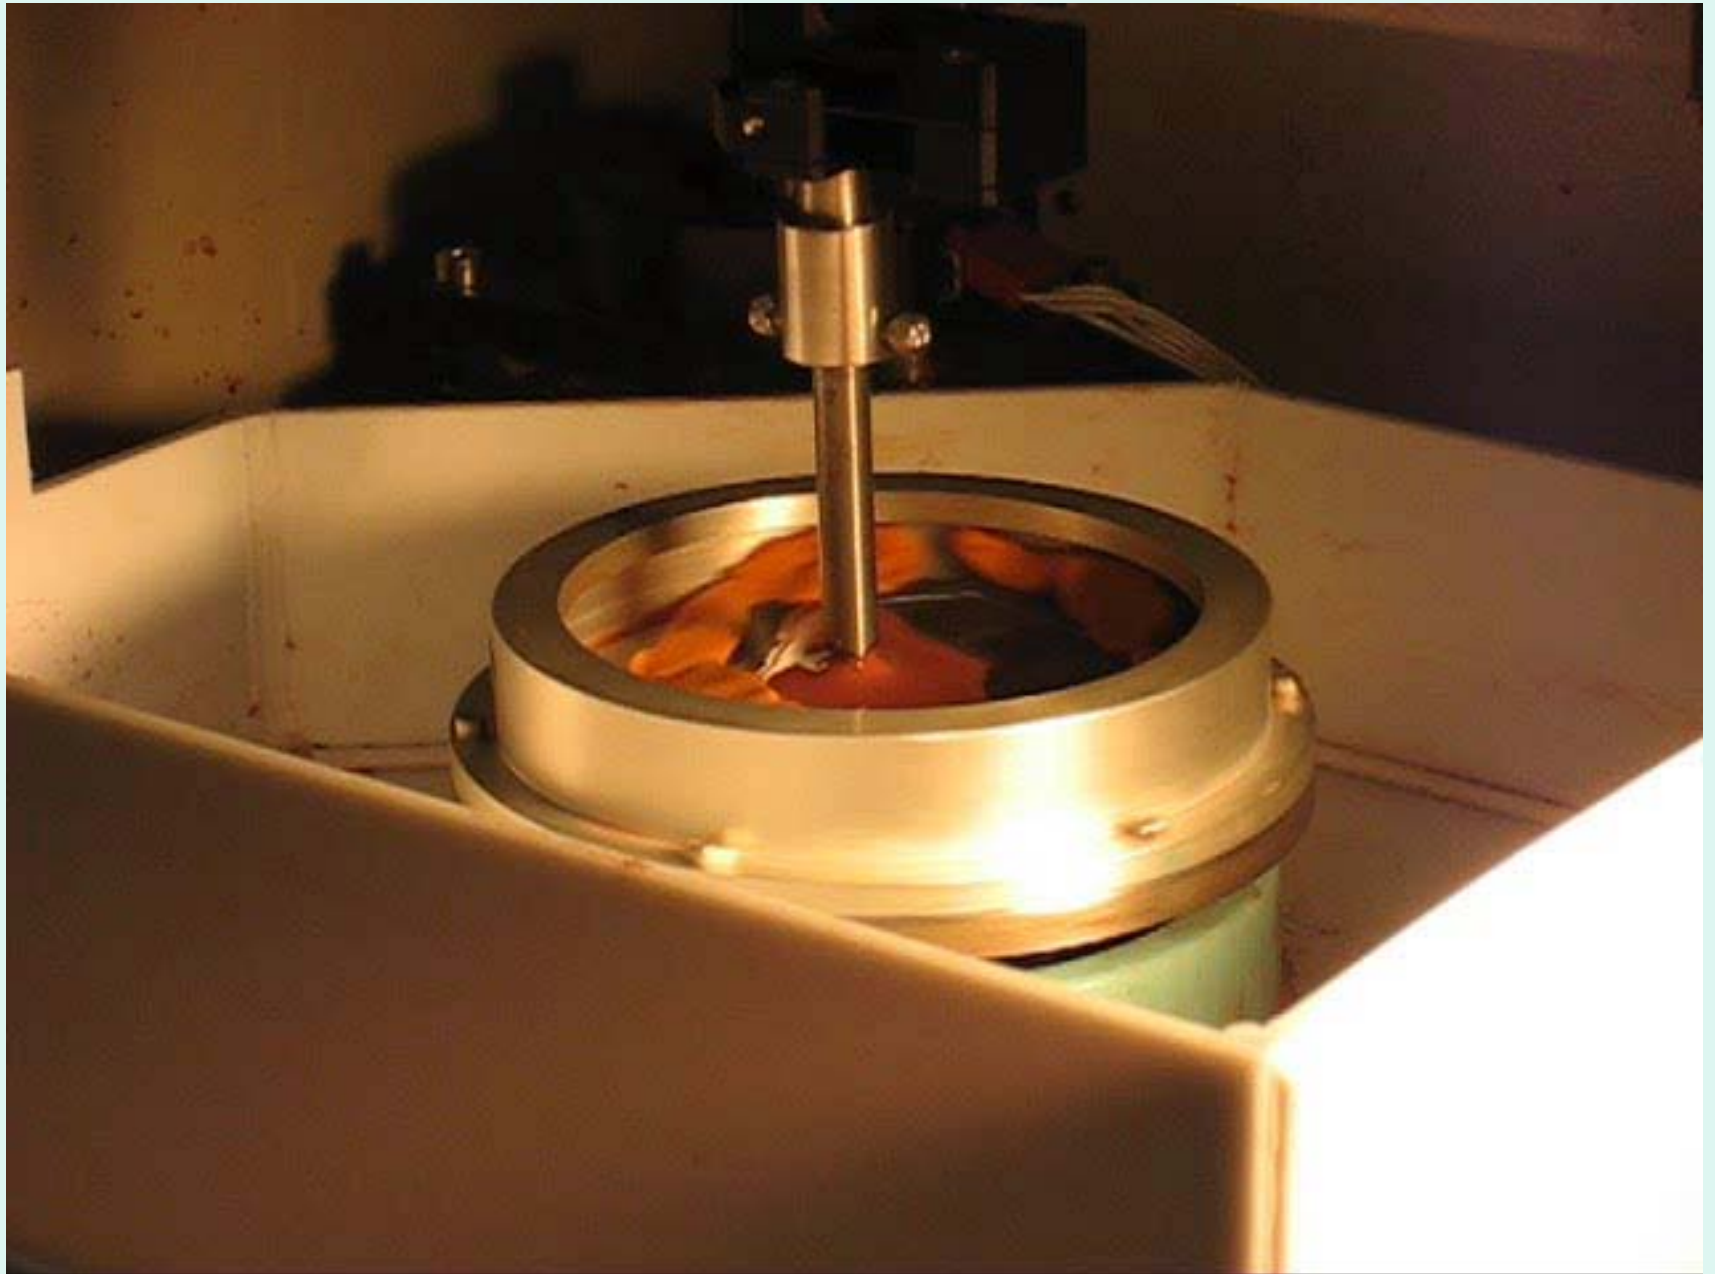
SPDT of SiC

Machining Parameters

Pass #	Depth of Cut	Feed ($\mu\text{m}/\text{rev}$)
1	2 μm	30
2	2 μm	30
3	2 μm	5
4	500nm	1
5	500nm	1
6	250nm	1

- The actual depths are usual about 50% of the programmed depths of cuts (due to elasticity)
- Best surface finish is achieved from the lowest feed (with a low depth of cut)

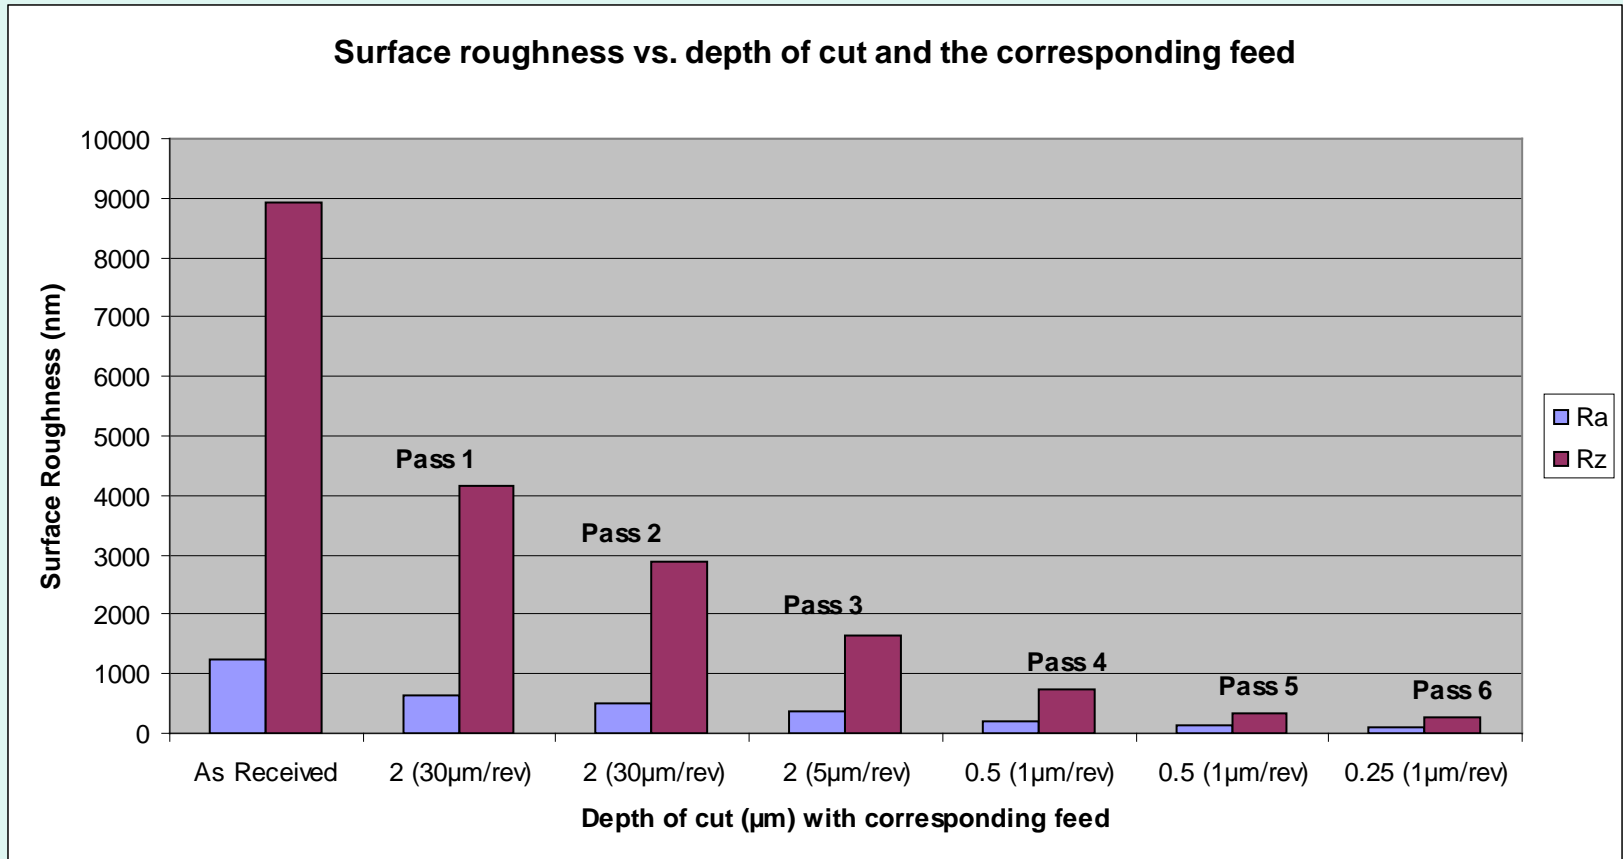
Results for final machining (surface roughness)

- Ra improved from 1.25μm to 85nm in 6 passes
- Rz improved from 9.0μm to 250nm
- Target Ra (Ra<100nm) achieved in 6 passes

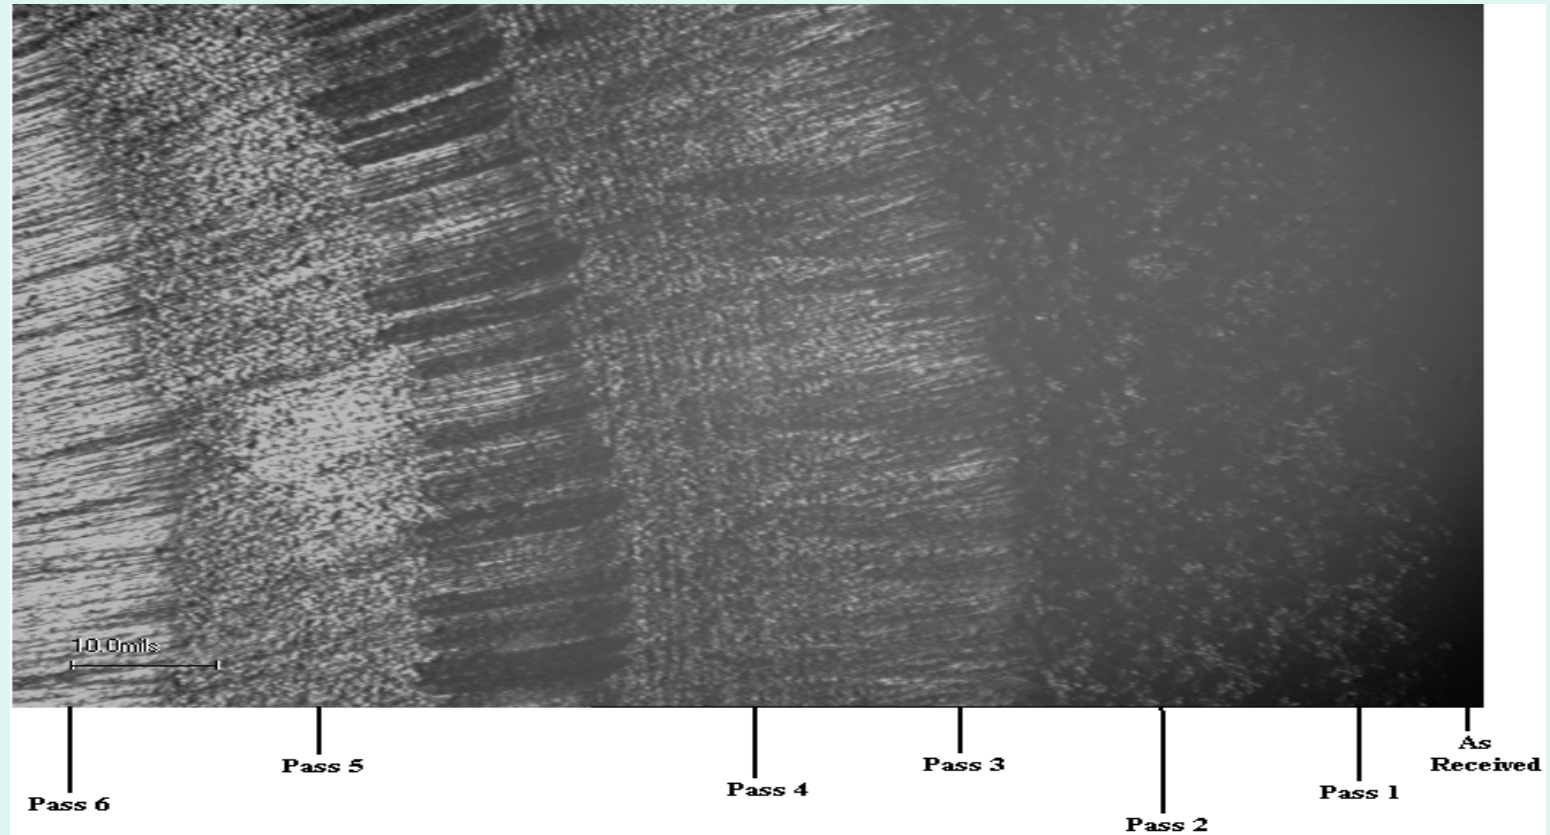
Results *(Surface image of 6 passes)*

- Image was taken at 50x magnification
- Surface continuously improved after each pass
- Band between pass 4 & 5 was due to tool chatter

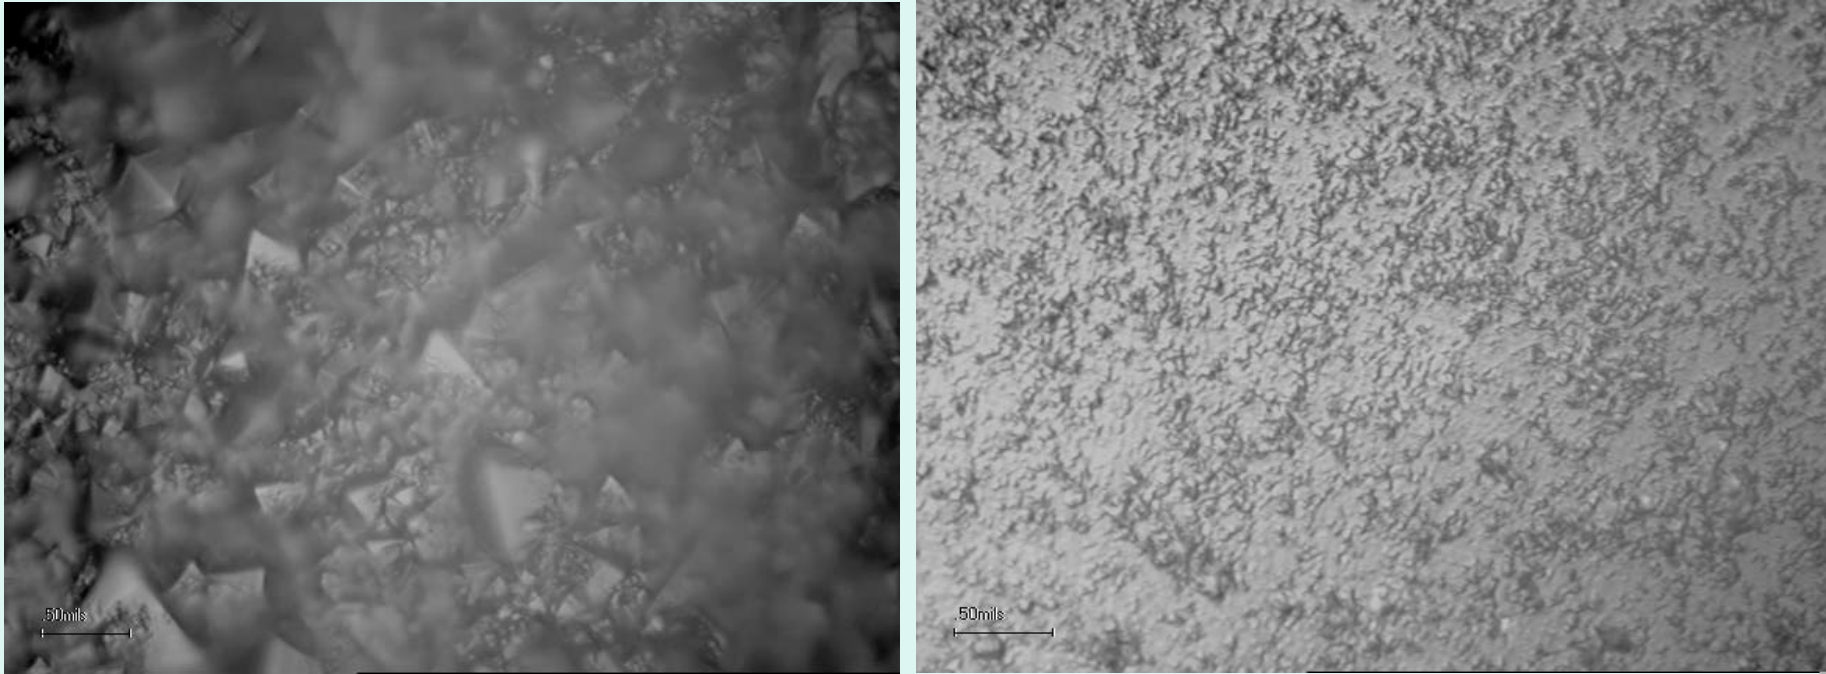
Results *(Surface image comparison)*

- Images comparing the surface before (left) and after (right) SPDT
- Images were taken at a 1000x magnification
- The sharp/uneven peaks on the surface disappeared after the SPDT operation

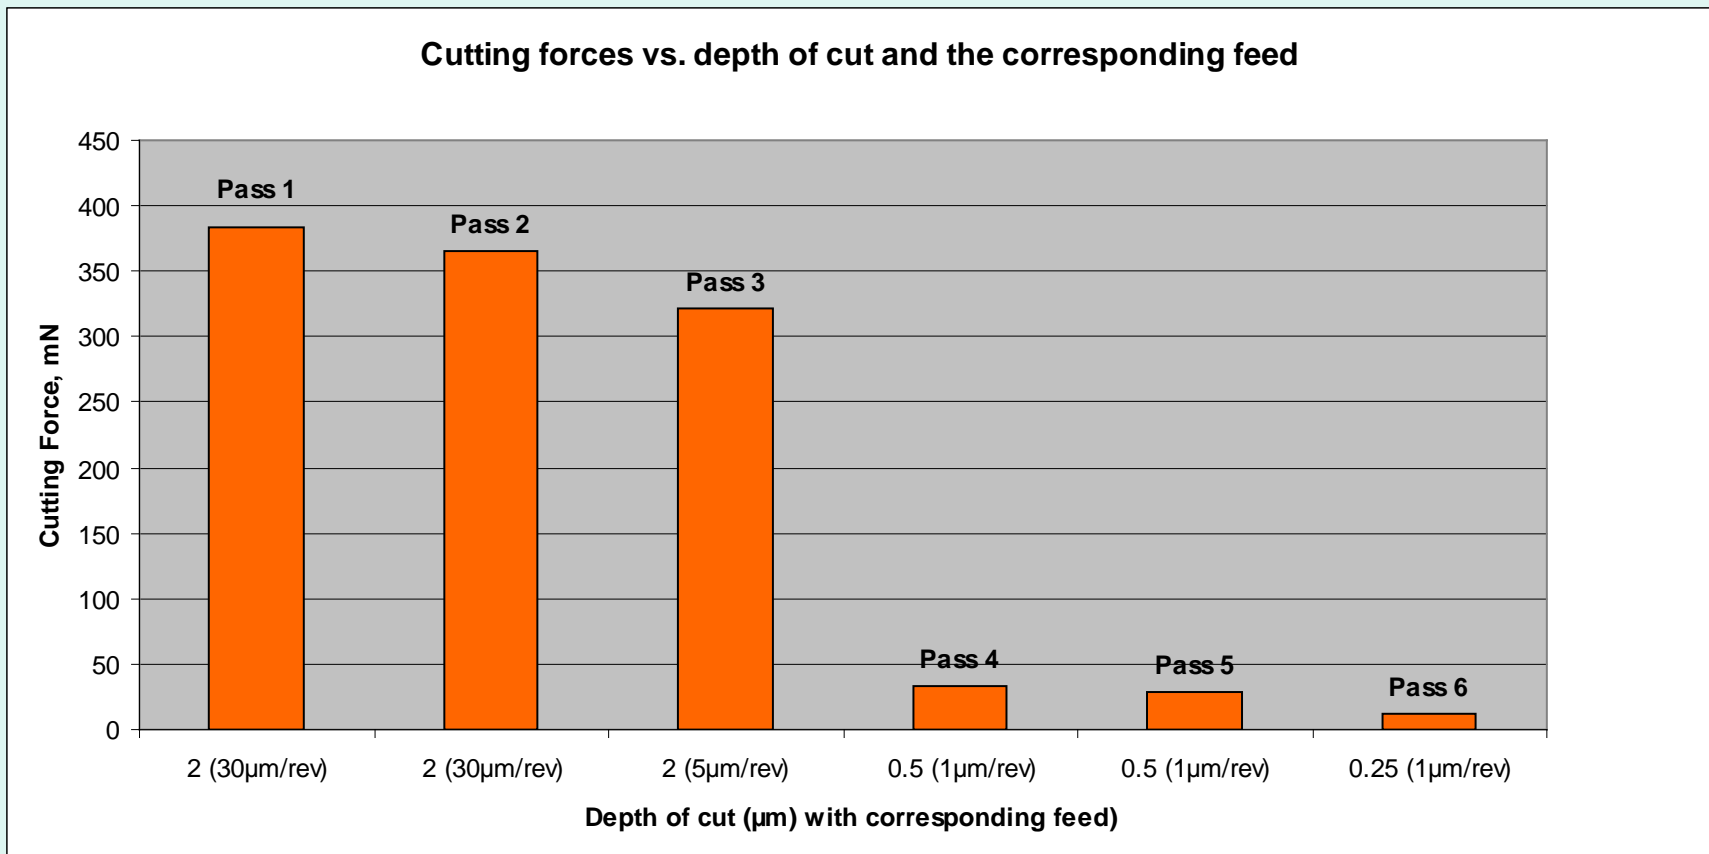
Results for final machining (cutting forces)

- Larger depths of cuts result in larger cutting forces
- Forces can also increase due to rough surfaces, machining debris, tool vibration, workpiece run-out, etc
- Cutting fluid helps several problems such as machining debris

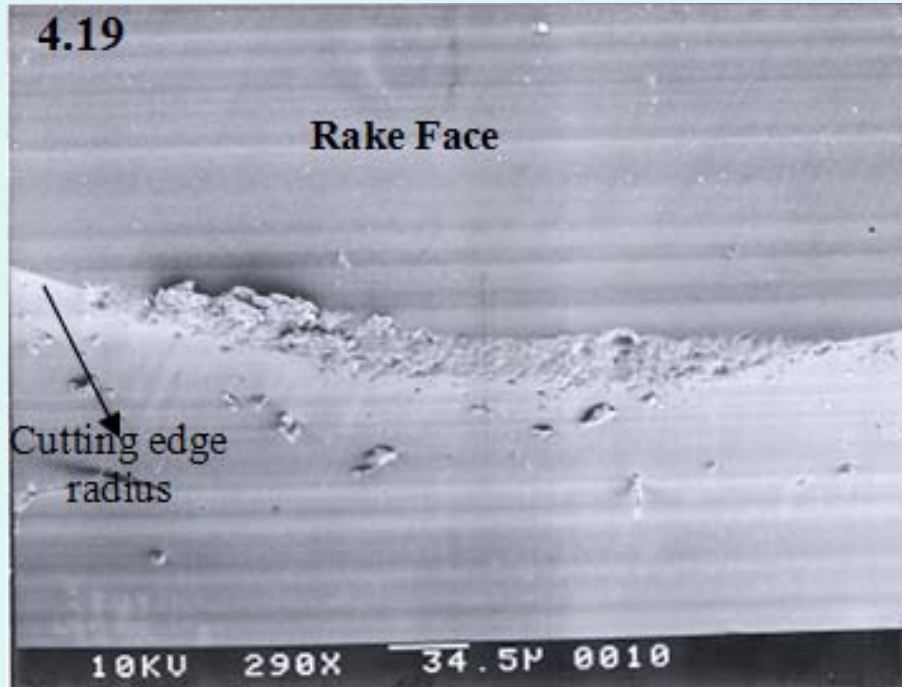
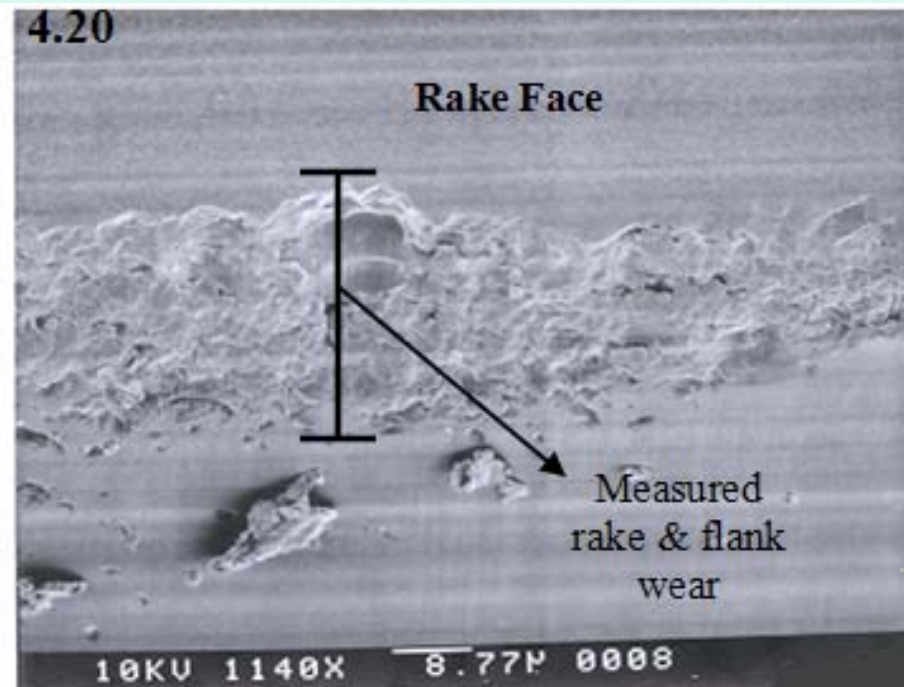
Results (*SEM images of tool wear*)

- Tool was used for pass 1 (2µm depth & 30µm/rev feed)
- SEM images are used to measure tool wear
 - Wear length across cutting edge (3mm nose radius)
 - Rake wear (-45 degrees rake angle)
 - Flank wear (5 degrees clearance angle)

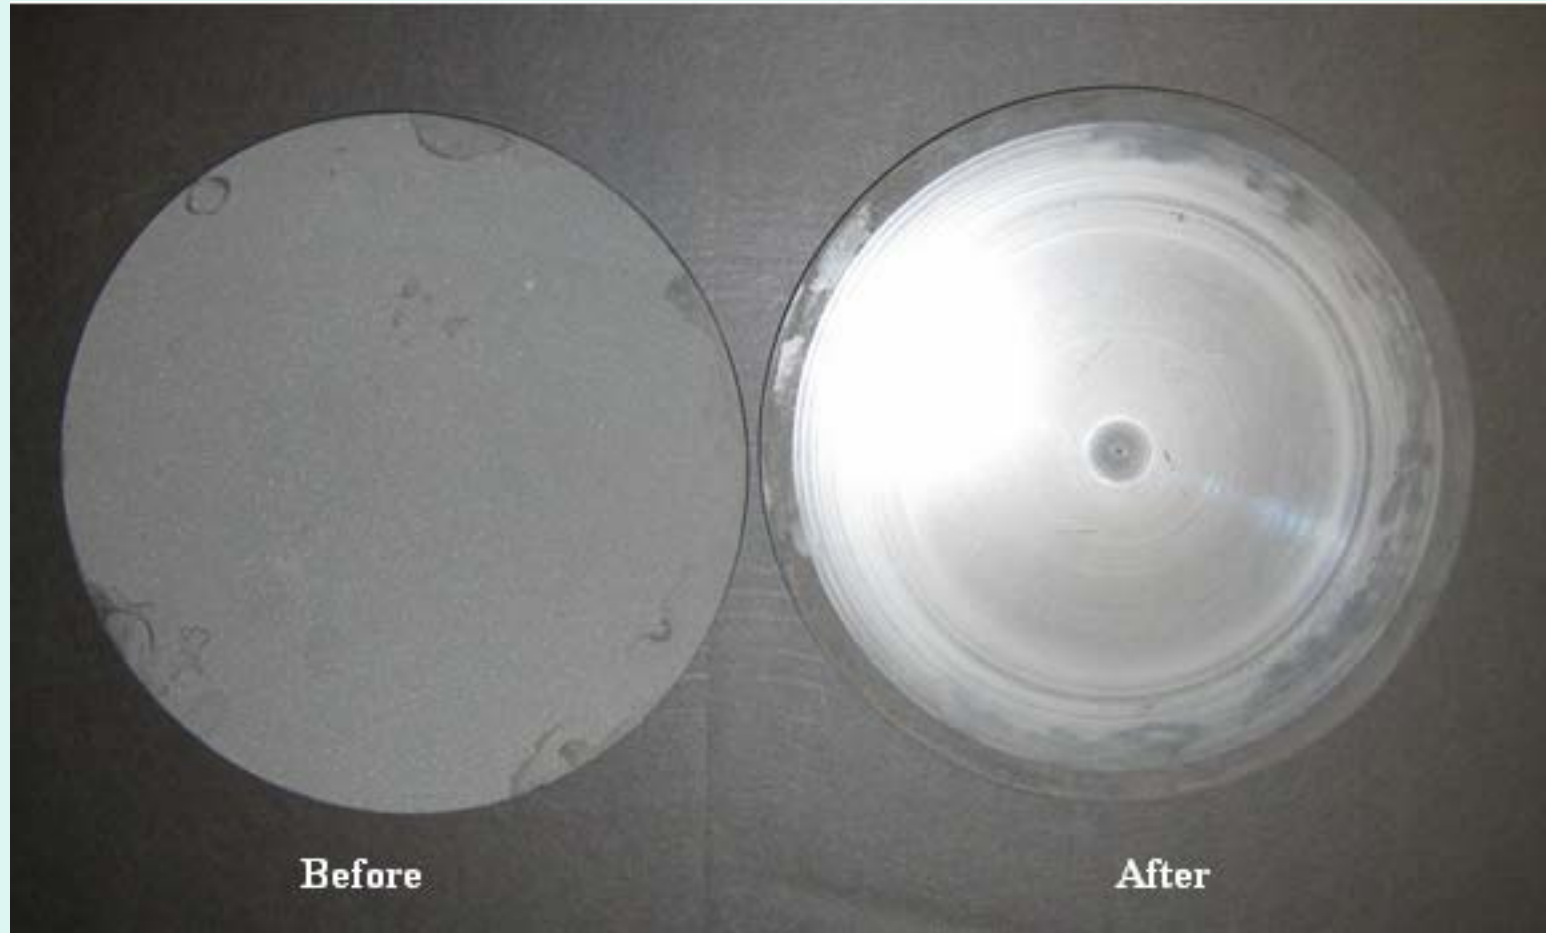
Results *(6" disk before & after SPDT)*

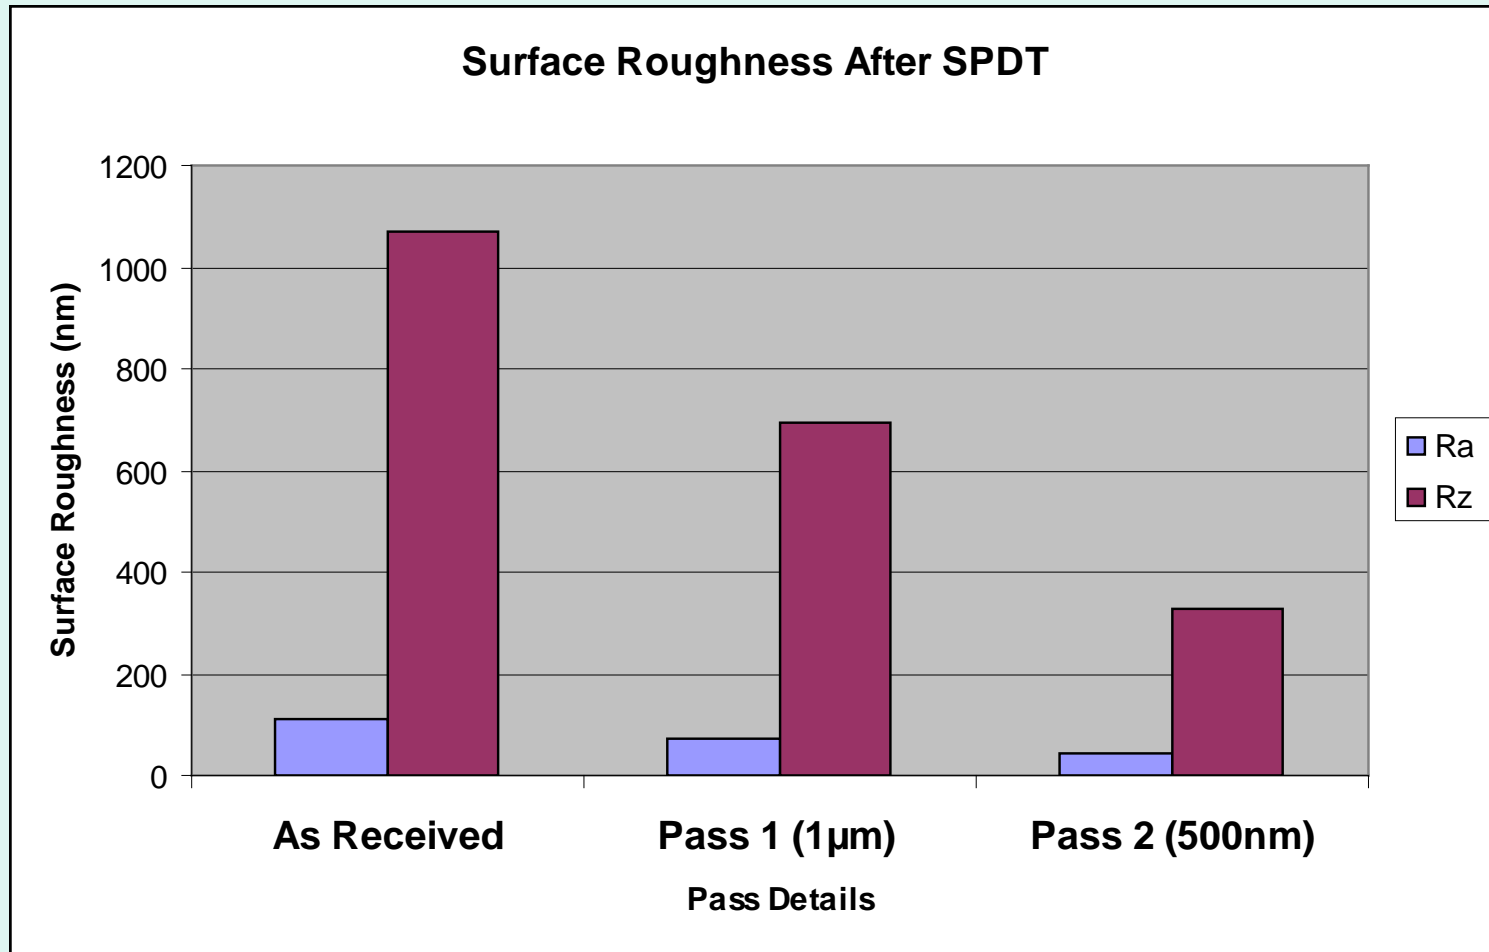
Results (*surface roughness*)

- A total of two passes were carried out to achieve the targeted Ra (achieved Ra~40nm)
- A feed of 1µm/rev was used for both passes

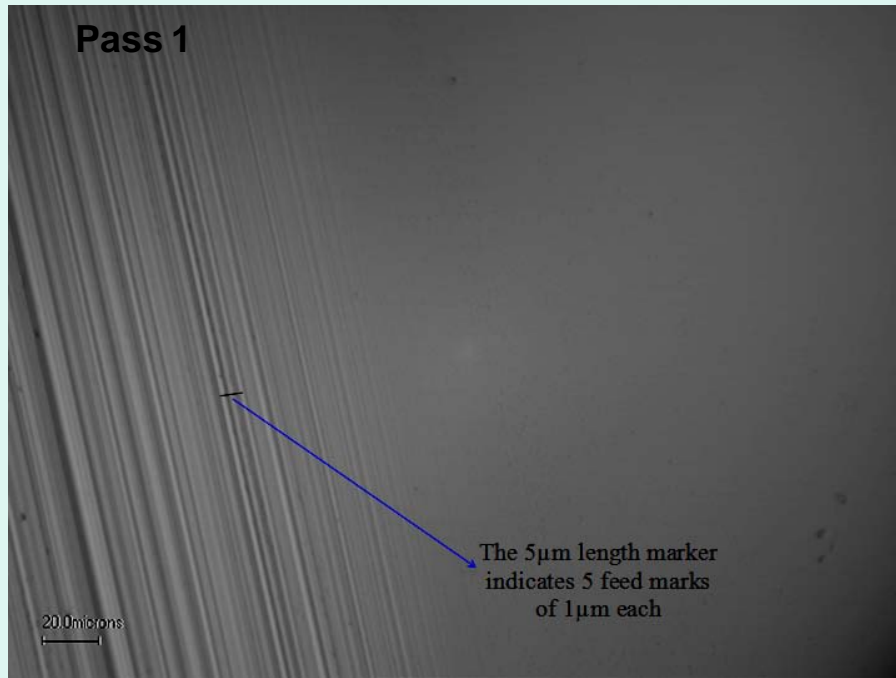
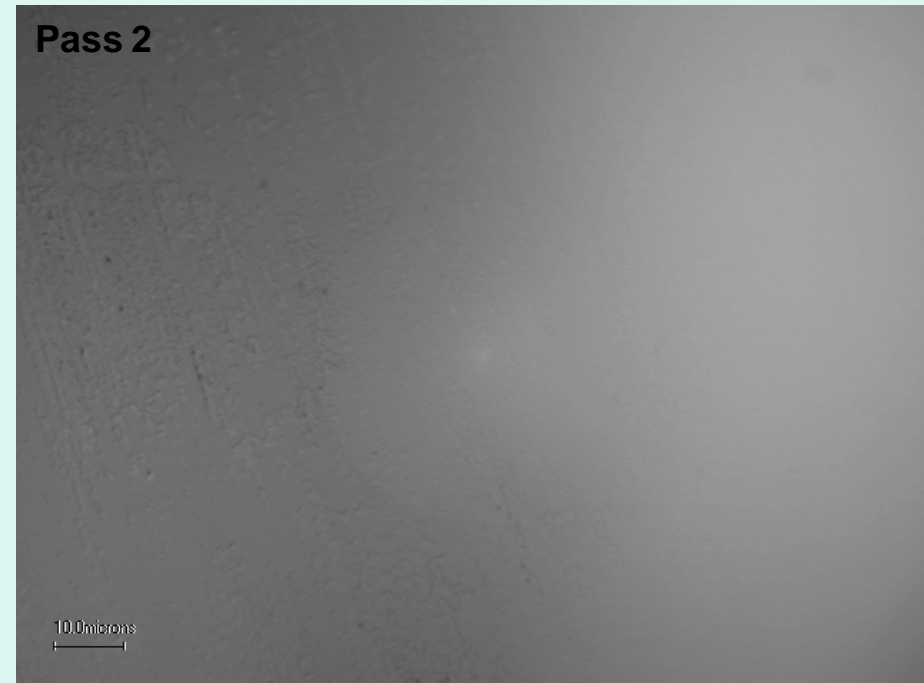
Results (*Quartz surface images*)

- Images comparing the surface after Pass 1 and 2 were carried out
- No signs of brittle machining – surface & subsurface can be imaged to a certain degree as Quartz is transparent

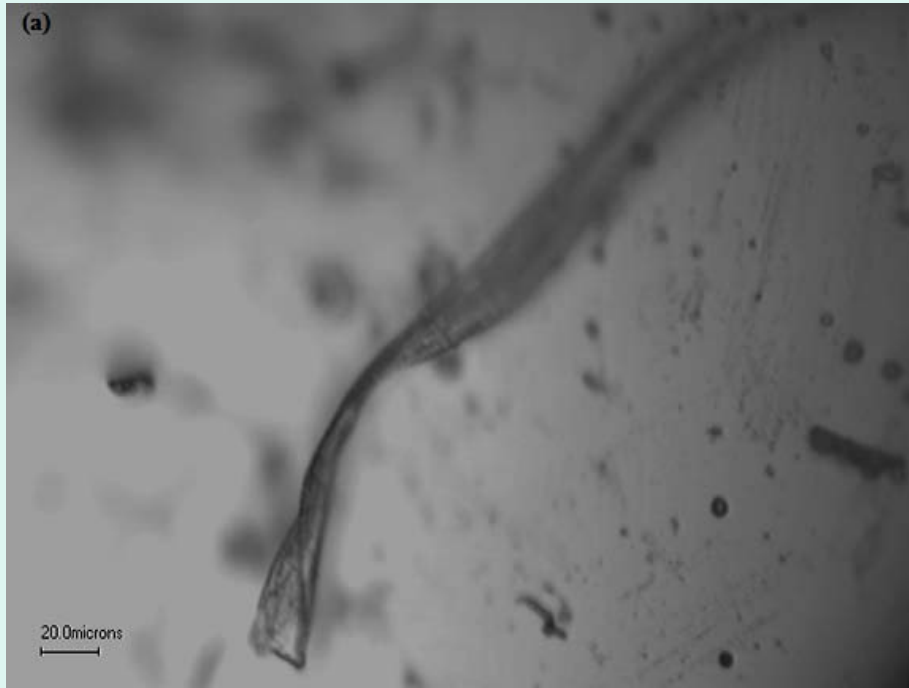
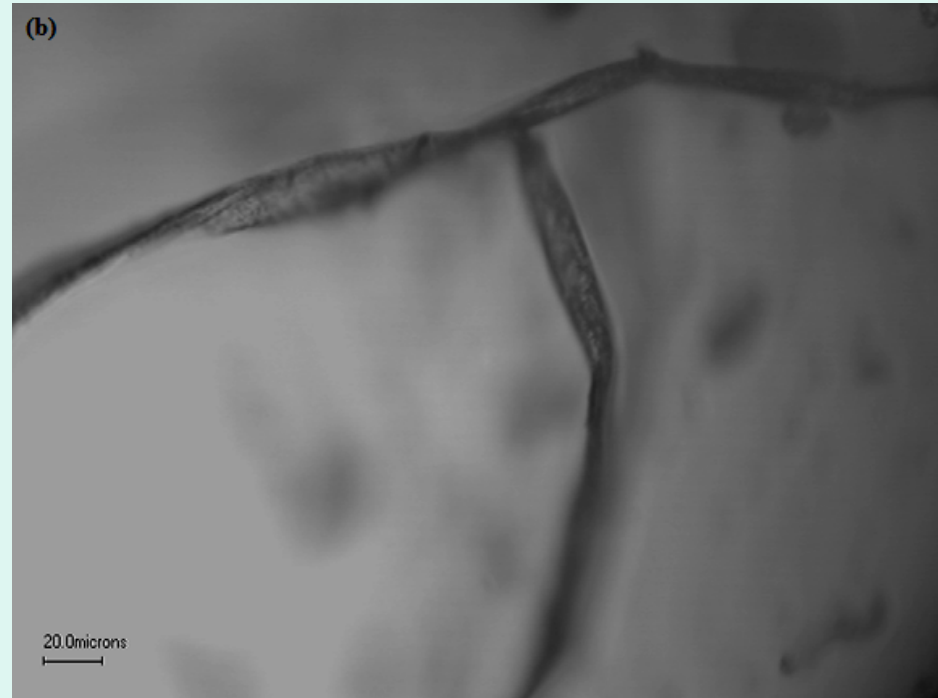
Ductile Chips from a Brittle Material

- Continuous plastically deformed chips indicate ductile mode machining.
- Both images were taken at a 400x magnification

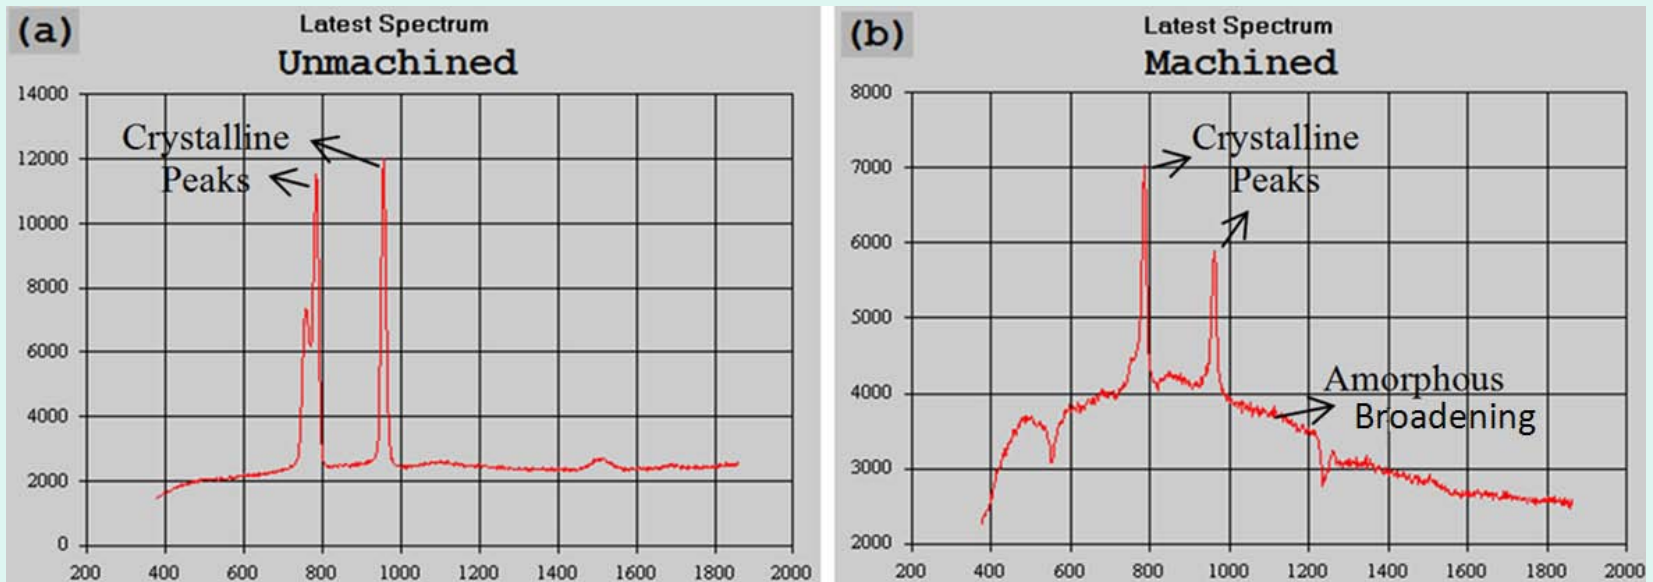
Raman Spectroscopy - SiC

- 633nm wavelength He-Ne laser

- Amorphous broadening is observed along with the smaller crystalline peaks in the machined region

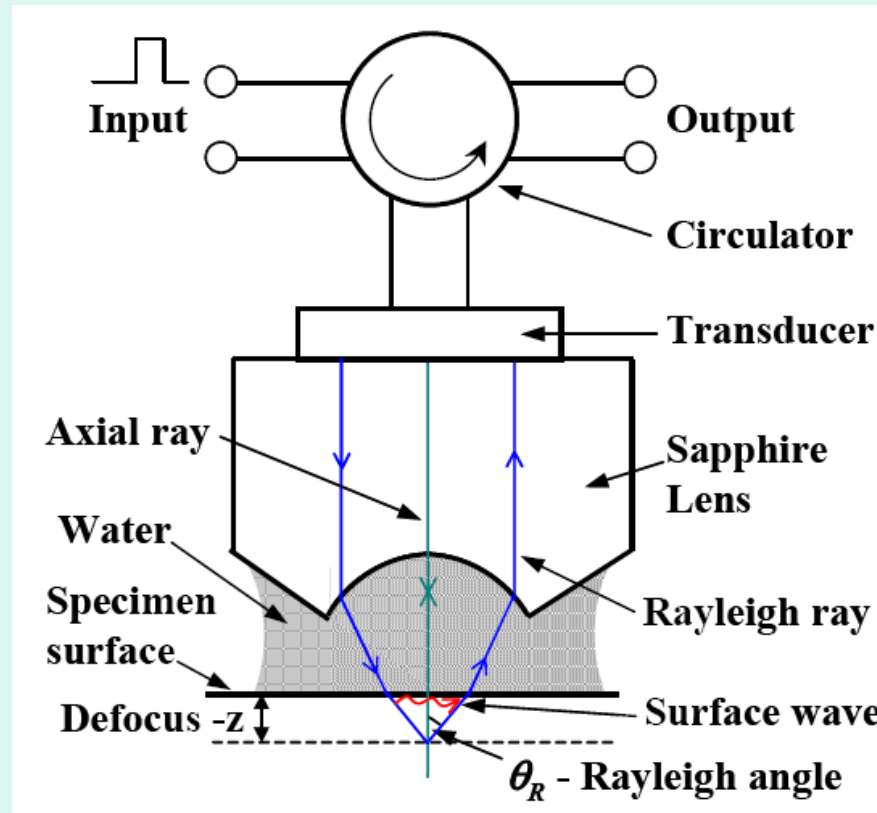
Scanning Acoustic Microscopy

- Scientific Instruments (KSI) SAM2000 (ORNL)
- Uses focused sound to image an object
- High-frequency acoustic waves (60MHz to 2.0GHz)

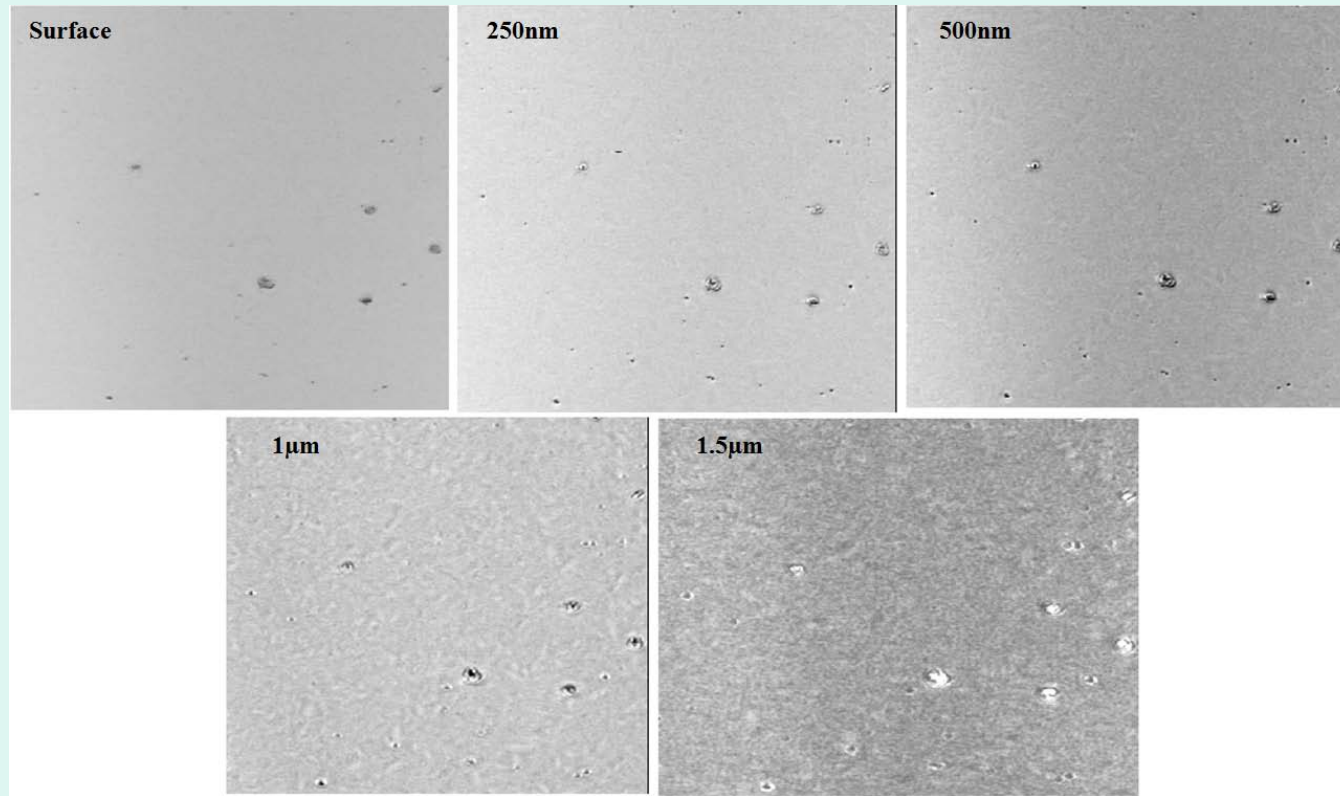
Typical Image of Scanning Acoustic Microscopy -SiC

- Images show no signs of subsurface cracks or damage
- Features seen are pits and voids that existed in the as received material and not from SPDT

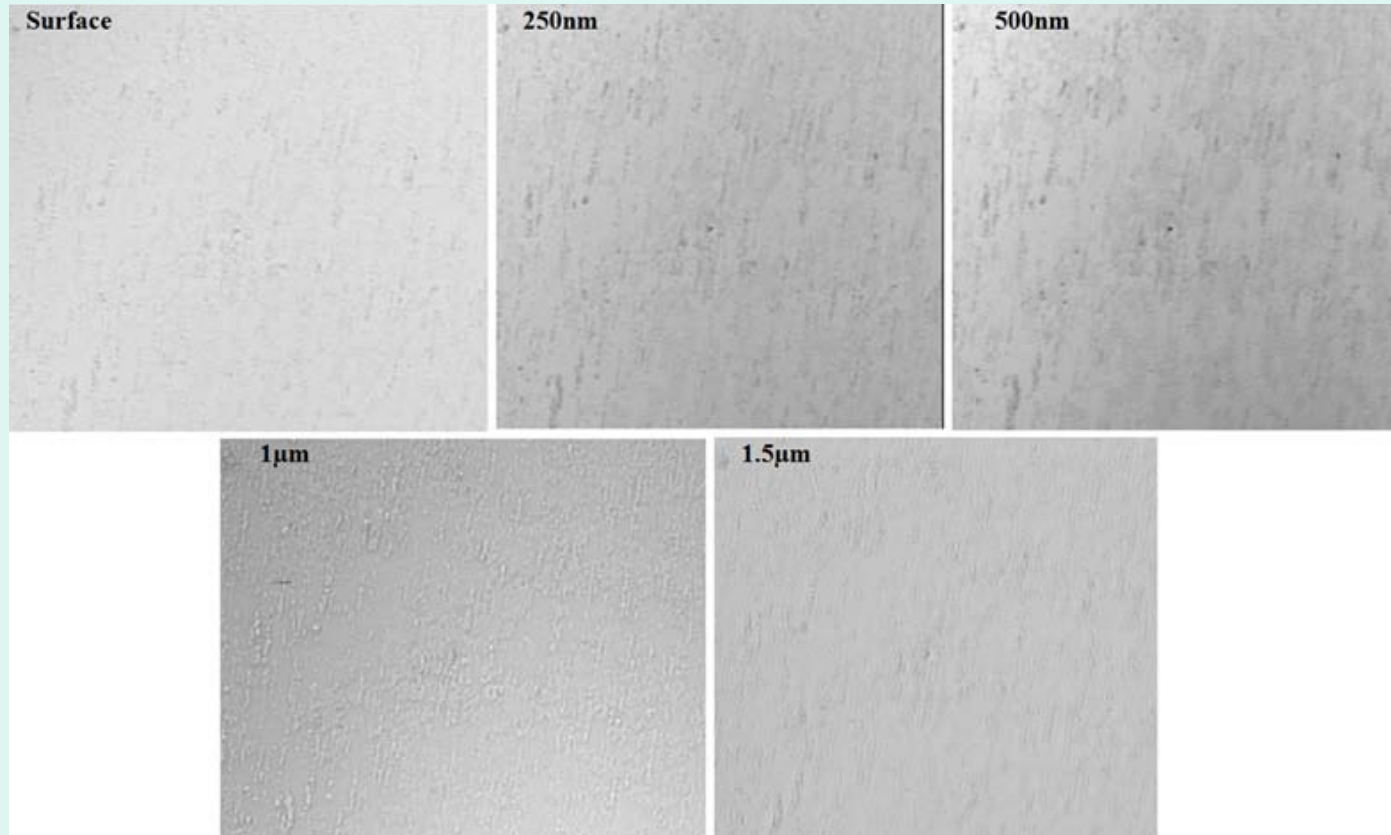
Typical Image of Scanning Acoustic Microscopy - Quartz

- Features seen are normal surface features and feedmarks
- No signs of fracture beneath the machined surface

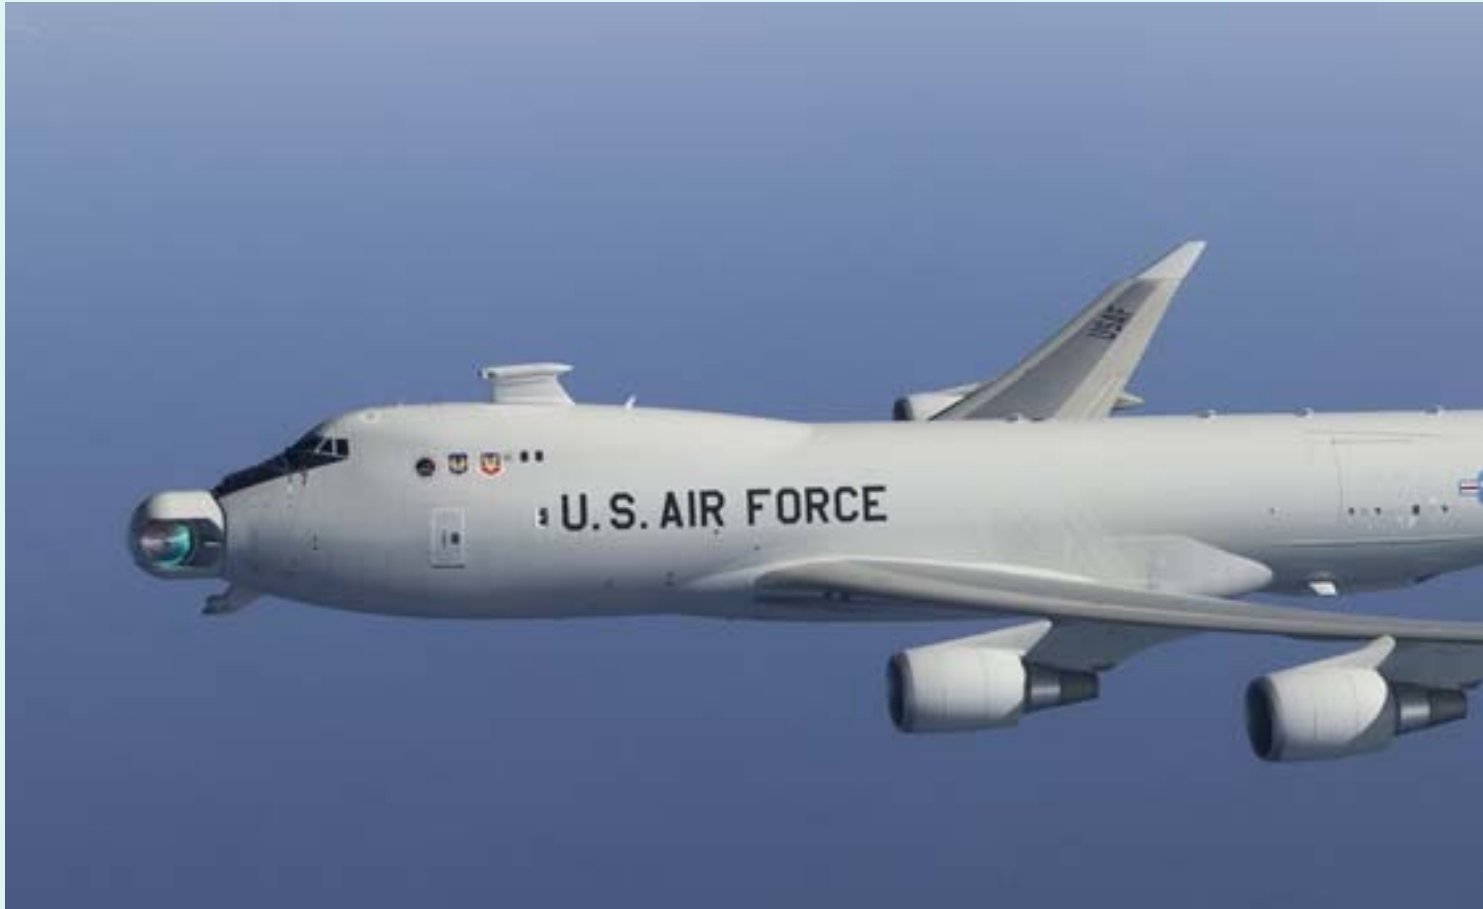
Potential use of SiC & Quartz disks

- Quartz to be used as ABL device nose cover
- Mirror finish surface required for the above use
- Image courtesy of Boeing Corporation
