**CONDITION ASSESSMENT AND  
METHODS OF ABATEMENT OF  
PRESTRESSED CONCRETE BOX-  
BEAM DETERIORATION  
PHASE I**

**FINAL REPORT – NOVEMBER 2005**

1. Report No. <b>Research Report RC-1470</b>		2. Government Accession No.		3. MDOT Project Manager <b>Steve Kahl, P.E.</b>	
4. Title and Subtitle <b>Condition Assessment and Methods of Abatement of Prestressed Concrete Box-Beam Deterioration</b>				5. Report Date <b>November 30, 2005</b>

**Report RC-1470**

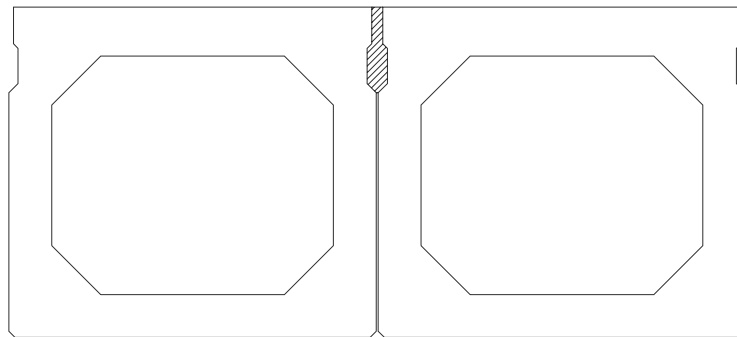
**Figure 2-1: Typical geometry for box-beam grouted shear key used in the U.S.**

The shear key used in most of the DOTs in the United States is relatively small (Figure 2-1). As shown in Figure 2-2 and Figure 2-3, Japanese practice is to place cast-in-place concrete in relatively wide and deep joints between the beams (Yamane et al. 1994; and El-Remaily et al. 1996). It is reported that longitudinal cracks are very rare on side-by-side box-beam bridges in Japan.

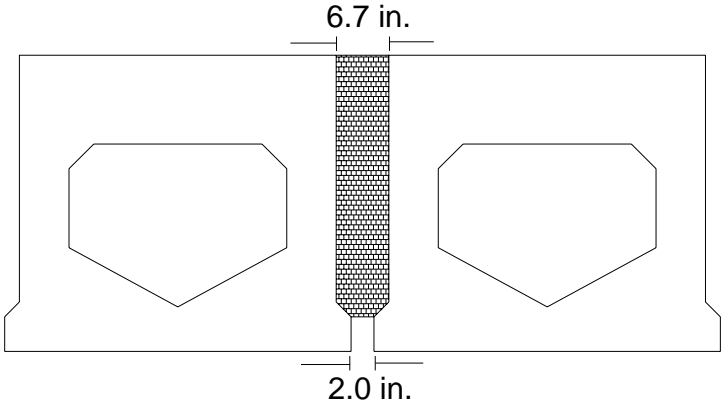
**Figure 2-2: Typical geometry for box-beam grouted shear key detail used in Japan**

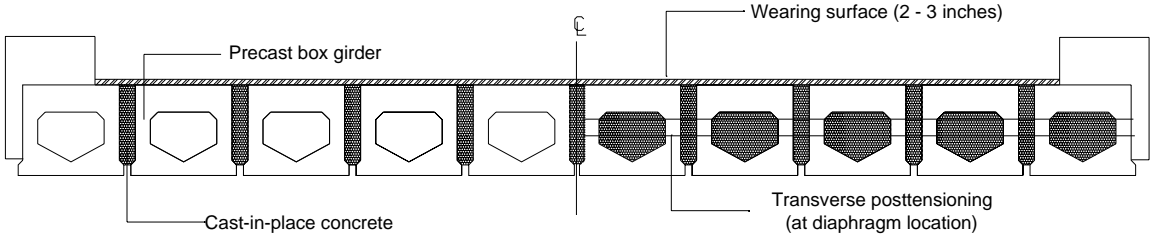
**Figure 2-3: Precast prestressed concrete box-beam bridge system in Japan**

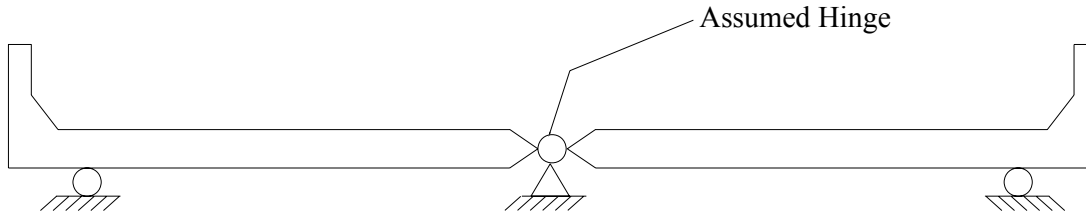
**Figure 2-4: Notional model for applying the lever rule**

If two or more lanes of the bridge are loaded and the distribution factors for live load per lane for moment in an interior beam (Table 2-2) are going to be used for the design, interconnection of the beams is a concern. The fully connected joint should be able to transfer moment and shear between beams. Transverse post-tensioning (minimum 0.25 ksi) or reinforced concrete structural overlay or both can be used to enhance this type of interconnection. Use of other types of transverse connections like mild steel rods secured by nuts or similar unstressed dowels should not be considered sufficient to achieve full transverse flexural continuity unless proven by tests or experience (AASHTO 2004). To calculate the distribution factors for moment and shear in an exterior beam when one design lane is loaded, (AASHTO 2004) recommends using a lever rule. This rule requires summing up the moments about one support to find the reactions at another support. It is assumed that all the supported components are hinged at interior supports (Figure 2-4).

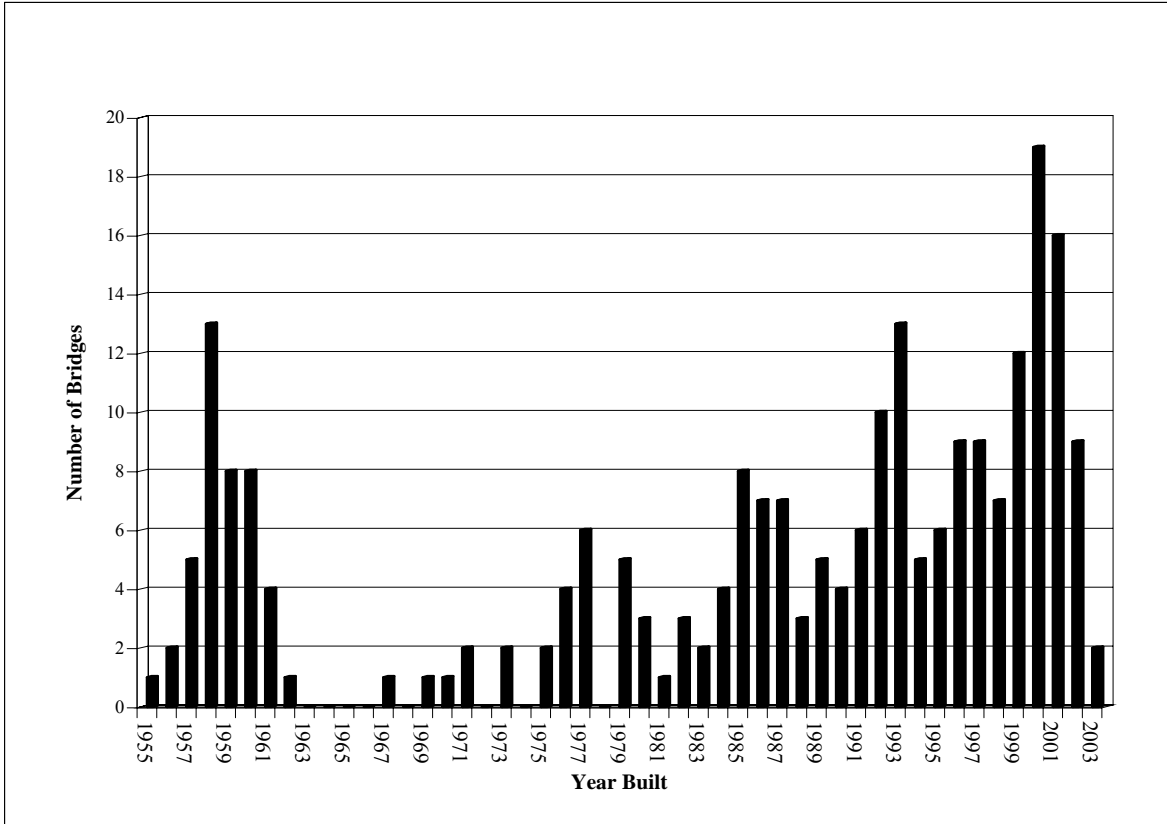
**Figure 2-5: Number of side-by-side prestressed concrete box-beam bridges under MDOT jurisdiction with respect to year built**

Prestressed concrete bridges quickly became popular because the beams could be built economically in plants and their span lengths could compete with that of steel beams (Needham and Juntunen 1997). According to the *Pontis 4.2* database, the first Michigan side-by-side box-beam bridge was built in 1955. The database shows that there are 1037 prestressed concrete bridges with the design types of side-by-side box-beams, spread box-beams, and I-beams under the jurisdiction of the Michigan Department of Transportation (MDOT). Of these prestressed concrete bridges, 236 are side-by-side box-beam bridges. Precast prestressed concrete box-beams are frequently used for short (20–60 feet) and short to medium span bridges (60–110 feet). The histogram shown in Figure 2-5 demonstrates the box-beam construction distribution over the last 49 years.

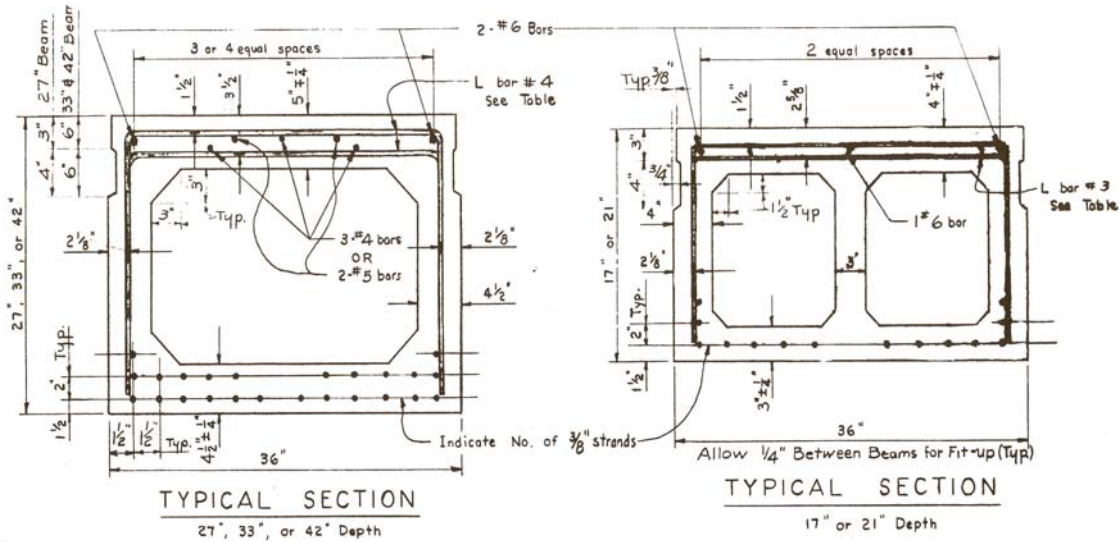
**Figure 2-6: Reinforcement details of (1956 box-beam sections)**

The prestressed side-by-side box-beam bridge was introduced to Michigan in 1955. The earliest side-by-side precast prestressed concrete box-beam design configuration (1956), shows two box-beam configurations: single-cell of 36x27, 36x33, and 36x42 and double-cell of 36x17 and 36x21 (Figure 2-6). The stirrups were open and did not extend to the bottom flange of the box-beam and the shear key configuration was narrower than the one used today. The specified spacing between adjacent beams was ¼-inch. For beams that span up to 40 feet, a tie-rod was used at the center of the span. When the span was greater than 40 feet, tie-rods were used at each 1/3 location. The specified wearing surface thickness was 3 inches.

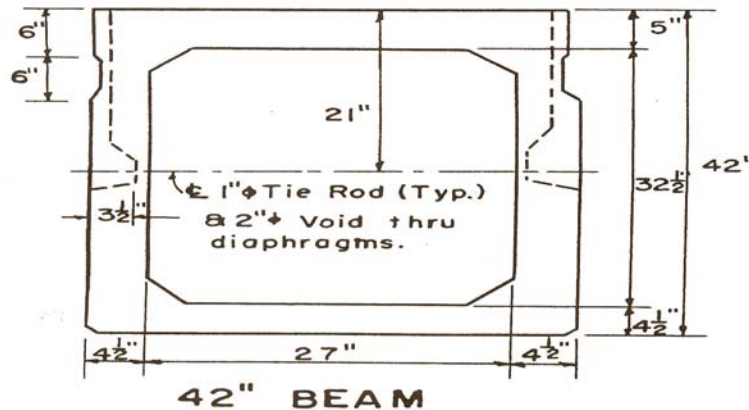
**Figure 2-7: Box-beam cross-section showing the 1958 tie rod location**

In 1958, deeper shear key configurations had been used at post-tensioning locations (Figure 2-7).

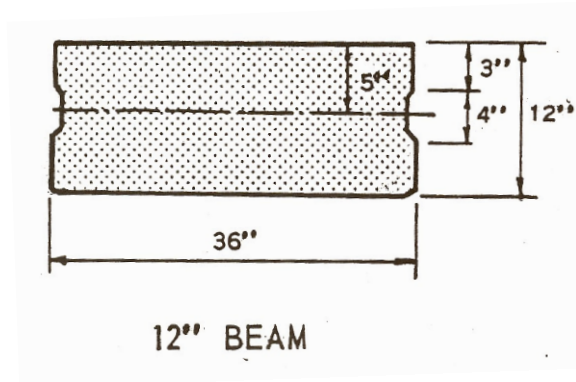
Figure 2-8: 36x12 solid box-beam section from 1974

In 1974 significant changes were made to the box-beam design. Standard beams were single-cell 36x17-inch, 36x21-inch, 36x27-inch, 36x33-inch, 36x39-inch, and 36x42-inch except for a solid 36x12-inch box-beam section (Figure 2-8).

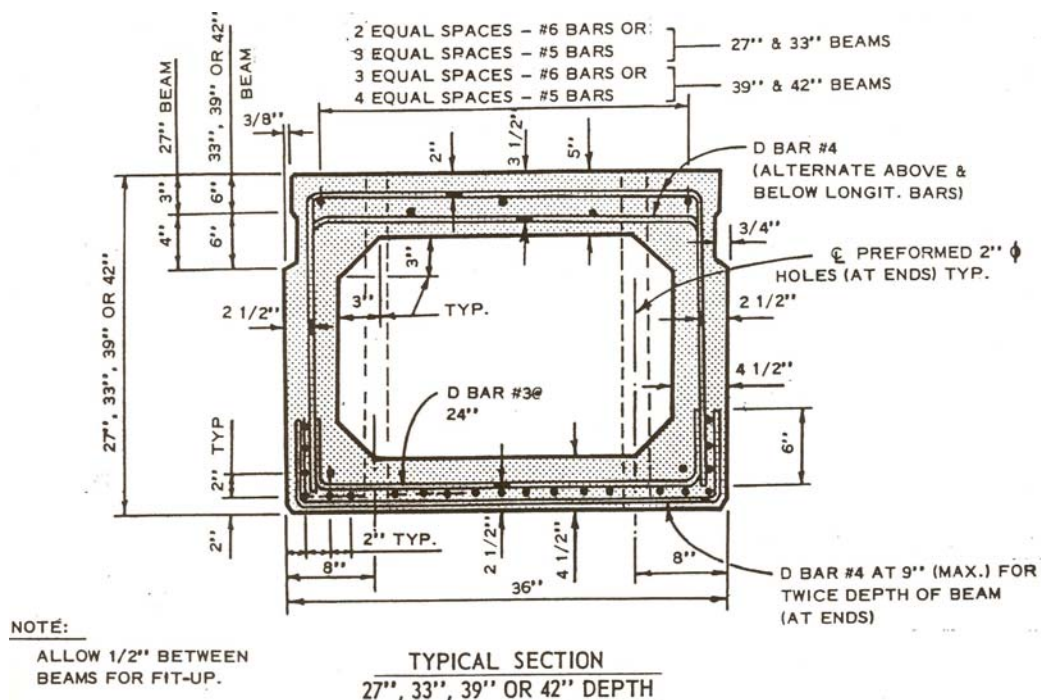
**Figure 2-9: Reinforcement details of box-beams in 1974**

The reinforcement details of the box-beams are shown in Figure 2-9. At this time all the sections contained closed stirrups. The spacing between adjacent beams was increased from 1/4-inch to 1/2-inch.

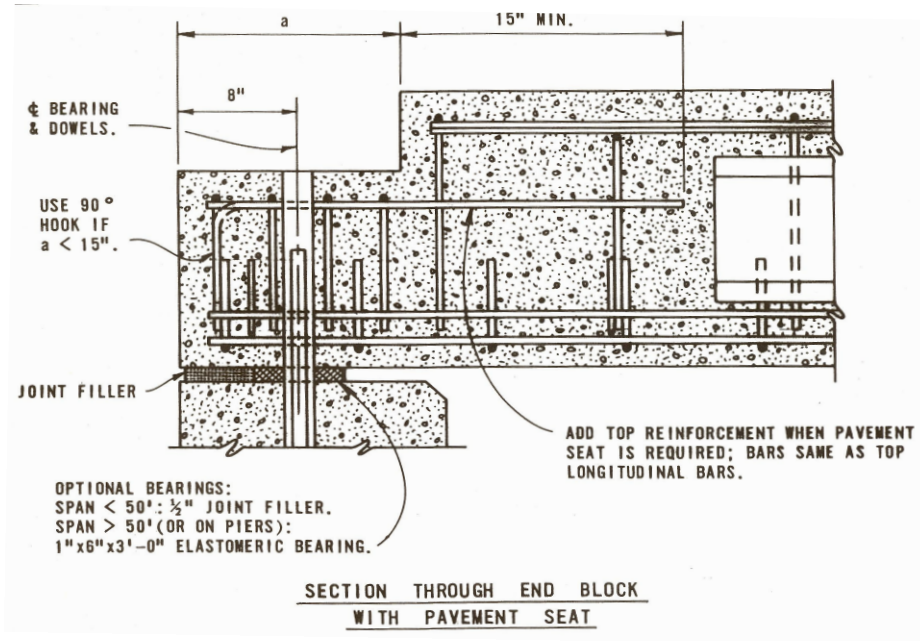
**(a) End block Details**

In 1975 the design was updated to introduce bond breaker at the anchorage zone and in 1976 the bearing conditions of the beam were altered. See Figure 2-10 (a) and (b) for details.

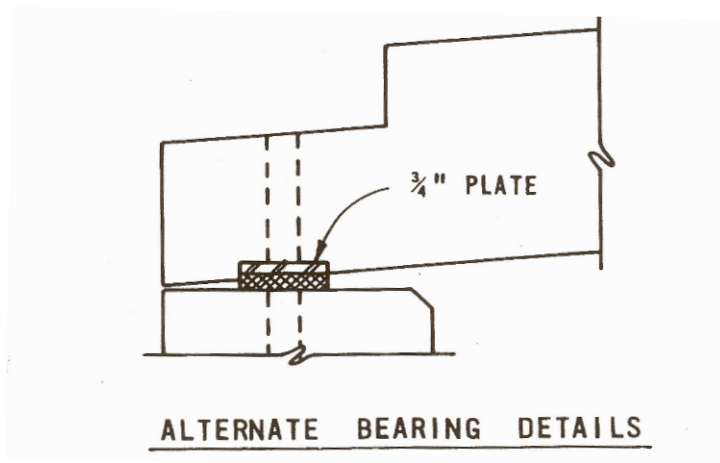
**(b) Alternate bearing details**

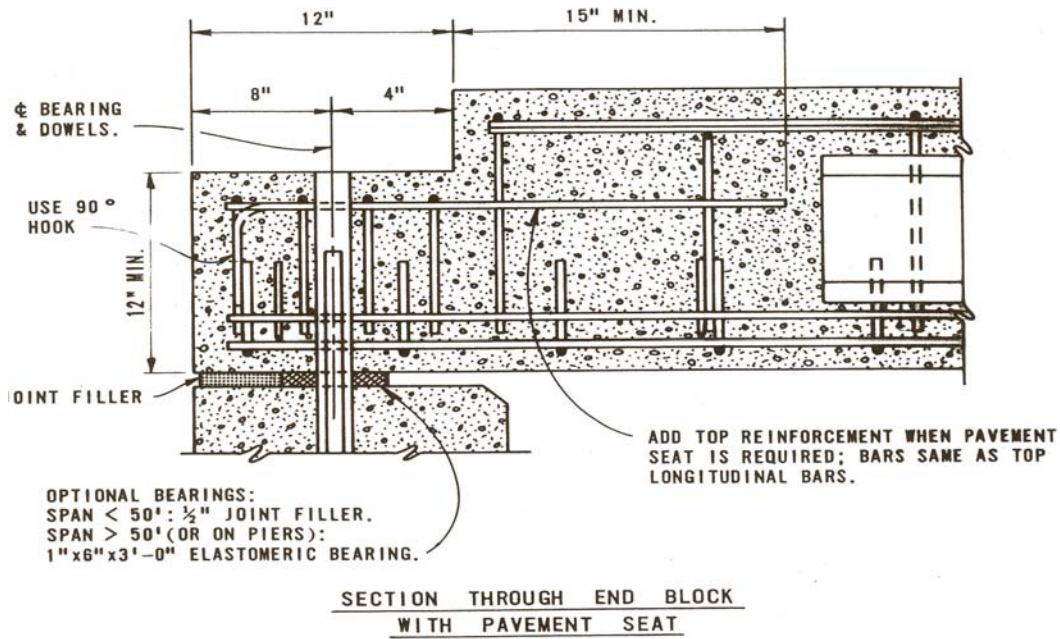
Figure 2-11: Detailing of end block (1977)

Use of the new bearing conditions stopped in 1977 and the end block design of the box-beam was changed (Figure 2-11). The end block was changed again in 1979 (Figure 2-12).

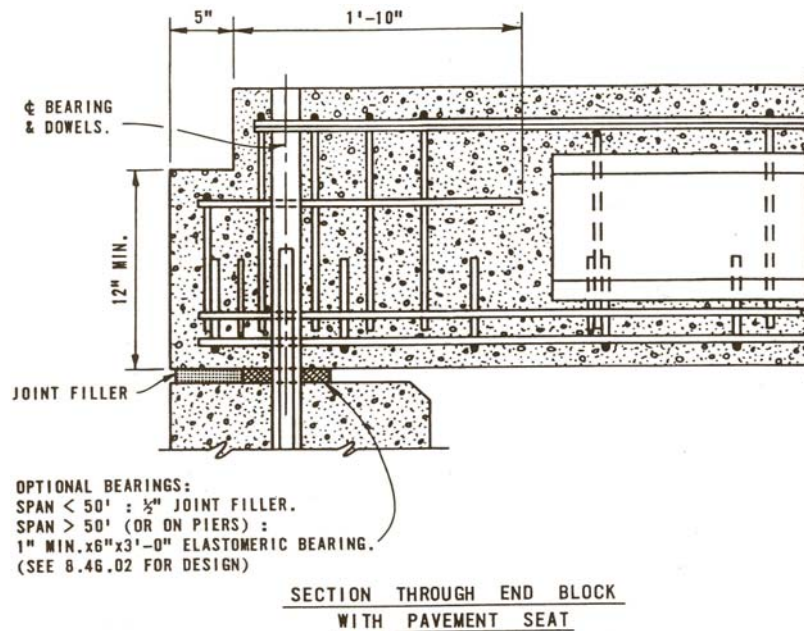
Figure 2-12: Detailing of end block (1979)

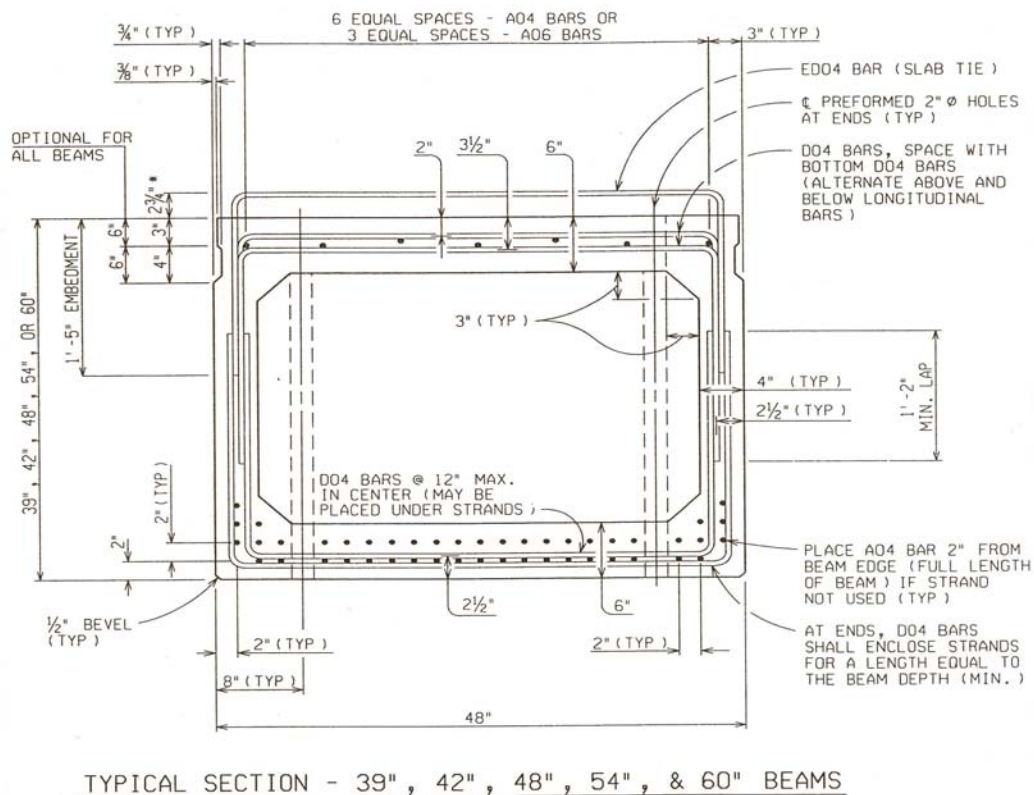
**Figure 2-14: Detailing of typical box-beam section (2001)**

In 2001, bottom flange thickness of the 36-inch wide box-beam was increased from 4.5 inches to 6 inches to provide more cover for double layers of prestressing strands while top flange thickness remains at 5 inches. The top and bottom flange thickness of a 48-inch wide box-beam is 6 inches. The spacing between adjacent box-beams may vary from 1½ to 3 inches.

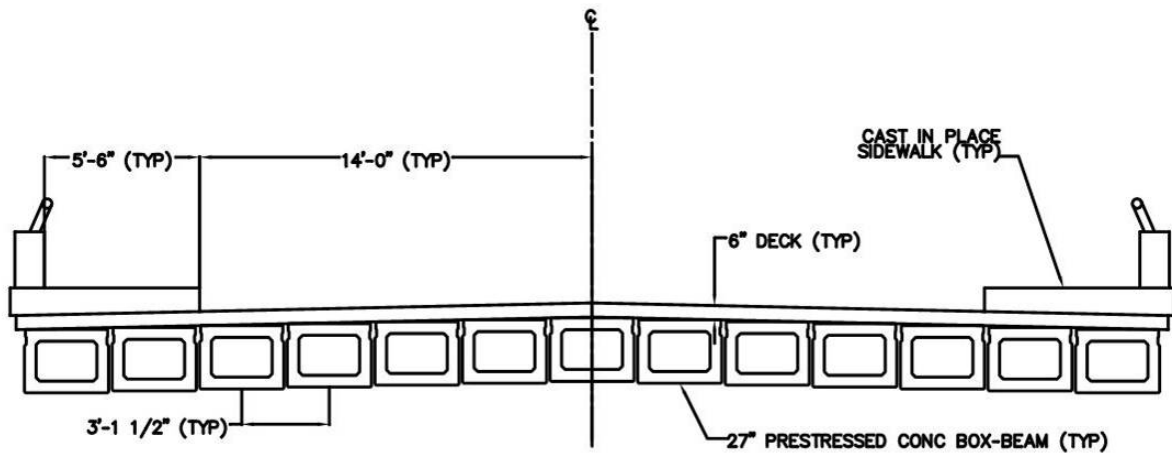
Figure 4-1: Cross-section: prestressed concrete side-by-side box-beam bridge (Example A)

Sample calculations for two of the nine load ratings performed as part of this project are found in Appendix G of this report. The control load rating represents the bridge in excellent condition (Case A-1). This example is reproduced from the *Bridge Analysis Guide* (MDOT 2003a) Example 6. This was done to allow those familiar with the example to better understand the effects of distress and to serve as a check on the calculations. Errors were found in the draft version of the referenced example, however, correction of these showed agreement between the results of Example 6 and Case A-1 of this report. Several calculations, such as prestress losses, were not recalculated in Appendix G. The reader is referred to the *Bridge Analysis Guide* (MDOT 2003a) Example 6 for a full and detailed description of equation references and calculations. The second example shows the effects of a concrete spall and loss of several prestressed strands (Case A-3). Parameters influenced by deterioration and the values used in each case are indicated in Table 4-4. A cross-section and elevation of the bridge used for Example A of the load rating, independent of distress level, is shown in Figures 4-1 and 4-2 respectively.

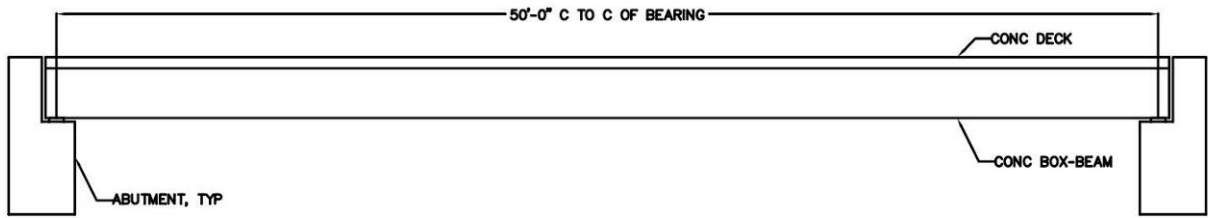
**Figure 4-2: Elevation: prestressed concrete side-by-side box-beam bridge (Example A)**

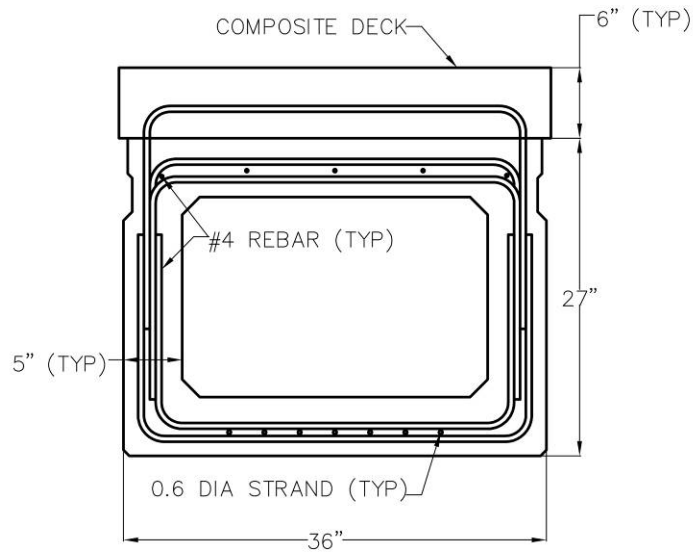
**Figure 4-3: 27-in composite box-beam – excellent condition**

A cross-sectional view of the beam used for the control condition in Example A is shown in Figure 4-3. This beam was modified by spalls and severed strands as described in Table 4-3, a cross-sectional view of the distressed section of Example A is shown in Figure 4-4.

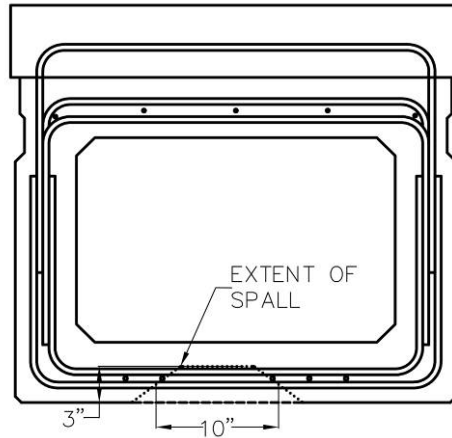
**Figure 4-4: 27-in composite box-beam – spalled concrete and severed strands**

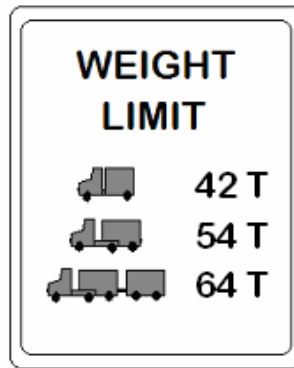
**Figure 4-5: Example of posted Michigan limits from load rating calculations (Case A-3)**

Only one deterioration model used in the examples was found to have a live load capacity exceeded by one or more legal-load vehicles. The deterioration model, Case A-3, included a 30-inch<sup>2</sup> spall and three severed strands. The weight restrictions were calculated as explained in Section 4.6.1 and are displayed in Figure 4-5 as an example weight limit sign to be posted at the bridge location. It should be noted that these values are different from those reported in the operating rating results of Table 4-7. This is because the vehicle with the smallest moment to weight ratio is used to determine operating ratings. After determining which vehicles exceed the live load capacity of the structure, the vehicle with the largest moment to weight ratio is used to determine the posted load. A significant reduction in weight of a 2 and 3-unit vehicle was found. The maximum legal-load vehicles, as shown in Table 4-8, are the weight limits for all other cases.

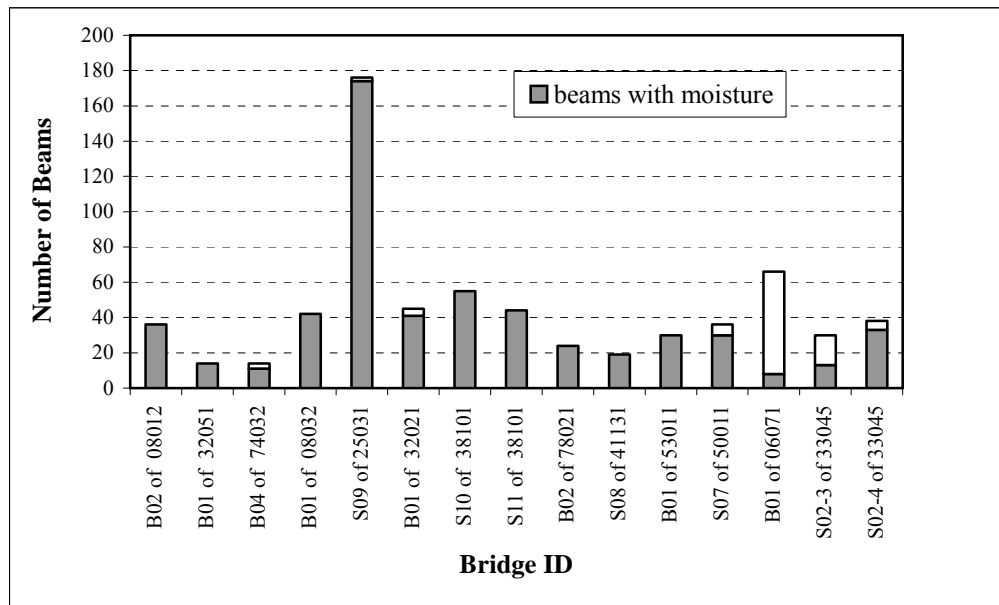
Figure 5-2: Observed beam moisture condition of the bridges inspected

Prolonged moisture exposure allows water penetration into the concealed sides of the beams. The moisture source appears to be surface water leaking from the deck cracks into the shear keys. Some beams become saturated as observed on the flange. Also repeated moisture exposure leads to efflorescence along the beam edges, shear keys and occasionally along the beam flanges. Calcium carbonate ( $\text{CaCO}_3$ ) deposits along the beam edges are observed indicating long term moisture exposure. Figure 5-2 shows the beam moisture conditions for the 15 bridges. Nearly all inspected beams showed prolonged exposure to moisture except for one bridge.

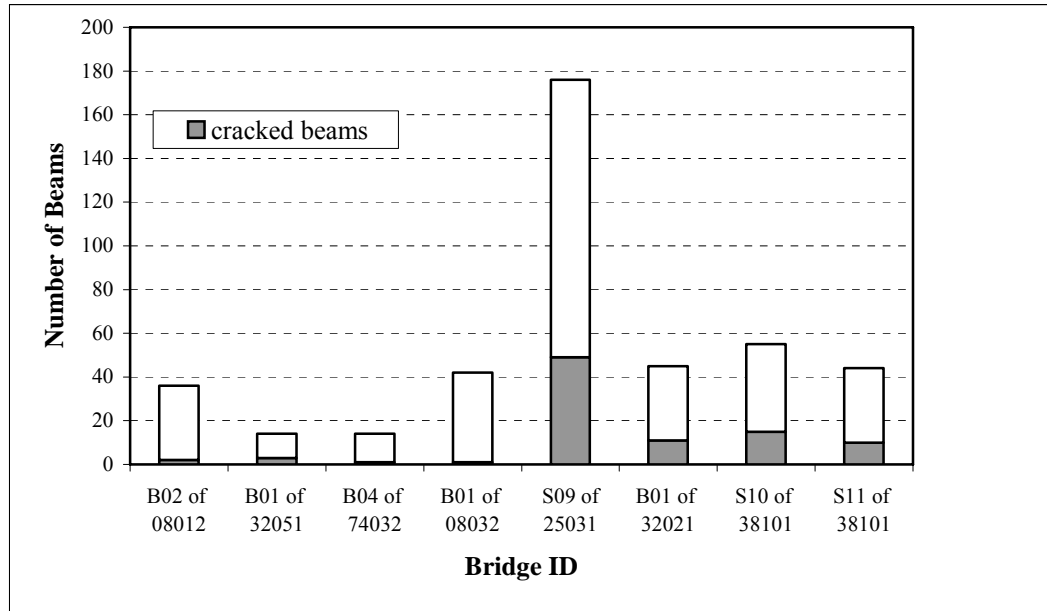
**Figure 5-3: Number of longitudinally cracked beams on bridges built before 1985**

by the freezing of water collected in the hollow cells. Longitudinal cracking on the beam flanges were common to bridges built before 1985. Beams designed in the 1950's and 1960's did not have stirrups in the bottom flange to control cracking. A summary showing the number of cracked beams of bridges built before 1985 is given in Figure 5-3. All types of cracks observed on the bottom flange were taken into consideration for generating Figure 5-3. For bridges built after 1985, longitudinal cracking was not observed.

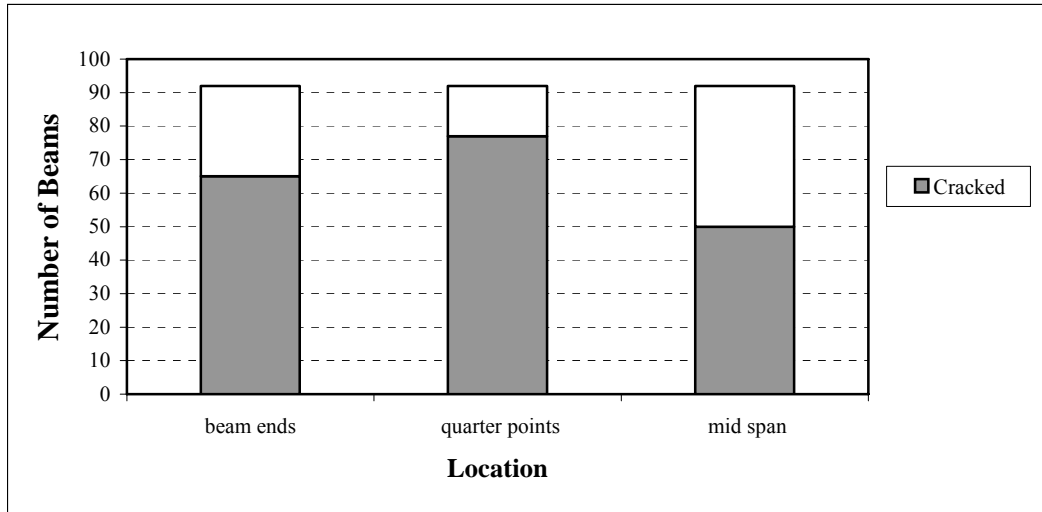
**Figure 5-4: Number of cracks at specified locations along the beam length**

The cracking location along the beam length was documented. Figure 5-4 shows the locations of the cracks along the beam length. As seen in the figure there are no dominant crack locations.

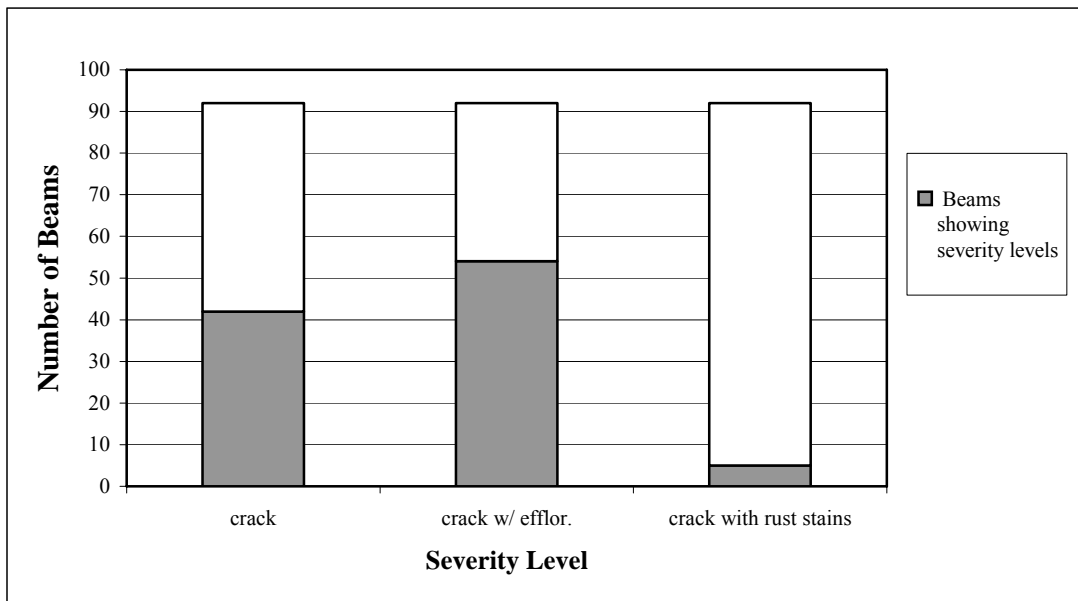
**Figure 5-5: Summary of crack severity levels on beams**

The severity of the cracks was noted for each beam. The three severity levels defined were: only crack, crack with efflorescence, and crack with rust stains. Very few cracks showed rust stains, the majority of the cracks were cracks or cracks with efflorescence. A summary of the severity levels of cracked beams is shown in Figure 5-5.

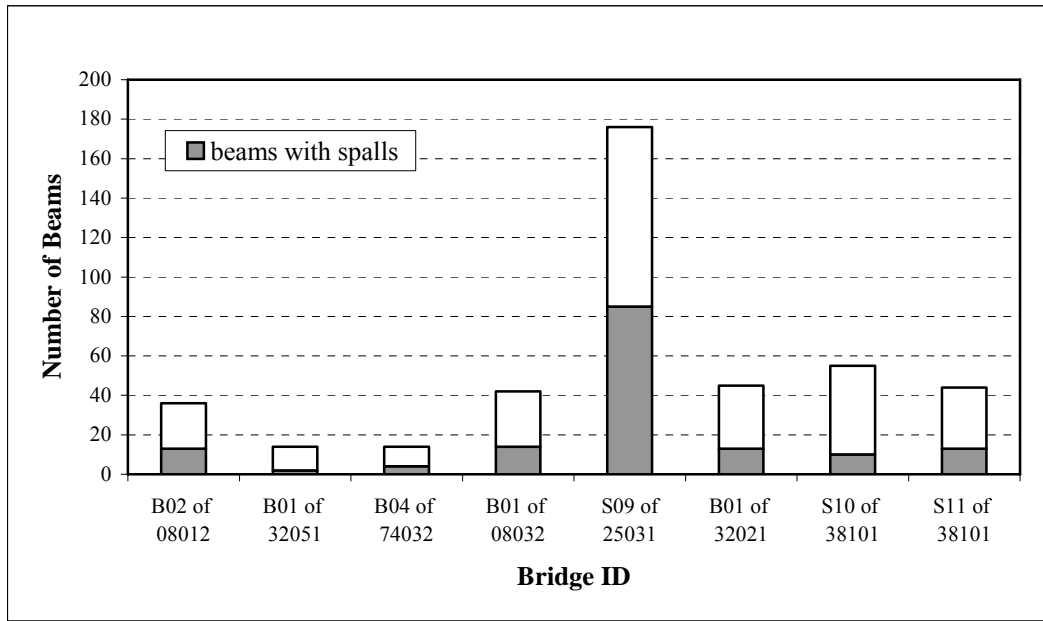
**Figure 5-6: Summary of beams with spalls for bridges built before 1985**

Prolonged moisture exposure initiates tendon and rebar corrosion which will result in delamination, cracking, and spalling of concrete. Corrosion stains were visible along the cracks on the bottom flange. The summary of beams with spalls on bridges built before 1985 is given in Figure 5-6. Concrete spalling was not observed on bridges constructed after 1985. The majority of concrete spalls were concentrated along the beam edges. Tendon breakage was observed infrequently.

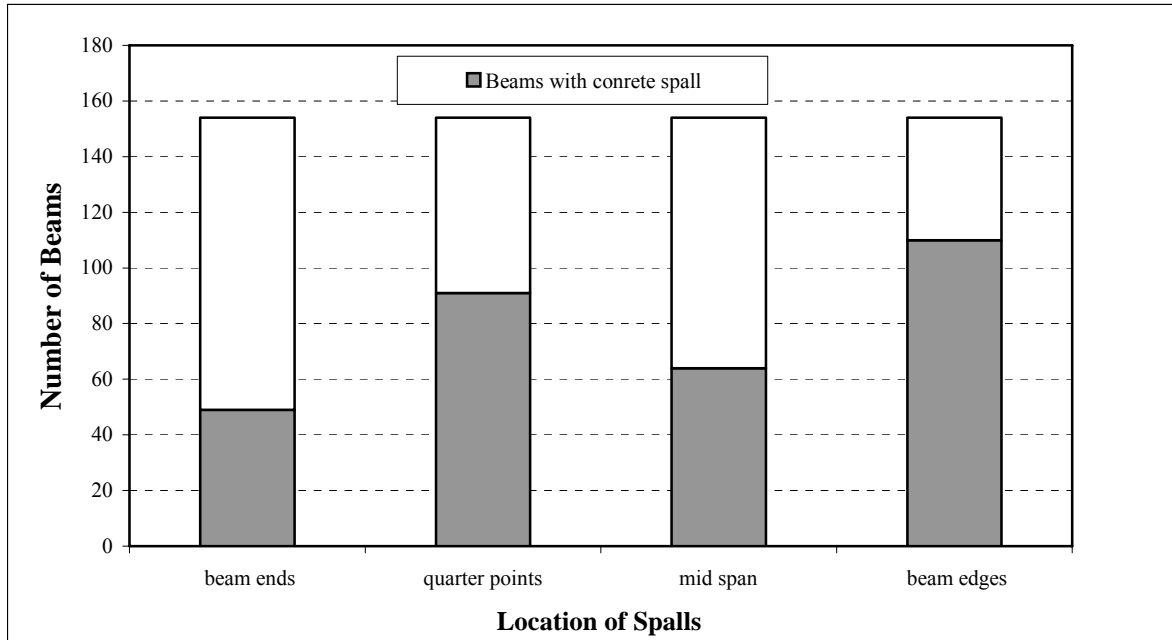
**Figure 5-7: Summary of location of spalls**

The spall locations were documented. Beams with spalls at the ends, quarter points, and midspan were documented. Also, spalls along the beam edges or shear key were noted. Figure 5-7 shows the spall locations on the beams. It appears that the spall locations are evenly distributed along the beam length.

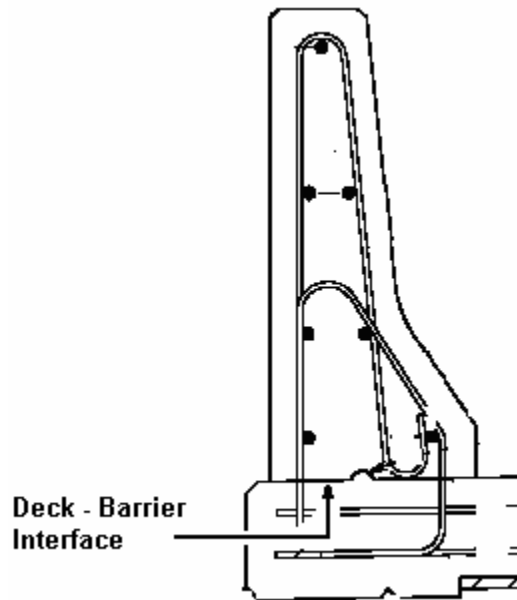
Figure 5-15: Cold joint between the traffic barrier and the deck (deck-barrier interface)

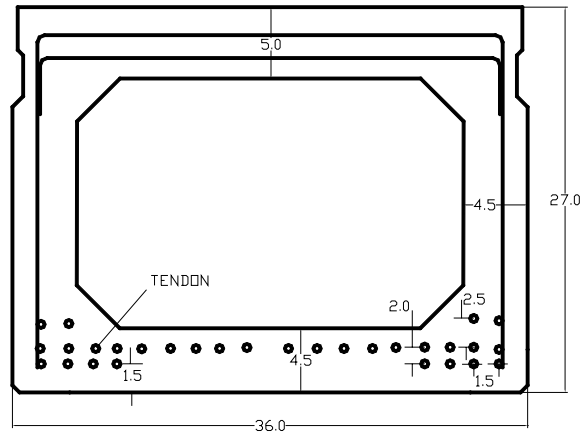
**Figure 6-6: Beam cross-section and tendon geometry for flexure critical model (dimensions in inches)**

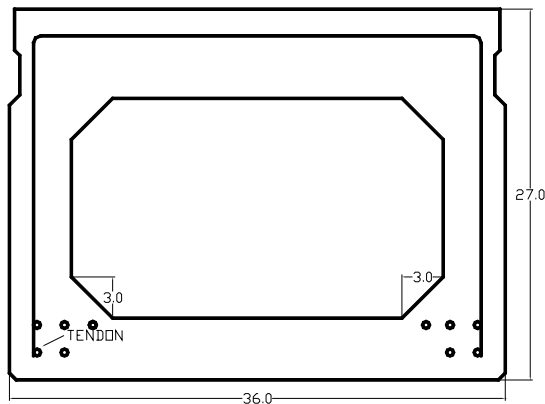
**Figure 6-7: Beam cross-section and tendon geometry for shear critical model (dimensions in inches)**

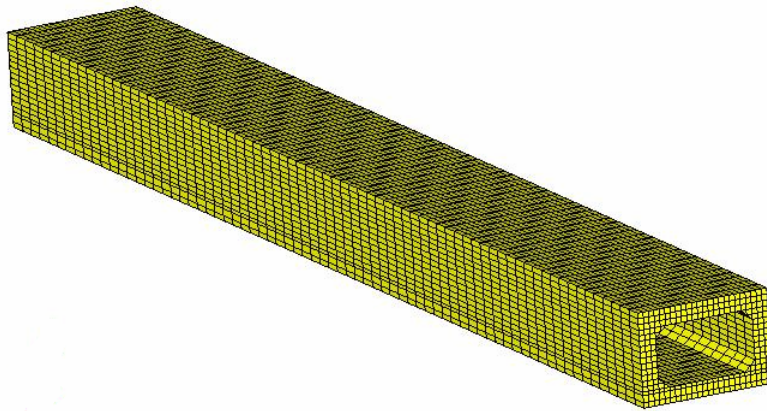
**Figure 6-8: Finite element model of box-beam**

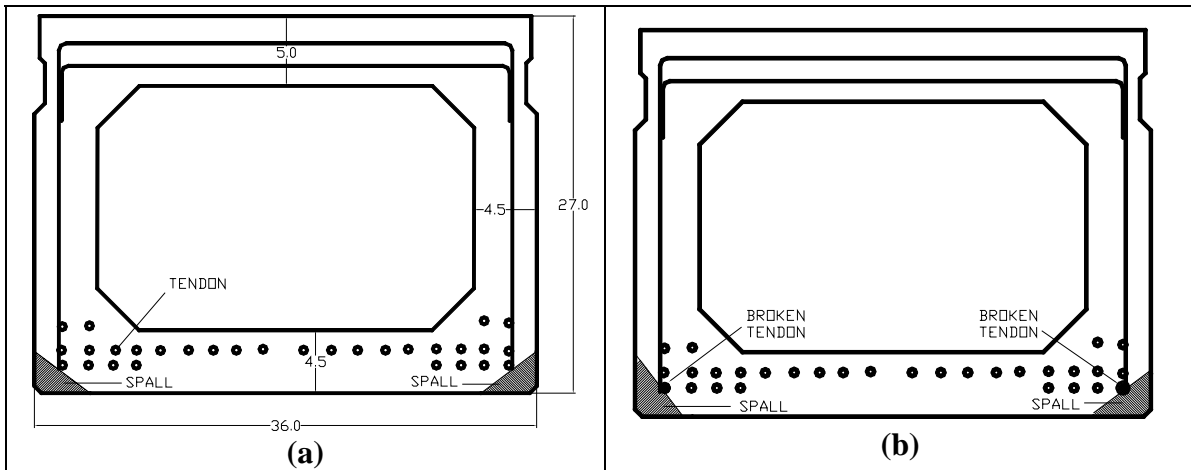
**Figure 6-9: Distress level 2 and 3 - (a) concrete spall and (b) spall and two broken tendons**

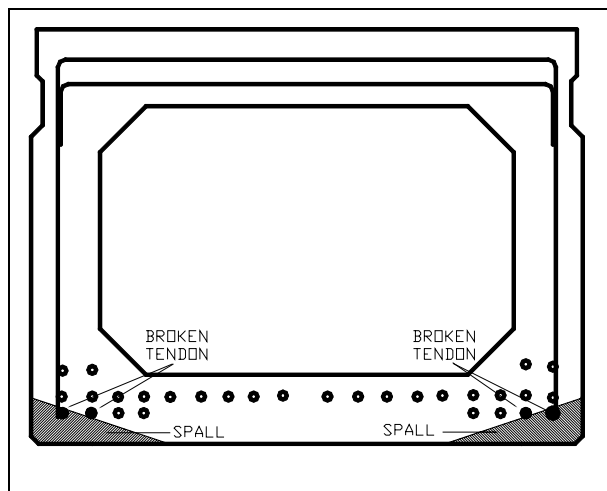
**Figure 6-10: Distress level 4 - spall and four broken strands**

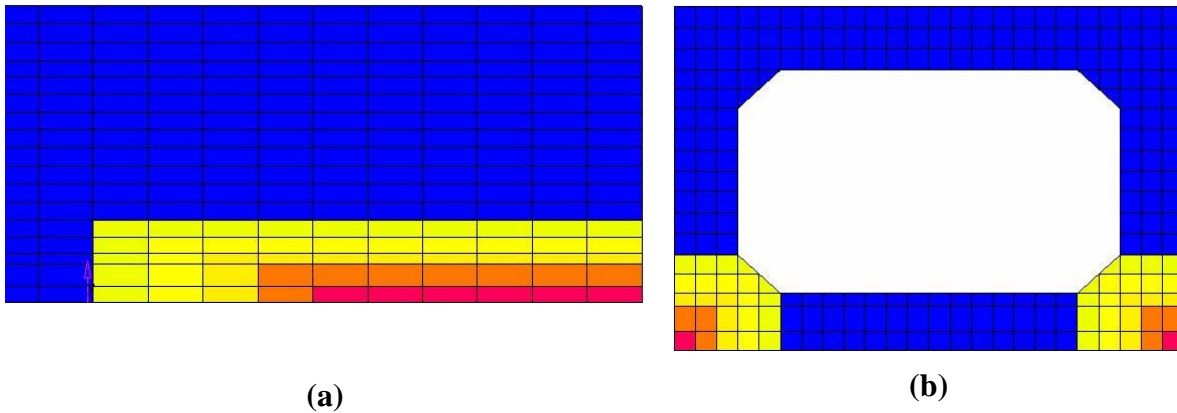
**Figure 6-11: Finite element model of distress levels 2 and 3: (a) enlarged view of one half of the distress zone along length and (b) section view of the distress zone (note: broken strands are not visible)**

Concrete spalling is modeled by incorporating the effect of partial section loss. This effect was generated in the FE analysis by significantly reducing the elasticity modulus of the concrete elements within the distress zones. Figure 6-11 shows an example of a spall for distress levels two and three. Figure 6-12 illustrates the spall in distress level four.

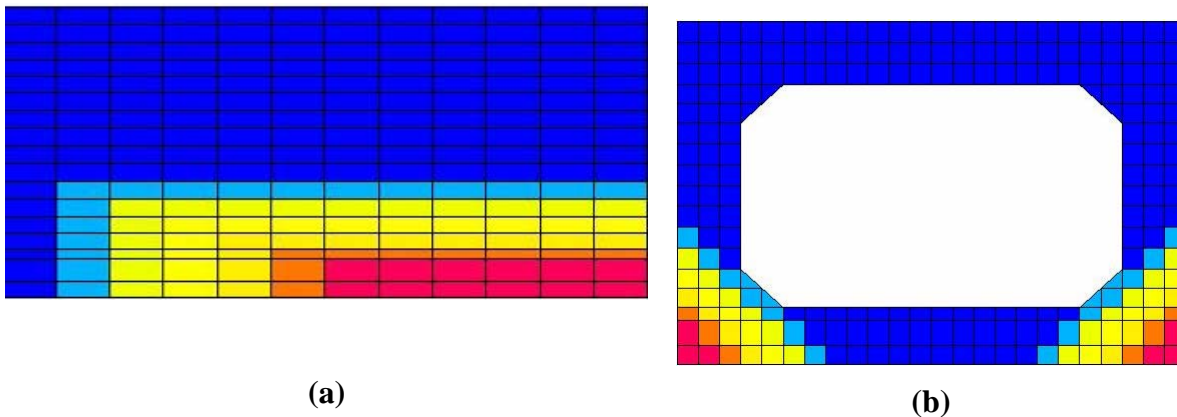
**Figure 6-12: Finite element model of distress level 4: (a) enlarged view of one half of the distress zone along length and (b) section view of the distress zone (note: broken strands are not visible)**

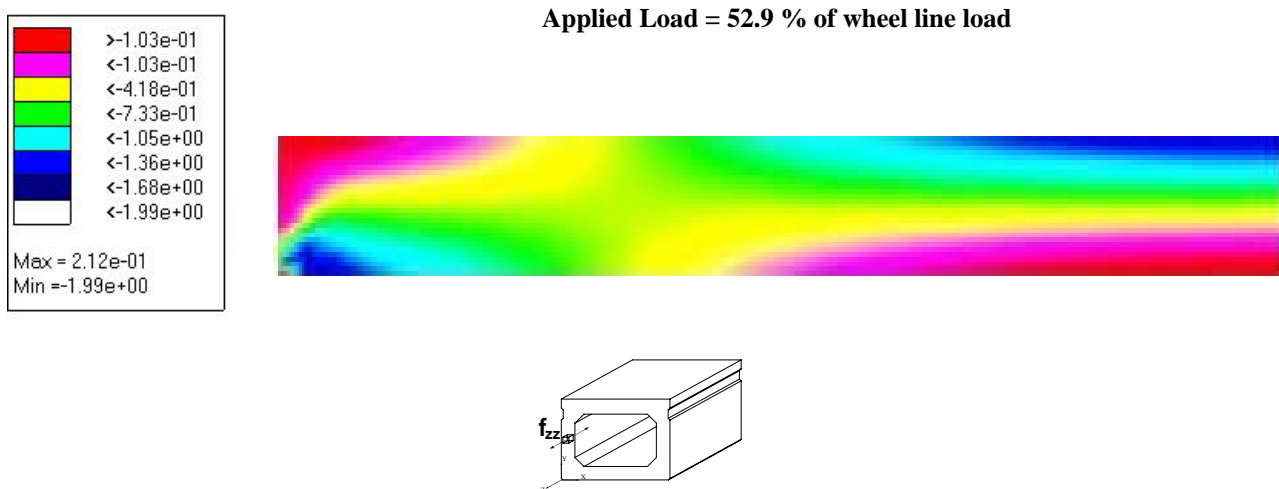
**Figure 6-14: Level 1 – undamaged axial stress ( $f_{zz}$ ) (ksi) trajectory along the length of box-beam for maximum moment at mid span (partial view, supported on left)**

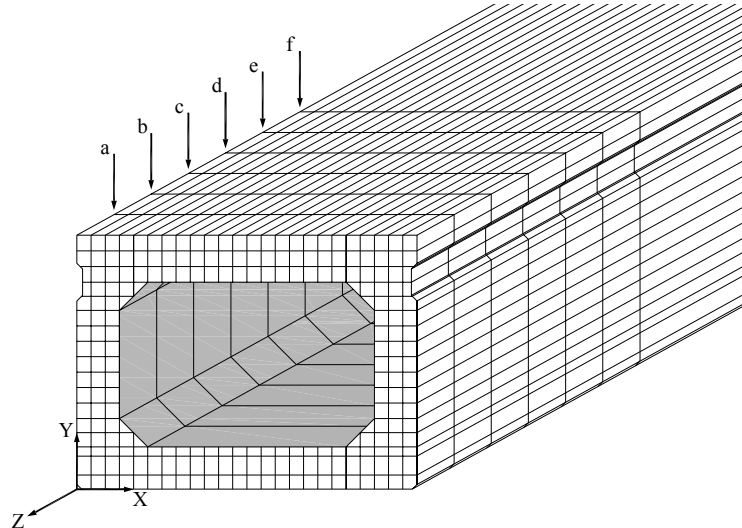
**Figure 6-18: Sections at which the shear stress distribution is evaluated**

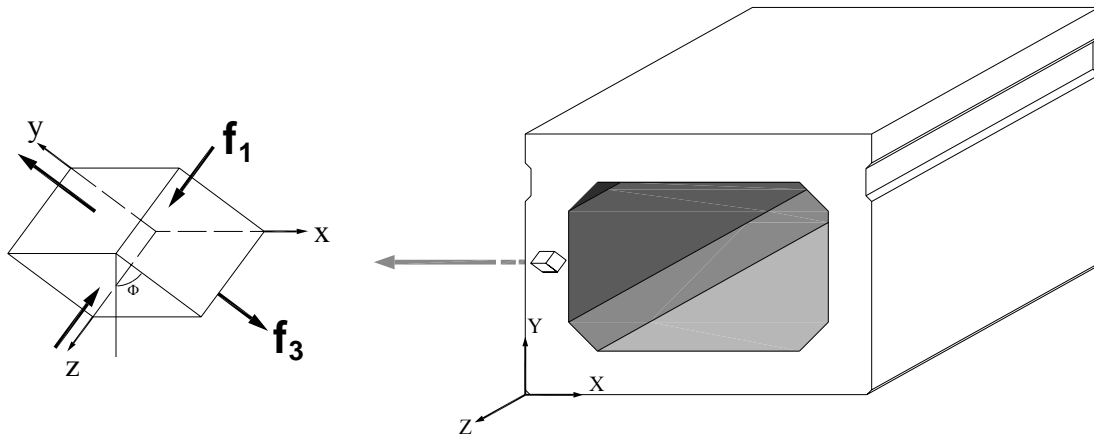
**Figure 6-19: Principal stresses on a finite element**
