### **Development and Validation of a Sensor-Based Health Monitoring Model for the Parkview Bridge Deck**

**Sponsored by Michigan Department of Transportation**

Final Report

January 31, 2012

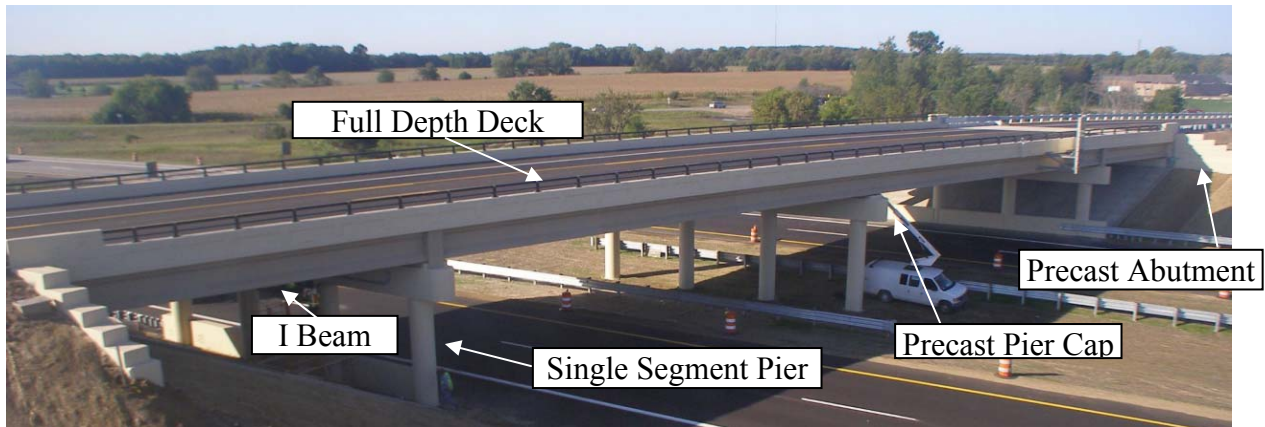
**Figure 5-1. Completed Parkview Bridge**

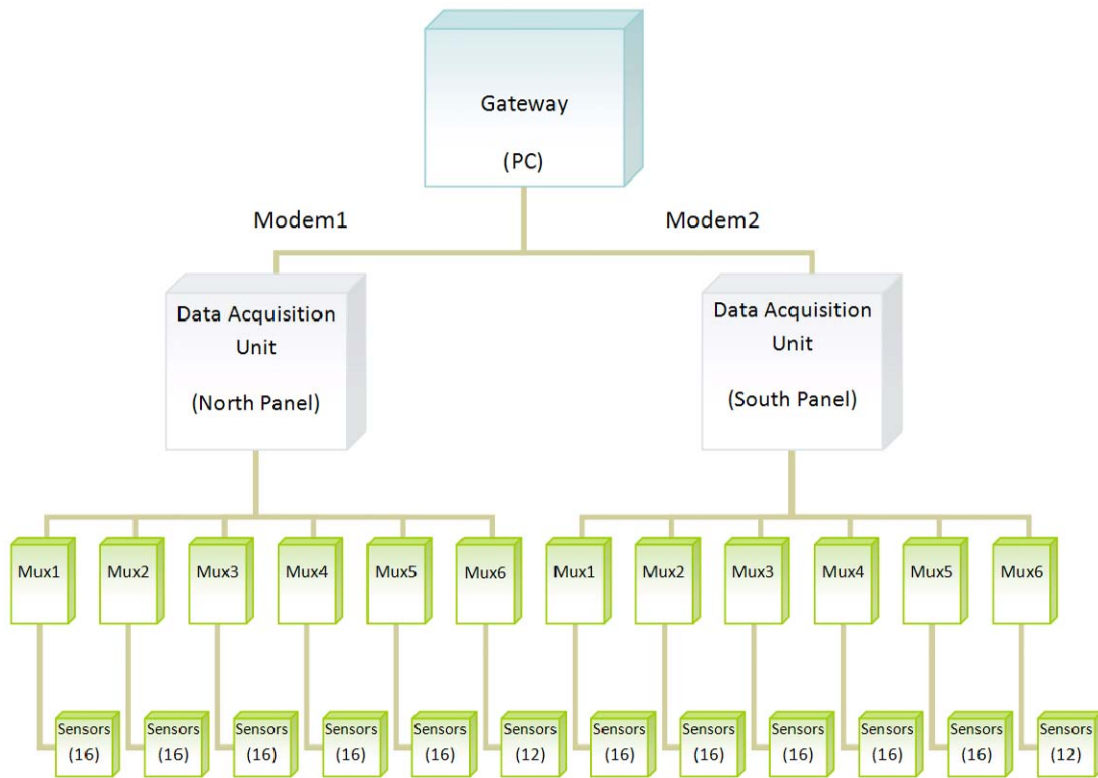
The two data loggers are contacted weekly through the modems and the telephone lines are dedicated to downloading and archiving the sensor data for future analysis. The SHM system started to function in December 2008. Therefore, data archiving for a period of three years has been completed, and a baseline for future continuous monitoring of this bridge's health condition has been developed. Figure 5-2 provides a schematic view of the system configuration.

**Figure 5-2. Schematic view of the Parkview Bridge SHM system configuration**

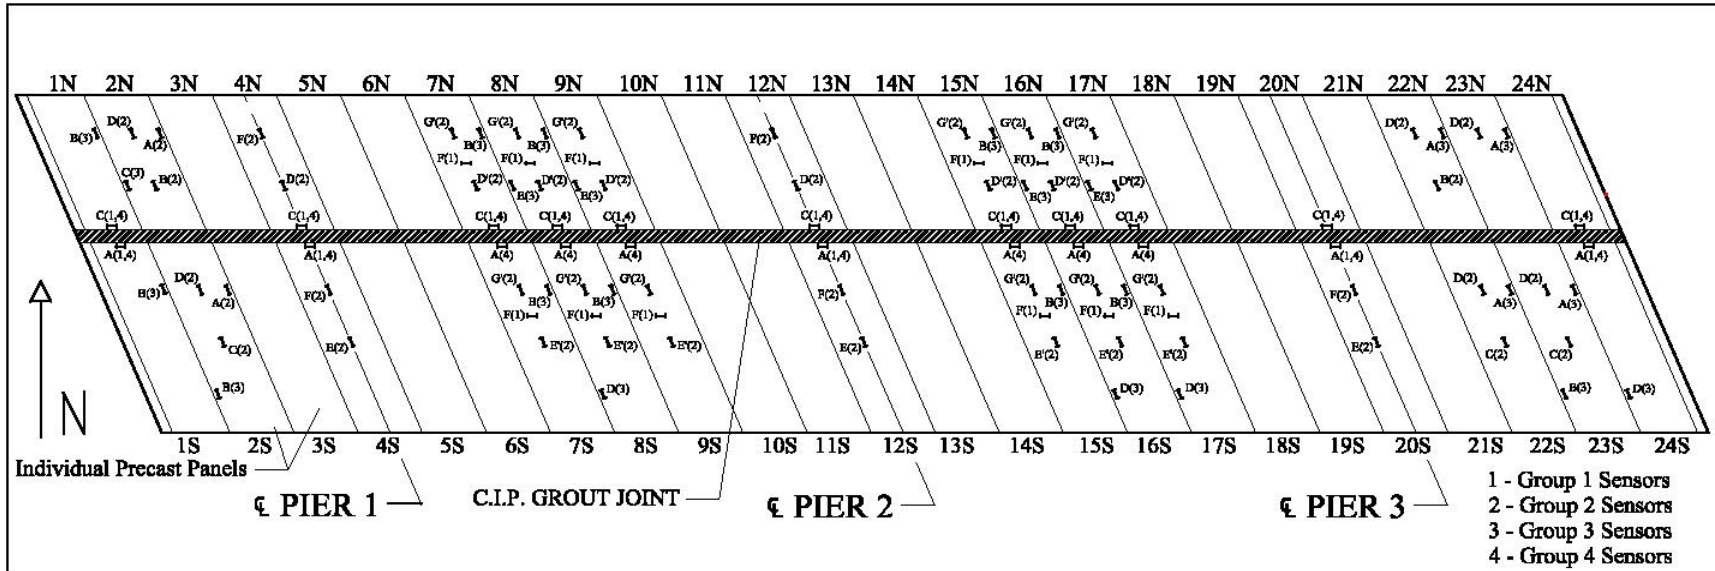
Figure 5-3 shows the locations and labels of all the sensors in the panels, and provides the group number for each sensor in parentheses. The construction details in terms of the plans and specifications for the design and installation of the selected instrumentation are provided in (Abudayyeh 2010).

Figure 5-3. Parkview Bridge deck layout\*

\*Note: the number between ( ) represents the group number(s) that the sensor belongs to.

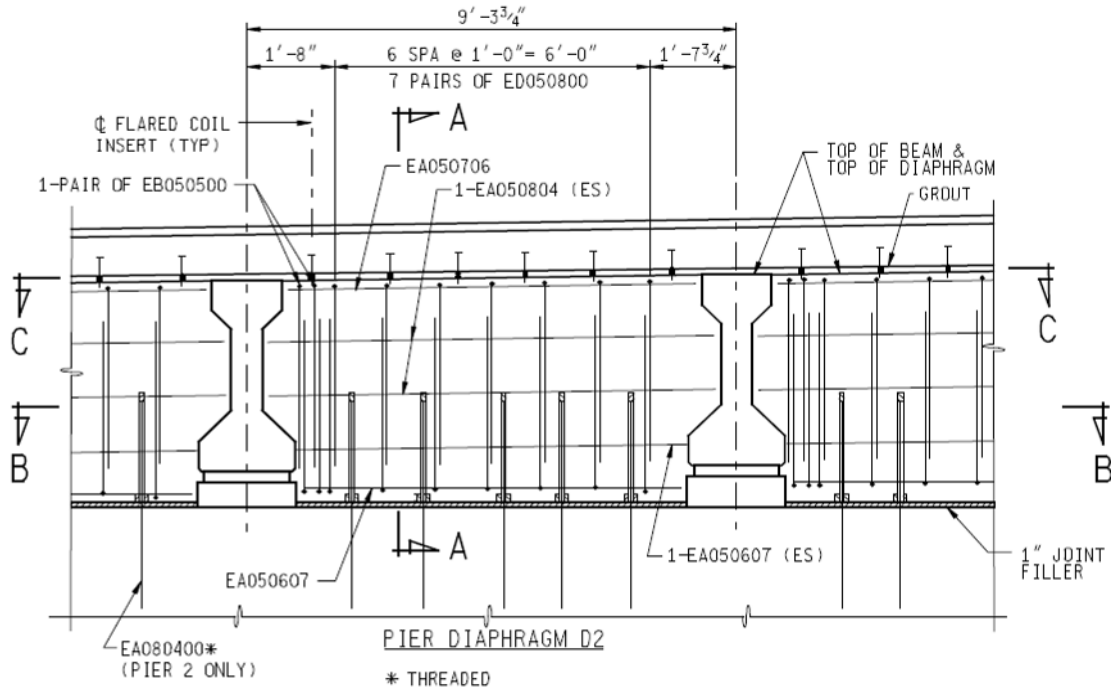
Figure 6-3. Pier-diaphragm-beam end connection details

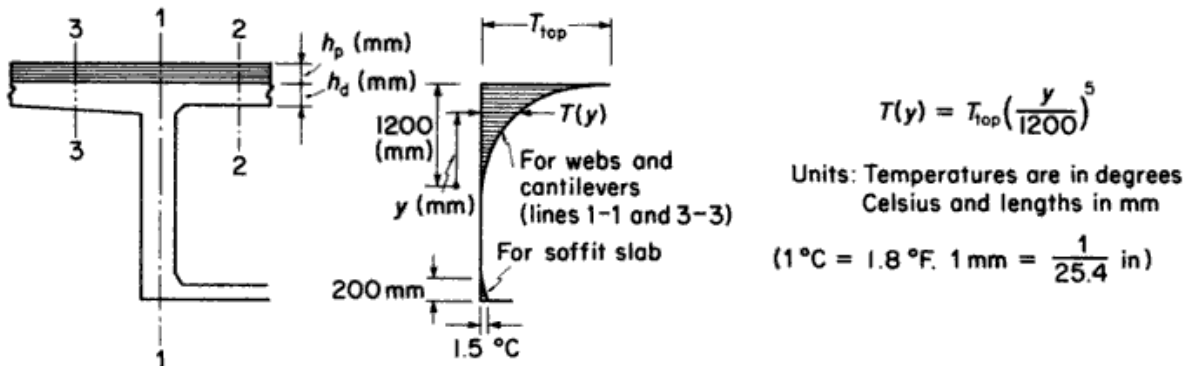
The thermal gradient profiles specified in AASHTO (2010) are defined for design purposes. The analysis performed in this project is to understand the structural performance; hence, the use of thermal gradient profile through the depth of bridge superstructure, at the time of interest, is important. This is a great challenge as there were no temperature sensors placed through the cross-section depth. Extensive literature review was performed and various recommendations were reviewed in order to identify thermal gradient profile representatives of a day in summer and a day in winter. Priestly (1976) proposed that vertical temperature gradient, during a period that the deck heats up follows a fifth-degree parabola (Figure 6-10). The example presented by Priestly (1976) is a box-girder in which the temperature reaches ambient value at a depth of 47.24 in. along the web during an early afternoon of a hot summer day.

Figure 6-10. Temperature profile proposed by Priestly (1976)

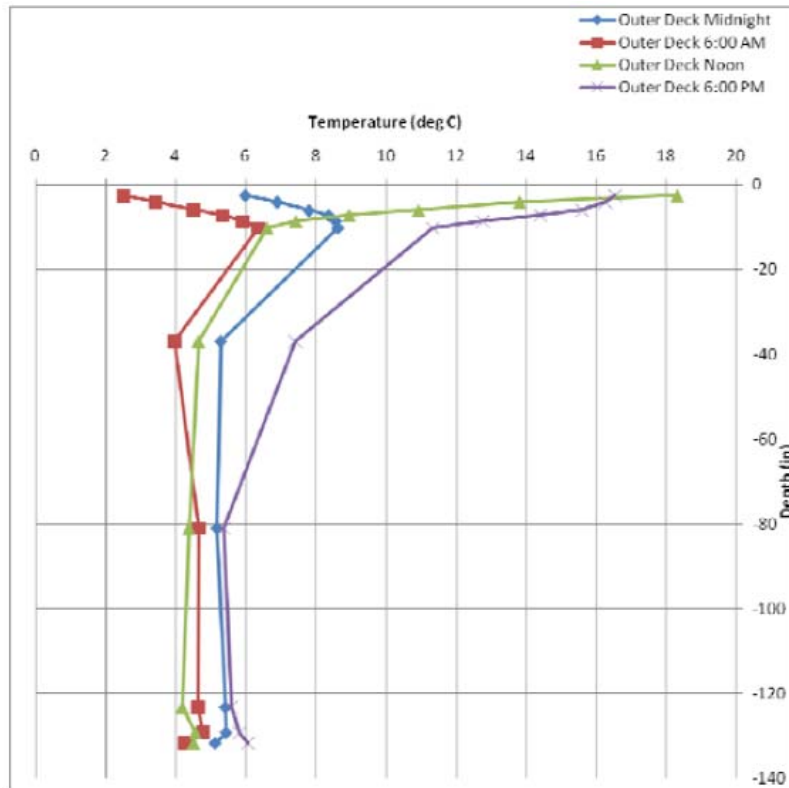
Based on a set of data collected over a period of 18 hours from the I-35W St. Anthony Falls Bridge, French et al. (2009) developed thermal gradients through the depth at midnight, 6 a.m., noon and 6 p.m. (Figure 6-11). The data collected at noon closely represents the fifth-order model presented by Priestly (1976). The profile at 6 p.m. closely represents a second-order curve.

Figure 6-11. Thermal gradient profiles at different times of a day (Source: French 2009)

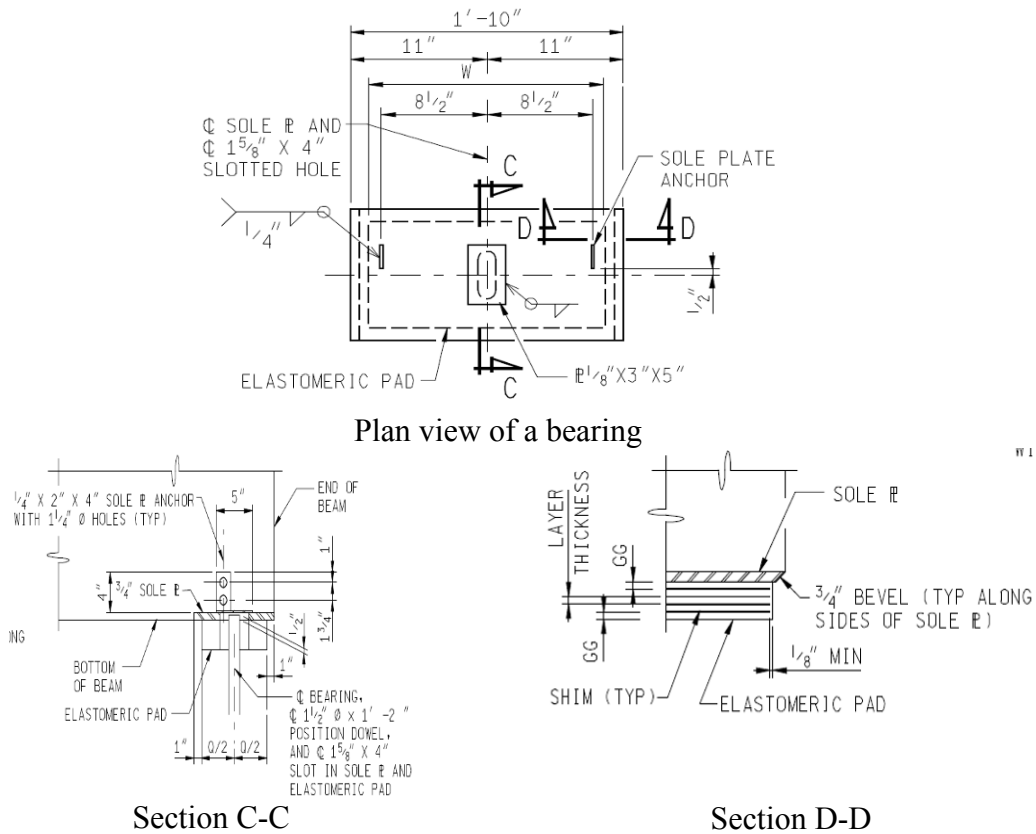
Movement is allowed over pier 1 and 3 while fixed bearings are used over pier 3 (Figure 6-1). Girder movement is allowed in the direction of the girder centerline by providing a slotted sole plate based on bearing details provided in Figure 6-17 and Table 6-8. Note that elastomeric pads are not used over the abutments. Further, dowels are used to connect the backwall to the abutment developing integral abutment details (Figure 6-18). As per the design plans, the shear moduli of plain elastomeric bearings and laminated elastomeric bearings are 200 psi (+/- 30 psi) and 100 psi (+/- 15 psi), respectively. Elastomeric bearing design is based on a maximum pressure of 500 psi under dead load and 800 psi under combined dead and live loads.

Figure 6-17. Bearing details

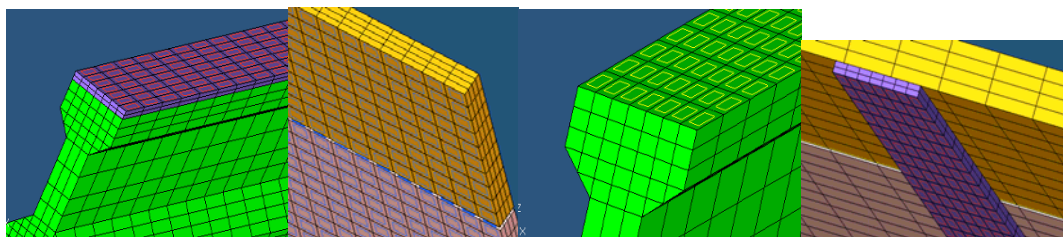
Interaction between dissimilar meshes can be established using contact interaction. Abaqus allows three different types of contact analysis which are general contacts, contact elements and contact pairs. According to Romkema (2010), the contact pair option requires a surface to be created at each interface but will yield more accurate results; hence, interaction between two dissimilar meshes was defined by using contact pair option in Abaqus. Details of this modeling process can be found in Romkema et al. (2010) and Simulia (2010). Master and slave surfaces were generated between the beam and haunch and haunch and deck panels (Figure 6-22).

Figure 6-22. Contact surfaces

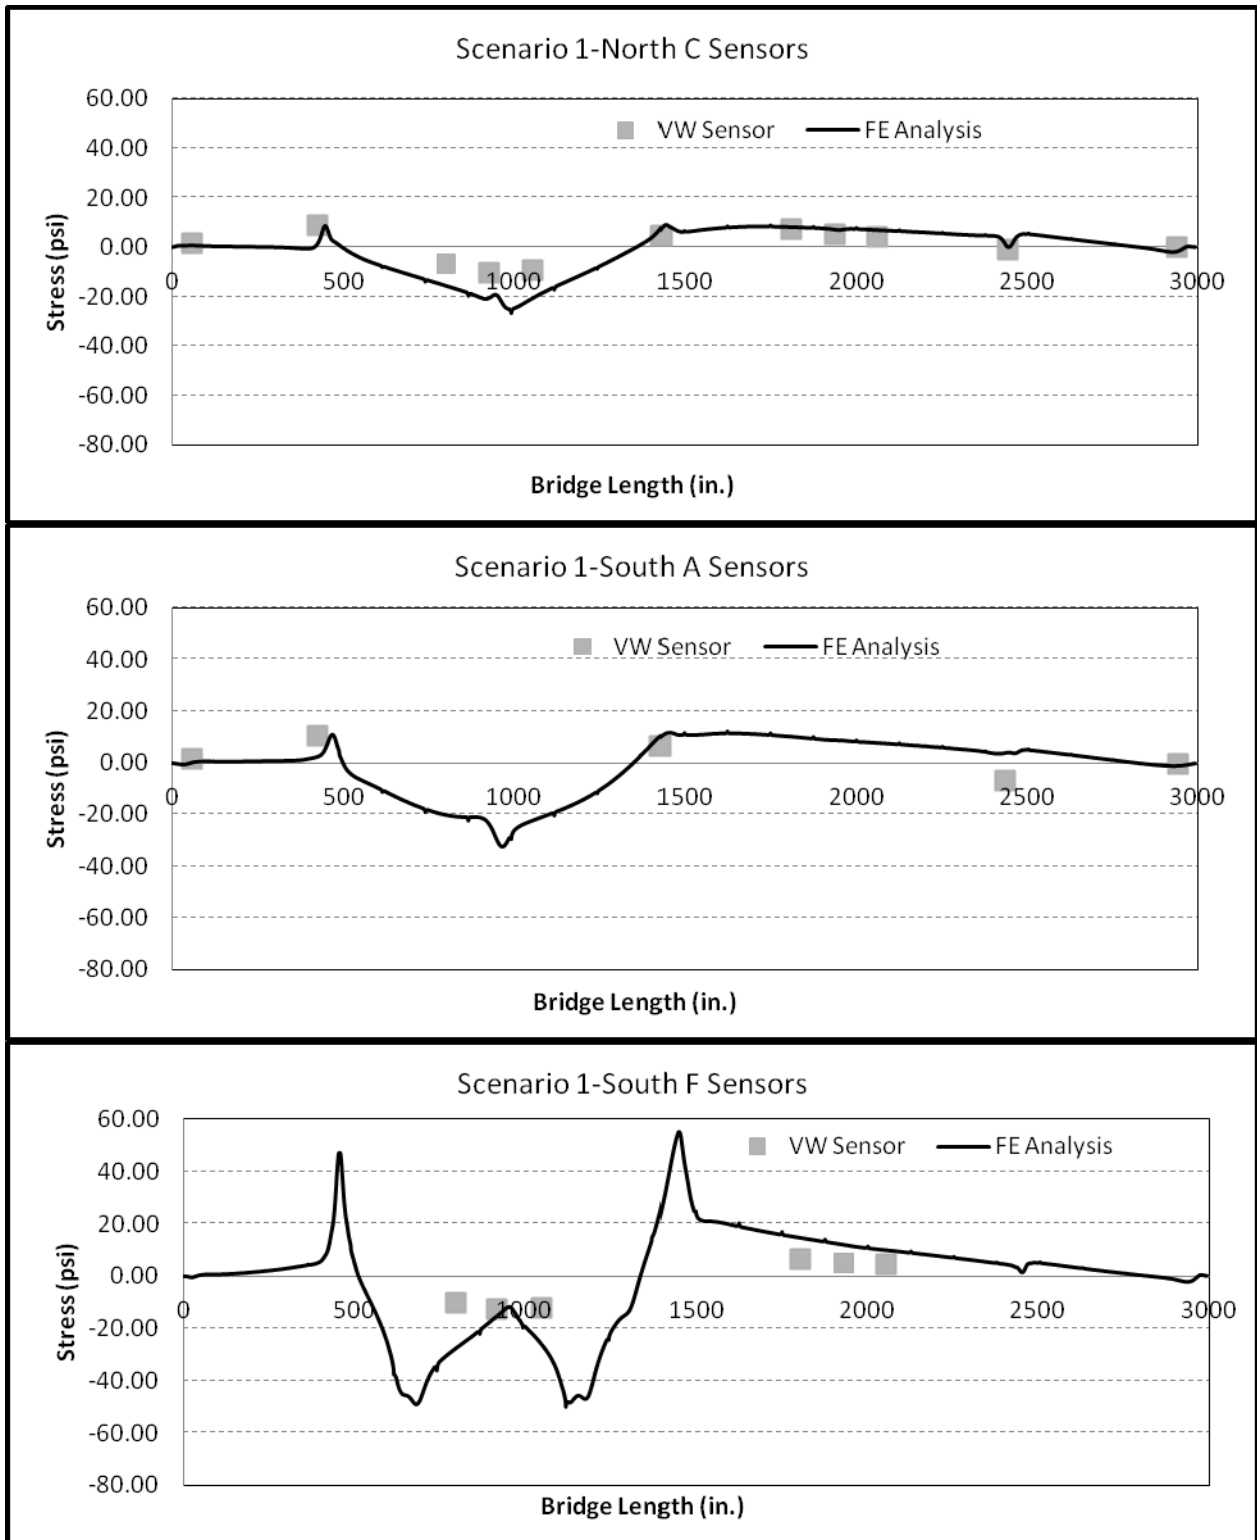
Figure 6-24. Comparison of load test data and FE analysis results – Scenario 1

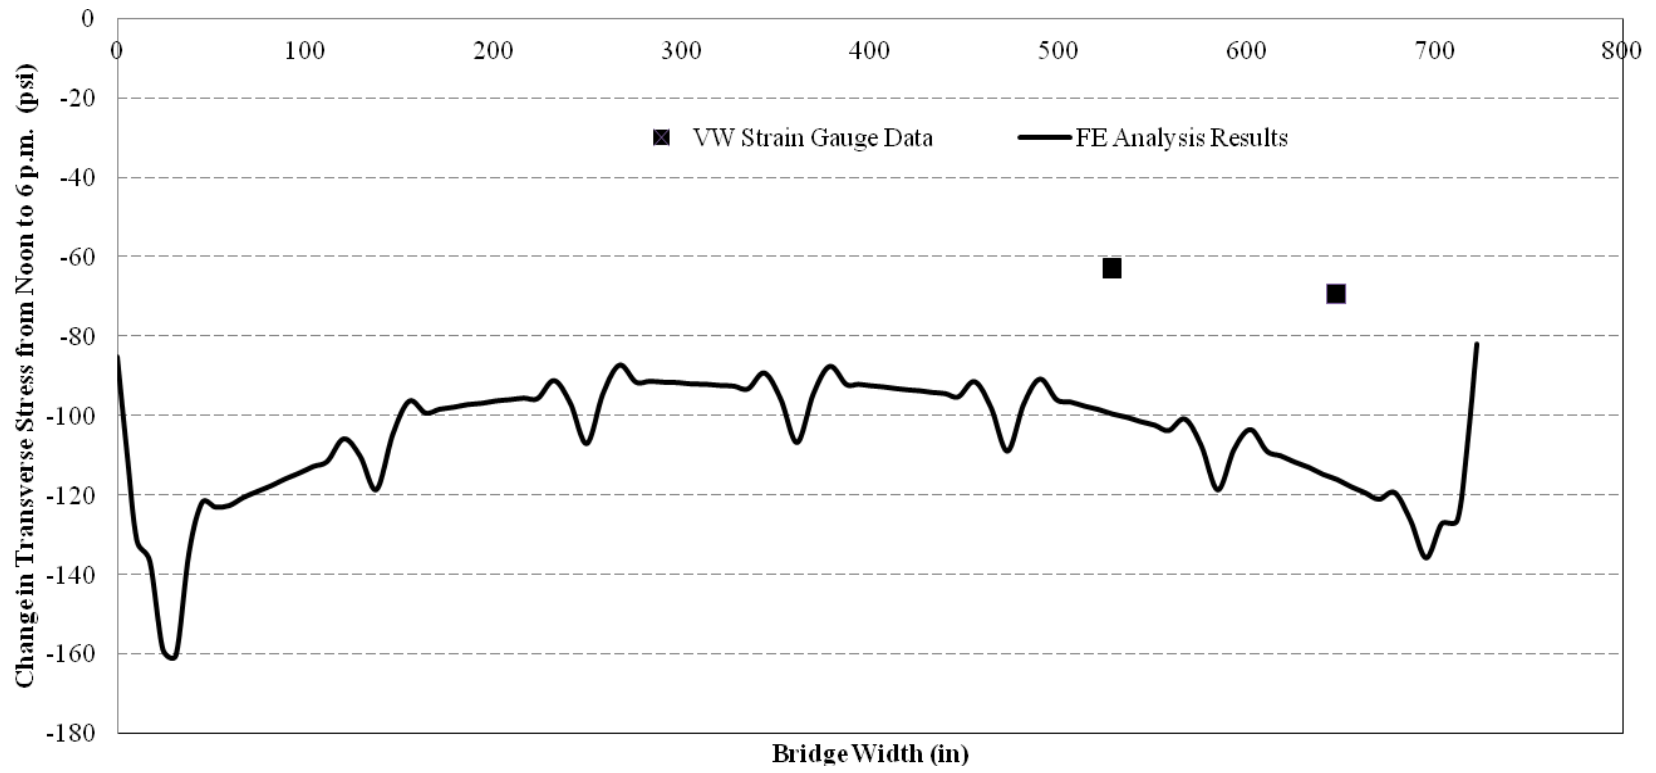
Figure 6-26. Change in transverse stress from noon to 6 p.m. under thermal load

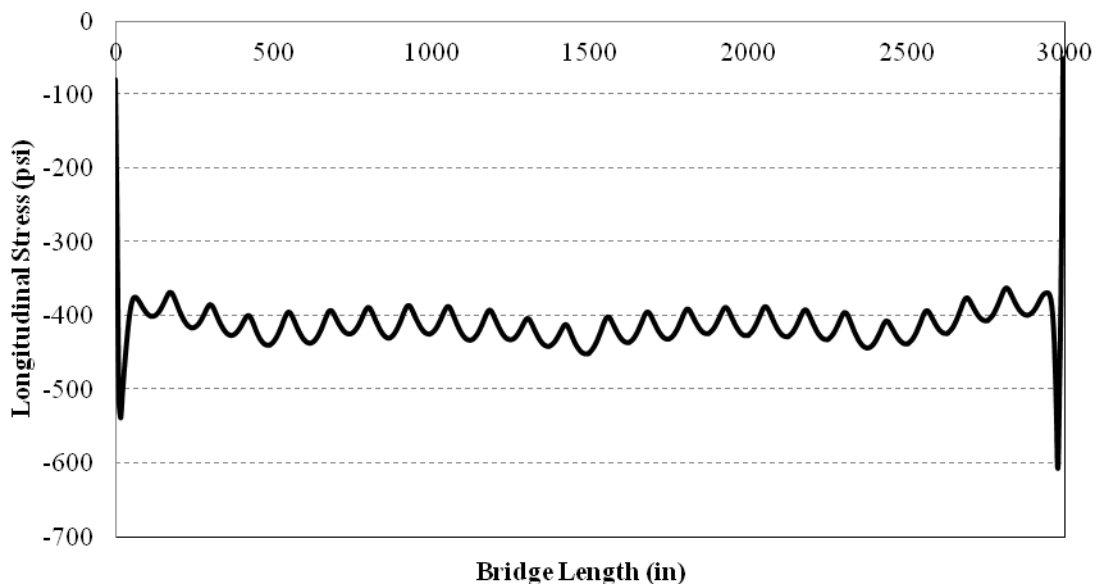
Figure 6-28. Bridge deck stresses at the end of construction

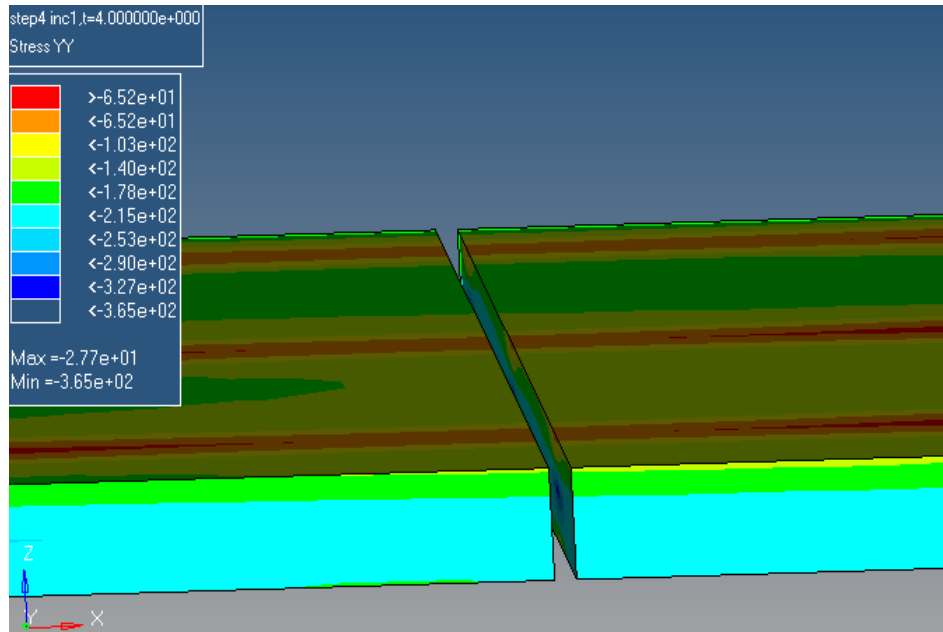
**Figure 6-29. Deck panel transverse stress at 6 p.m. - without joint deterioration (psi)**

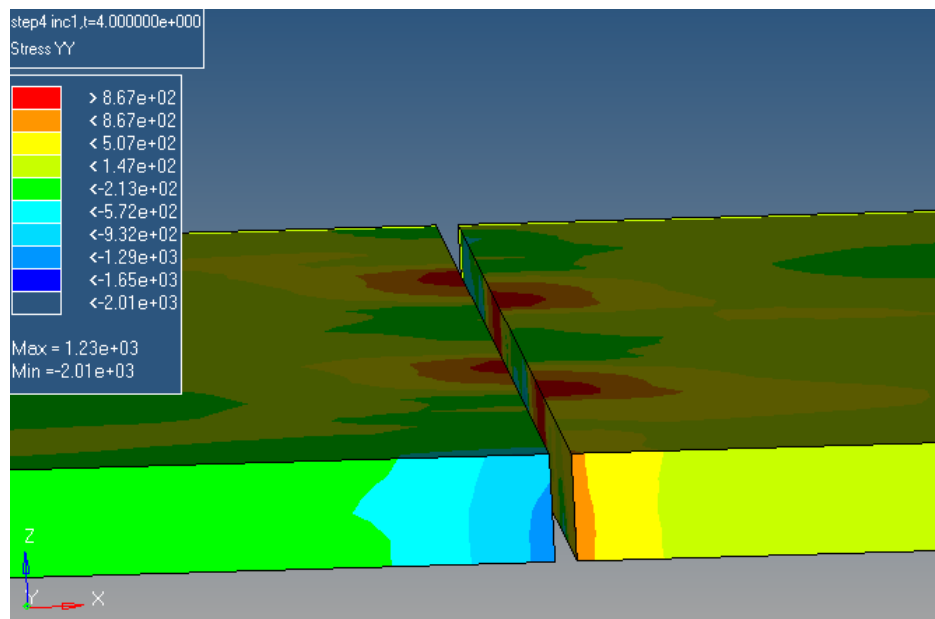
Deterioration of joint between panel 7 and 8 on the north span (i.e., 7N and 8N in Figure 6-23) was considered. Considering the worst case scenario, joint separation was simulated. Abaqus version 6.10 allows changing material properties between analysis steps. This option was used and grout modulus of elasticity was changed to a very small value so that there was no load transfer across the joint. Post-tension strands were continued through the joint, irrespective of the joint condition. Stress variation in panel 7N and 8N without and with deterioration is shown in Figure 6-29 and Figure 6-30, respectively. Stresses shown in the figures are due to change in temperature from noon to 6 p.m., as discussed in Section 6.4.3. When there is no deterioration at the joint, panel 7N and 8N behave monolithically while the deck panels remain compressed (note that the negative values presented in the figures represent compression). On the other hand, panels start to show tensile stresses as monolithic behavior between panels is lost due to deterioration at the joint (Figure 6-30).

**Figure 6-30. Deck panel transverse stress at 6 p.m. - with joint deterioration (psi)**

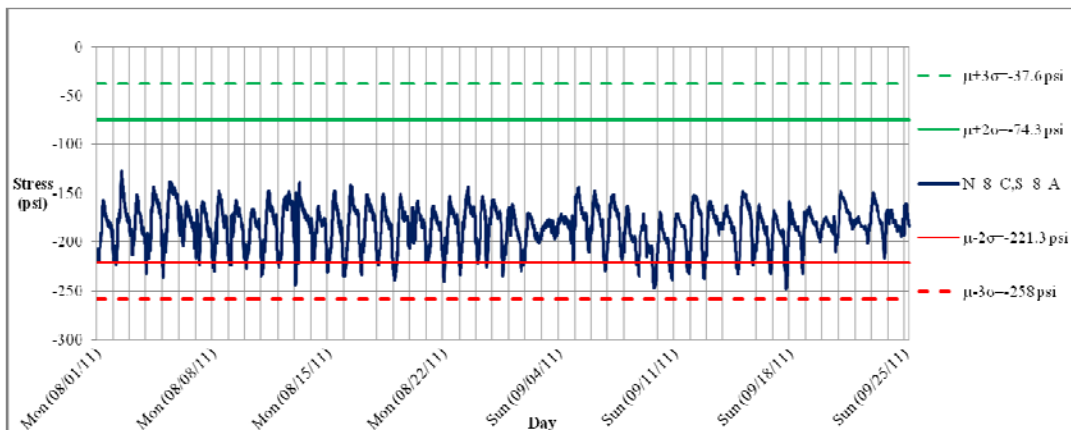
Figure 7-16. An example of the envelope for the closure grout sensors between north panel 8 and south panel 8 (Span 2) with stresses collected during August and September 2011.

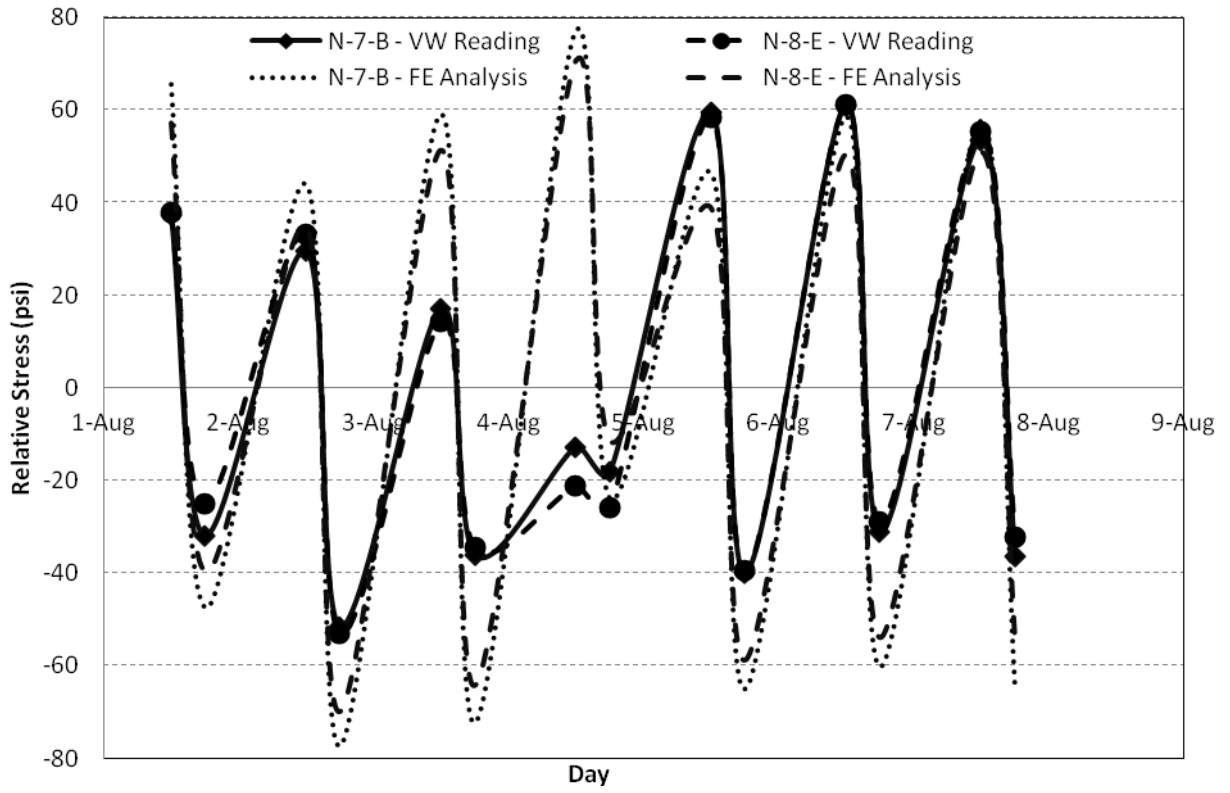
In order to recommend distress signatures for panel joints, a procedure similar to Section 7.1.3 was followed. The stress differences between sensor N-7-B and N-8-E were calculated from one week's data as shown in Figure 7-19. It is worth reiterating that the FE data shown in Figure 7-19 correspond to the change in stress at sensor locations due to change in temperature from 12 p.m. to 6 p.m. Differential stresses calculated from deteriorated model are greater than  $3\sigma$ ; beyond the 99% confidence level of the data recorded from the sensors. Hence, on-set of deterioration can be identified using sensor data once the differential stress envelopes and FE simulation results similar to Figure 7-19 are made available for each joint. However, before developing FE analysis results simulating deterioration of each joint in the system, it is required to fine-tune the model developed for the joint between panel 7N and 8N. Once long-term monitoring data is available, fine-tuning of distress signatures needs to be performed and further refinements to the  $3\sigma$  limits needs be evaluated.

Figure 7-17. Relative stress variation against time

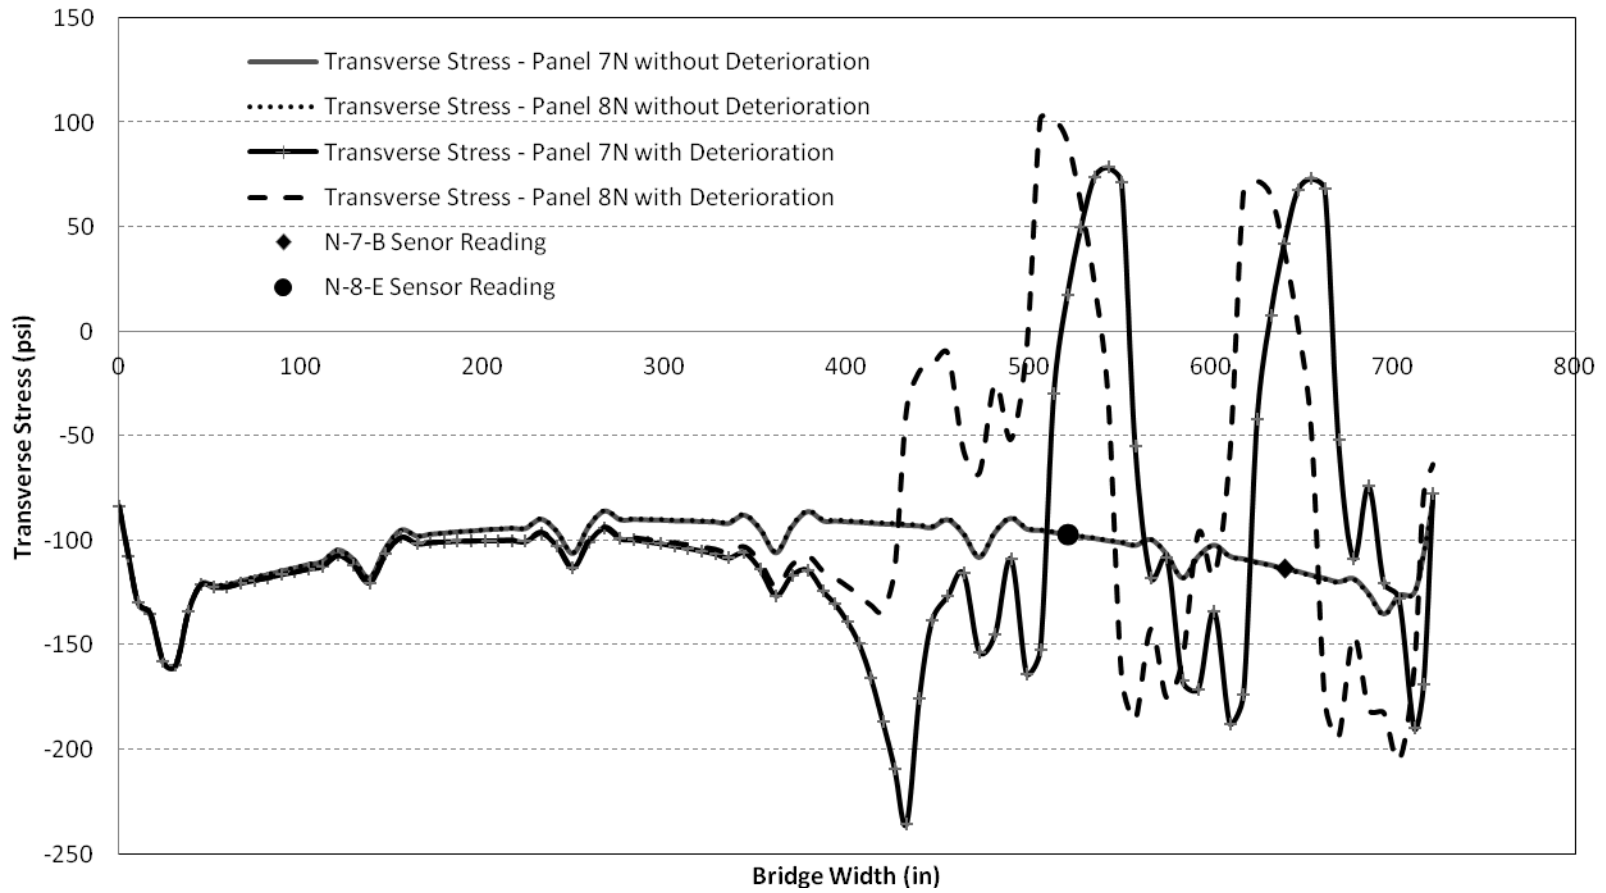
Figure 7-18. Transverse stress variation along the panel joint

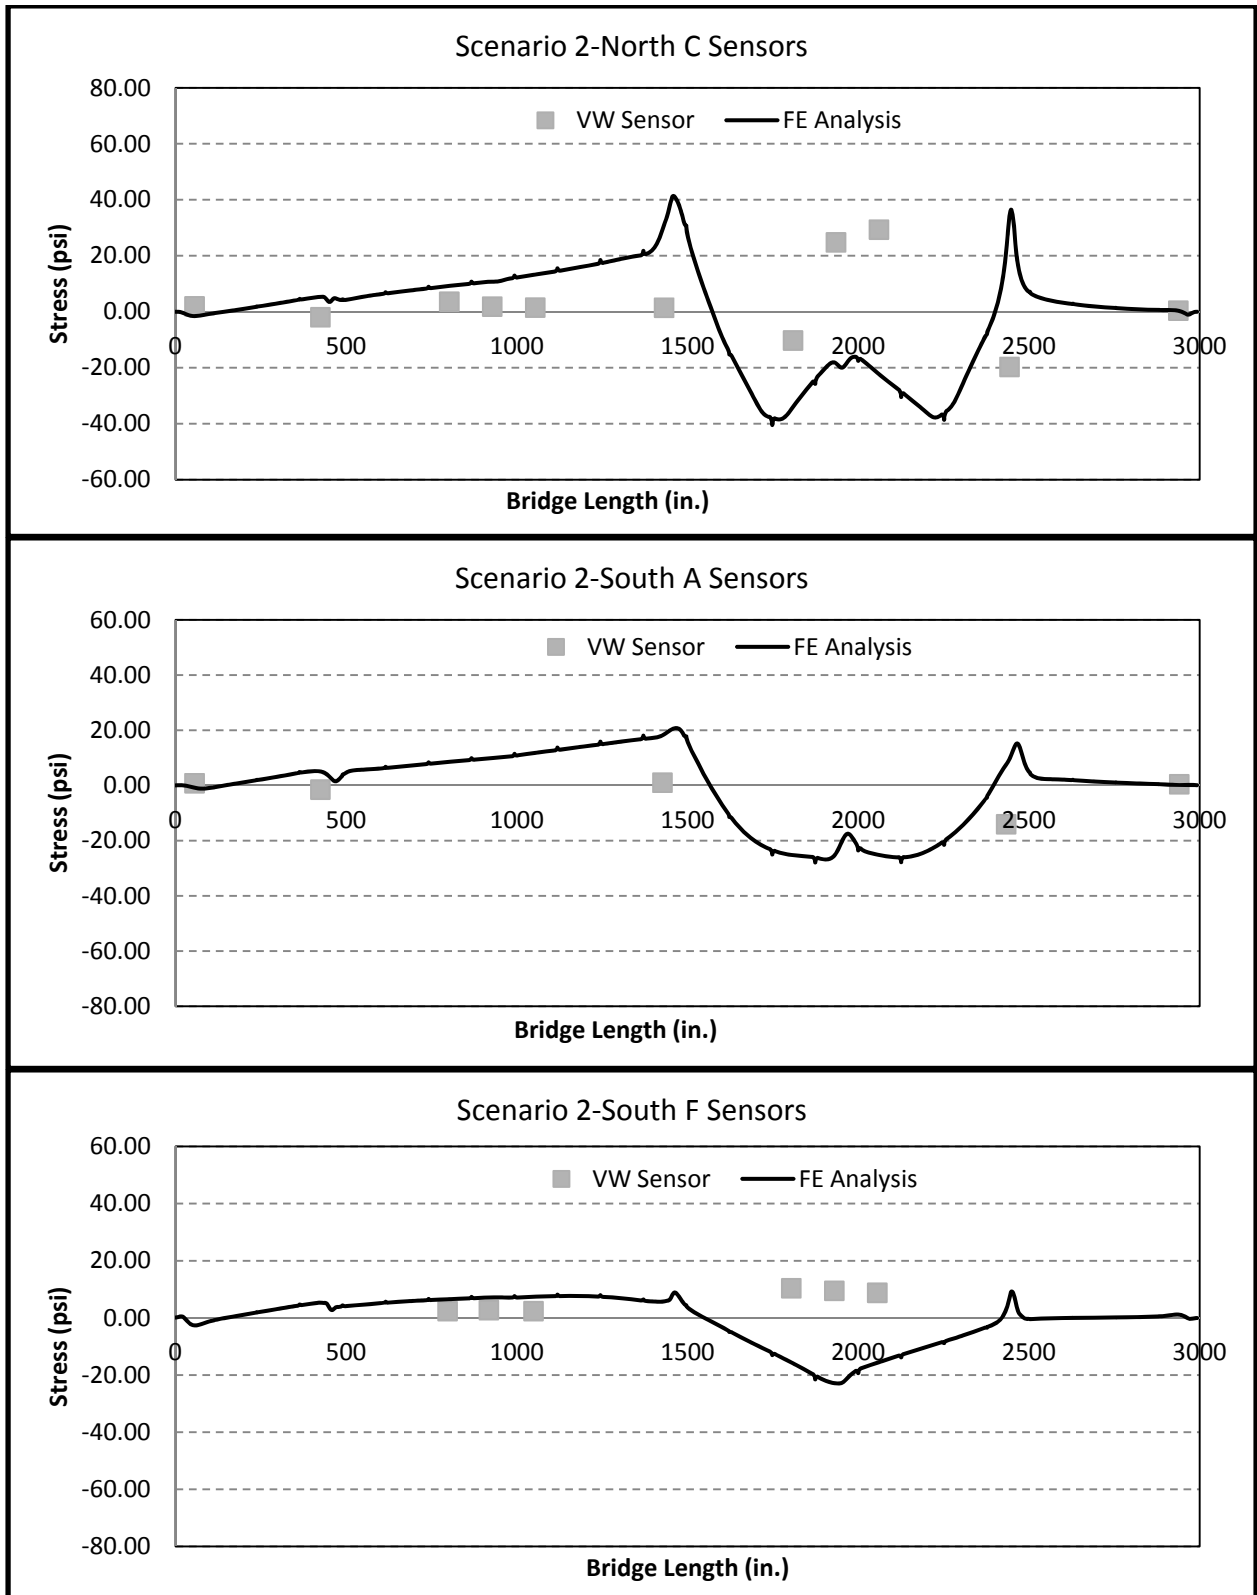
**Figure B-1. Comparison of load test data and FE analysis results – Scenario 2**

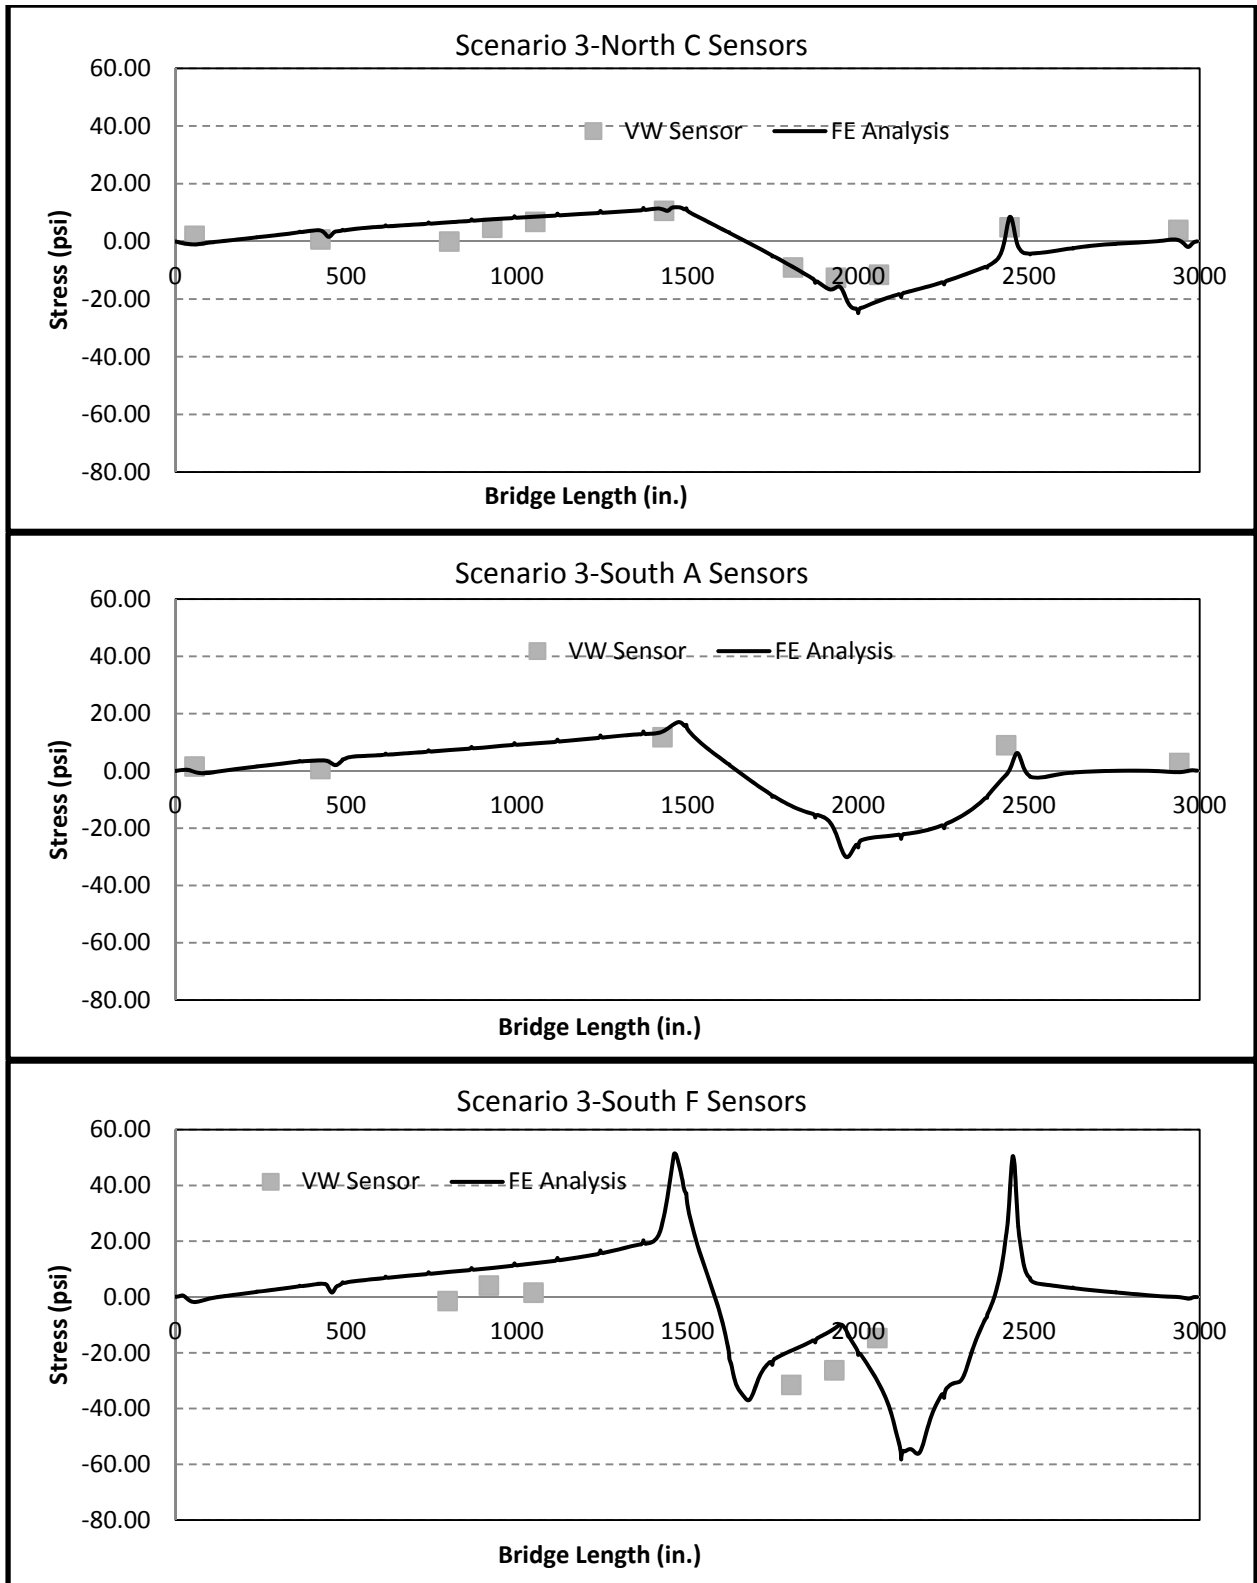
Figure B-2. Comparison of load test data and FE analysis results – Scenario 3

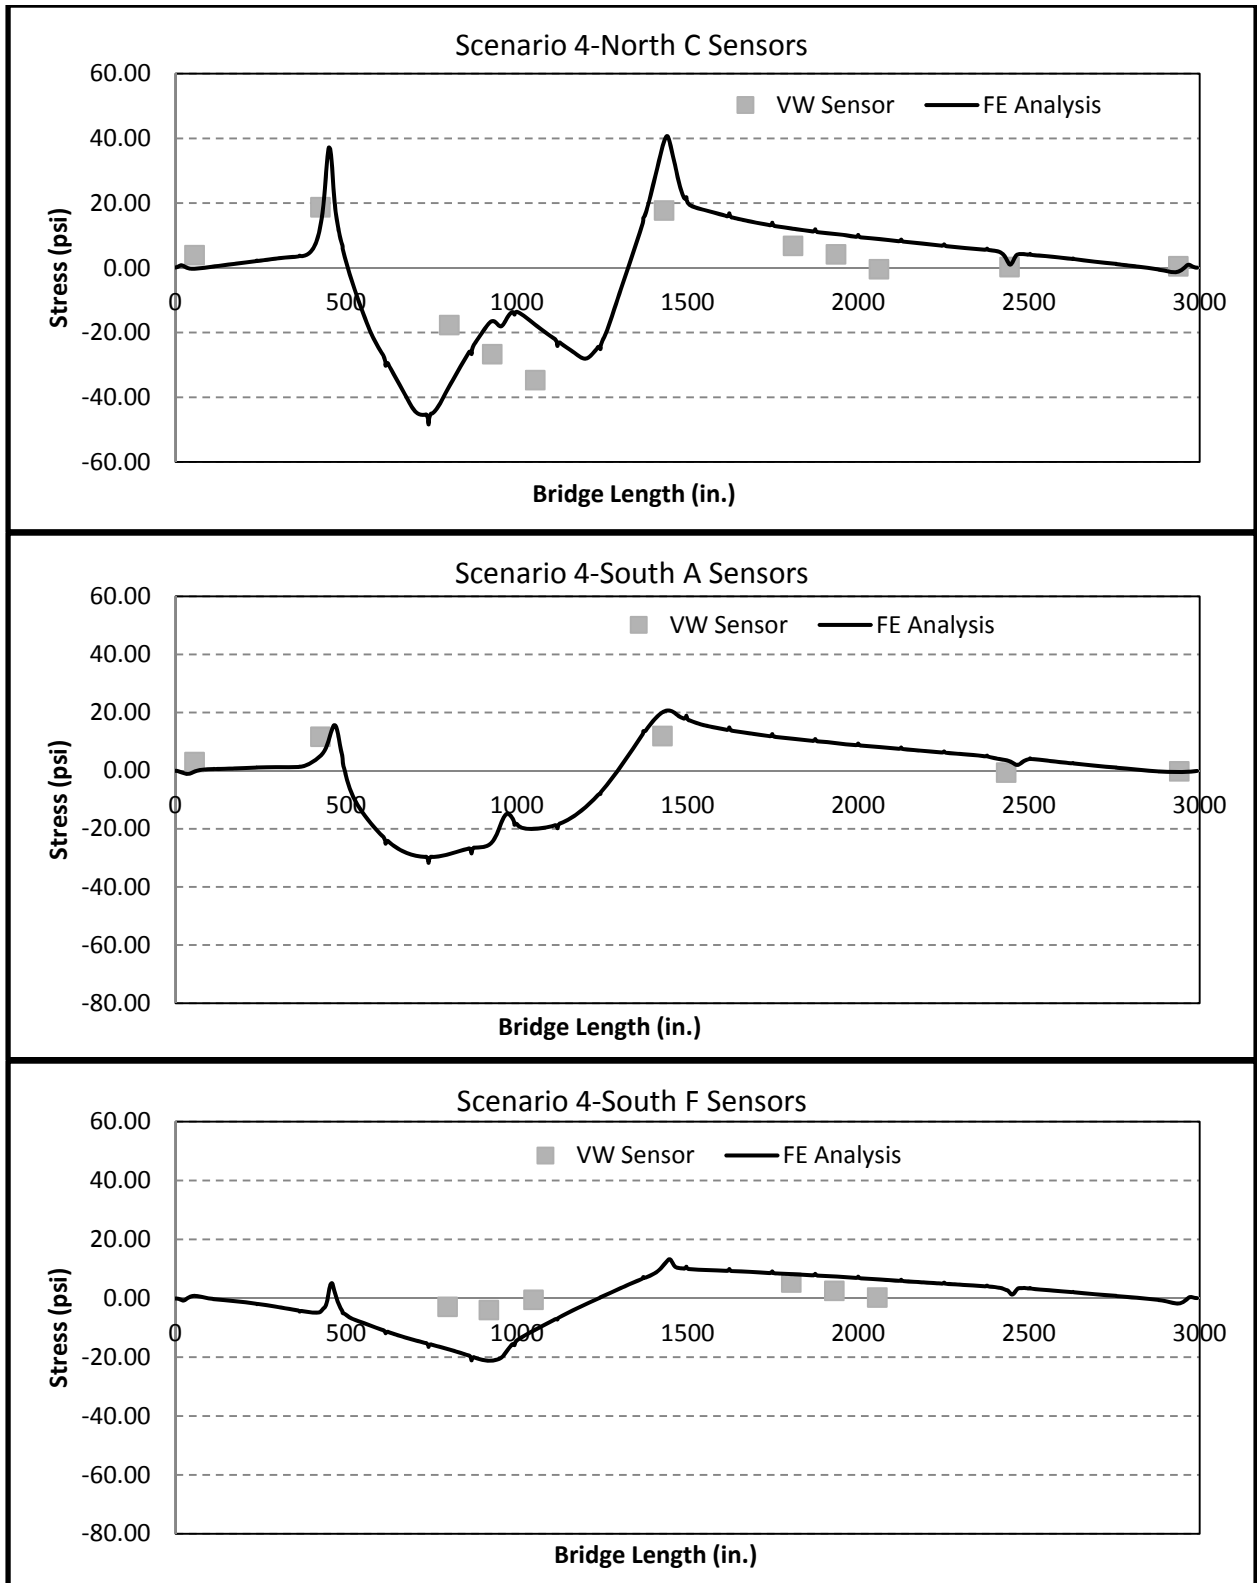
Figure B-3. Comparison of load test data and FE analysis results – Scenario 4
