### **Development and Validation of a Sensor-Based Health Monitoring Model for the Parkview Bridge Deck**

**Sponsored by Michigan Department of Transportation**

Final Report

January 31, 2012

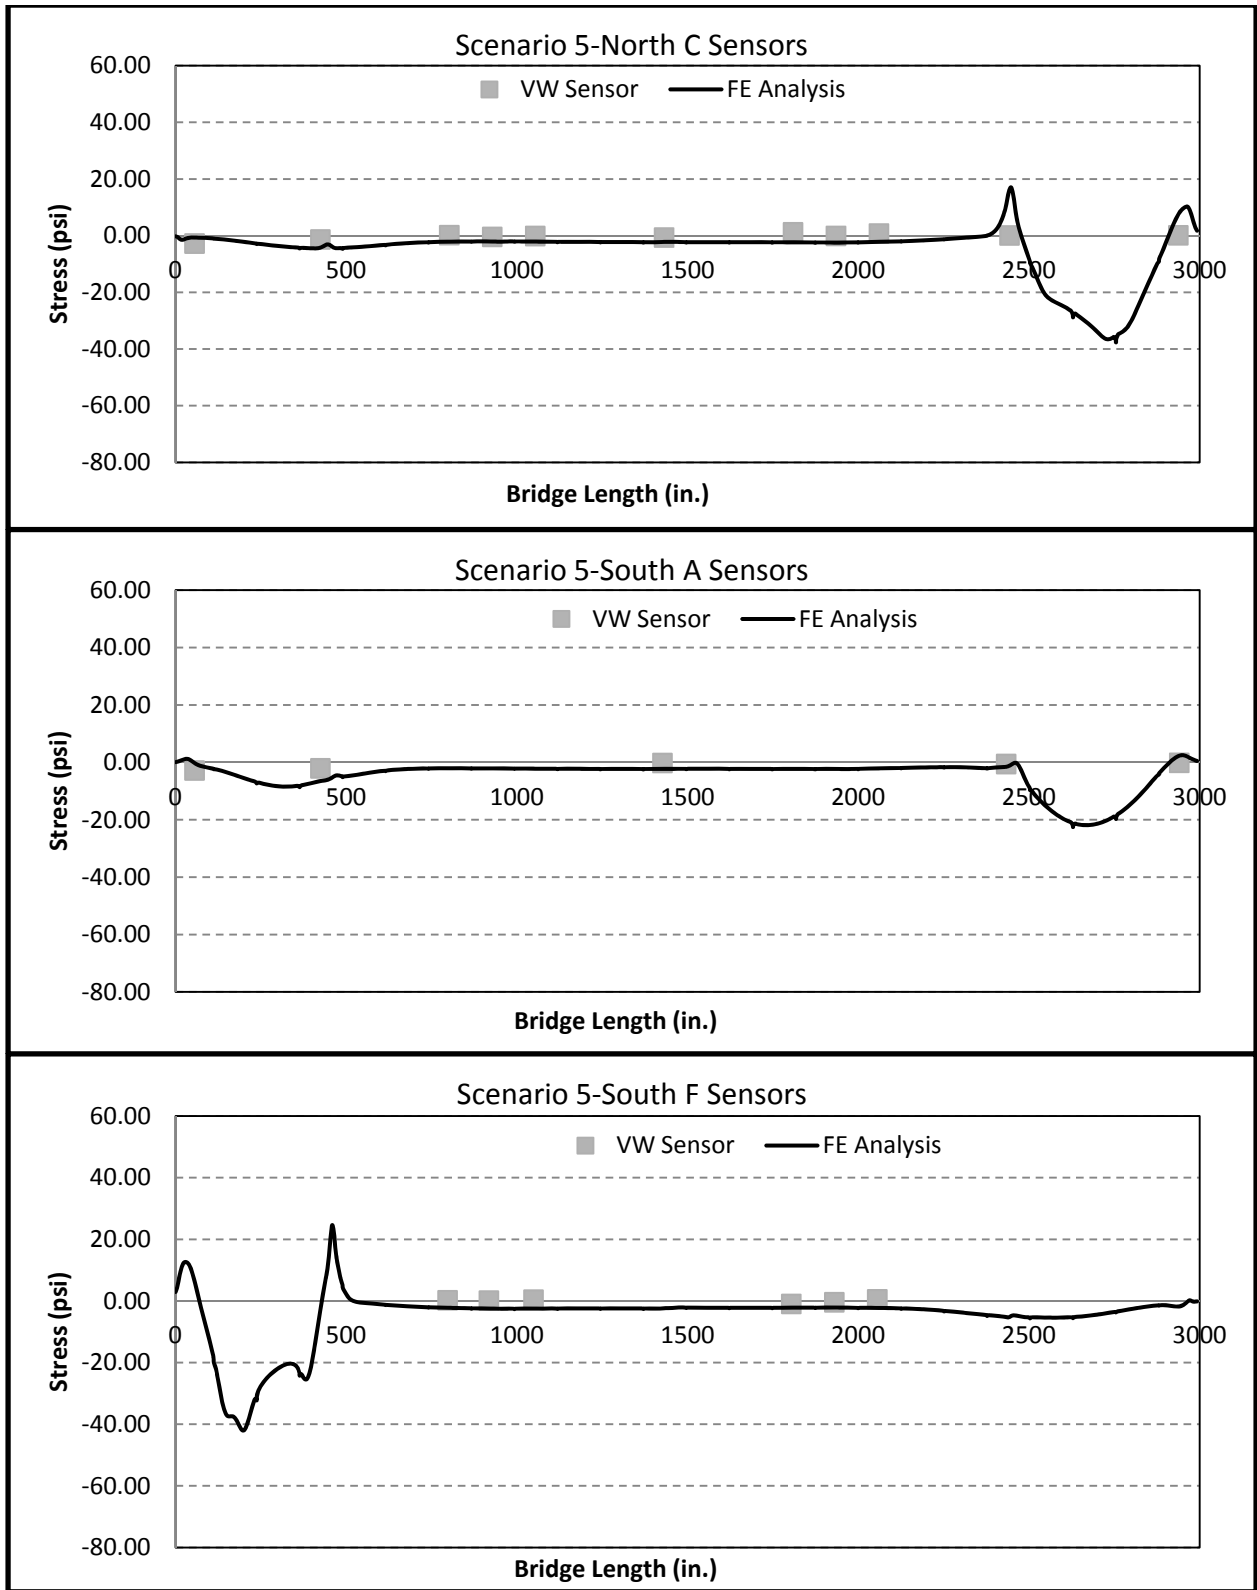
Figure B-4. Comparison of load test data and FE analysis results – Scenario 5

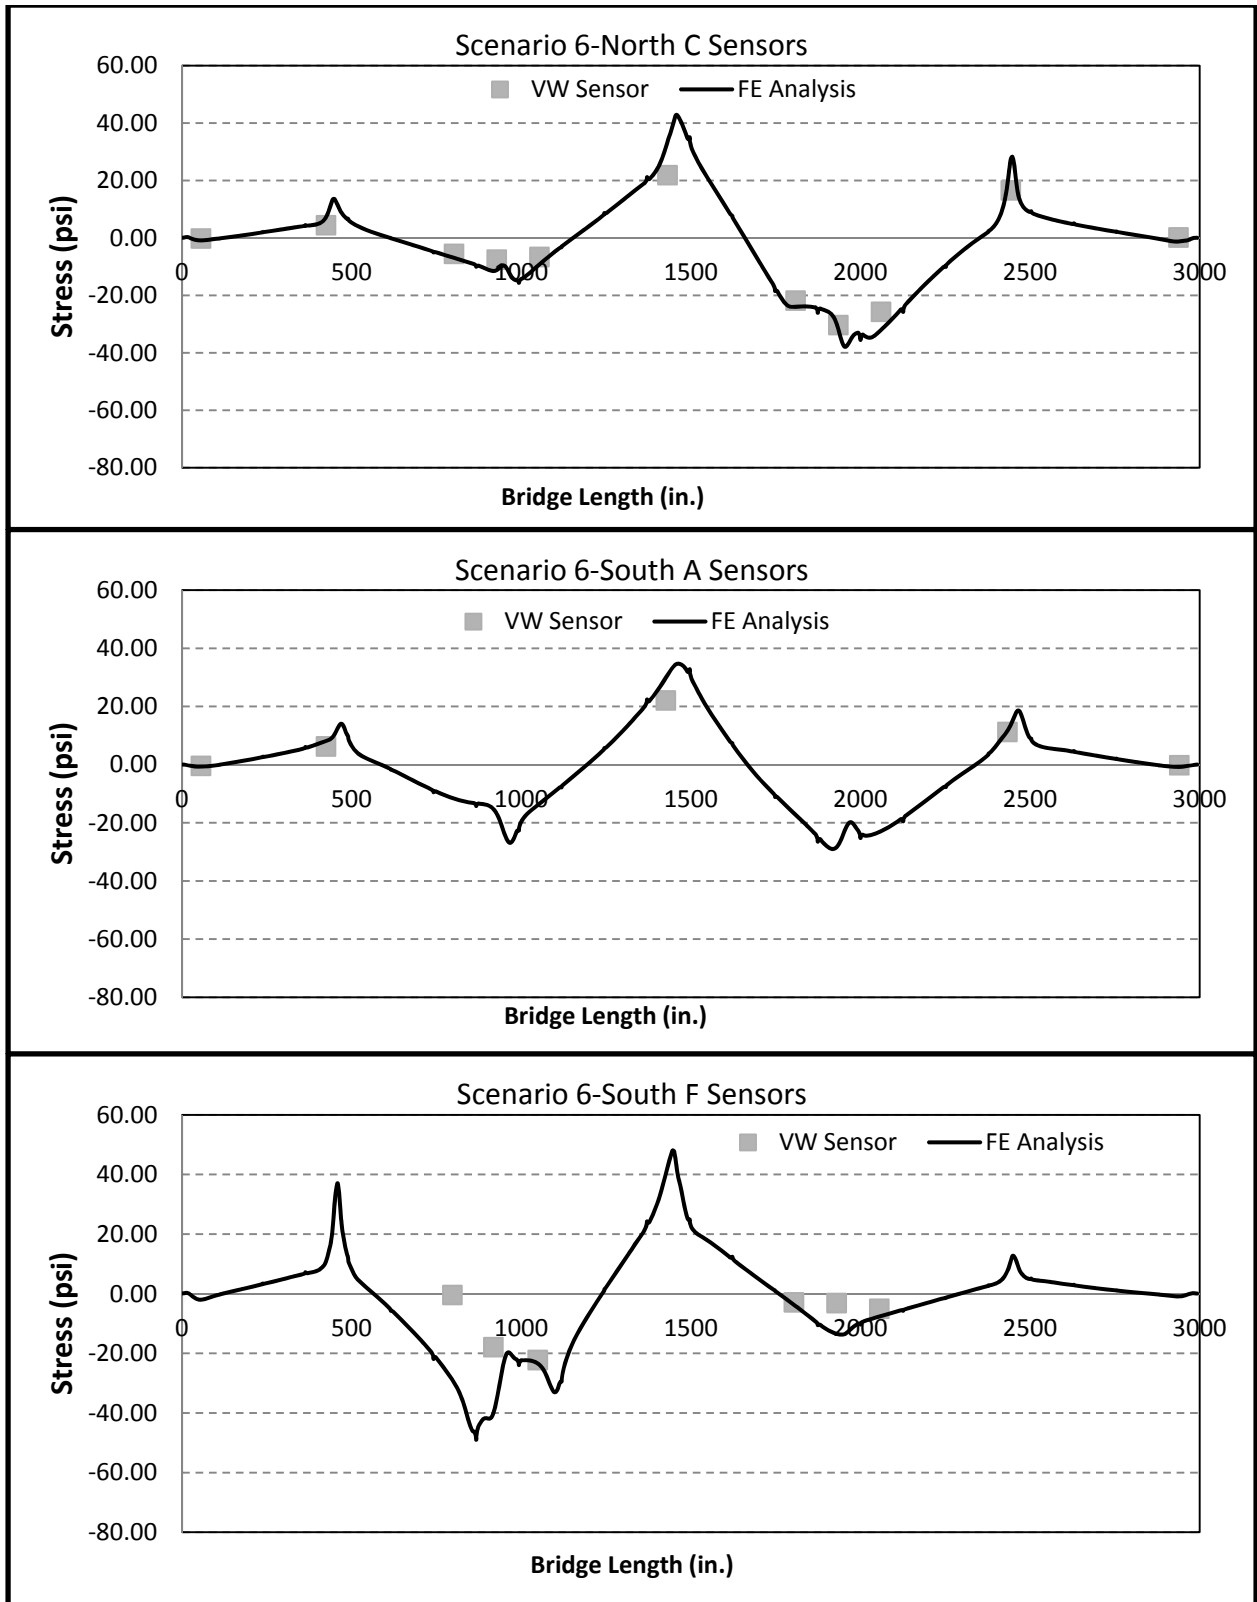
Figure B-5. Comparison of load test data and FE analysis results – Scenario 6

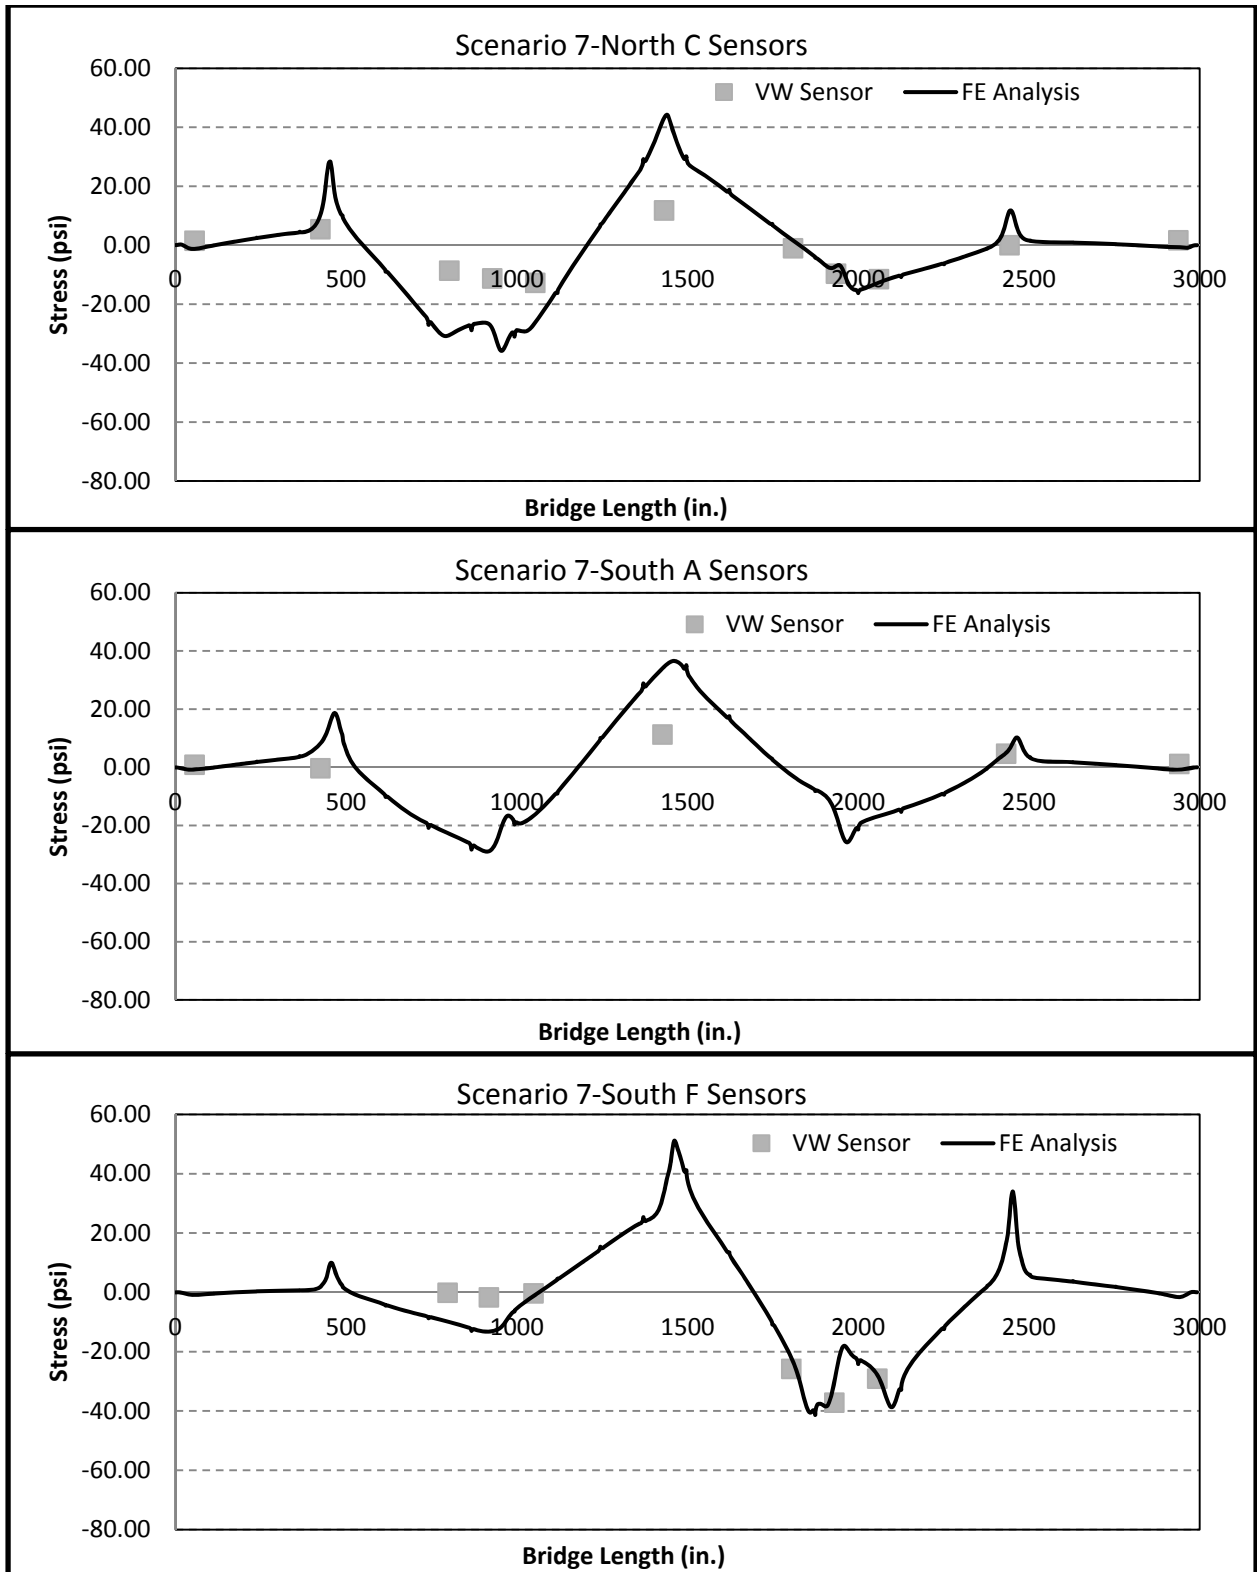
Figure B-6. Comparison of load test data and FE analysis results – Scenario 7

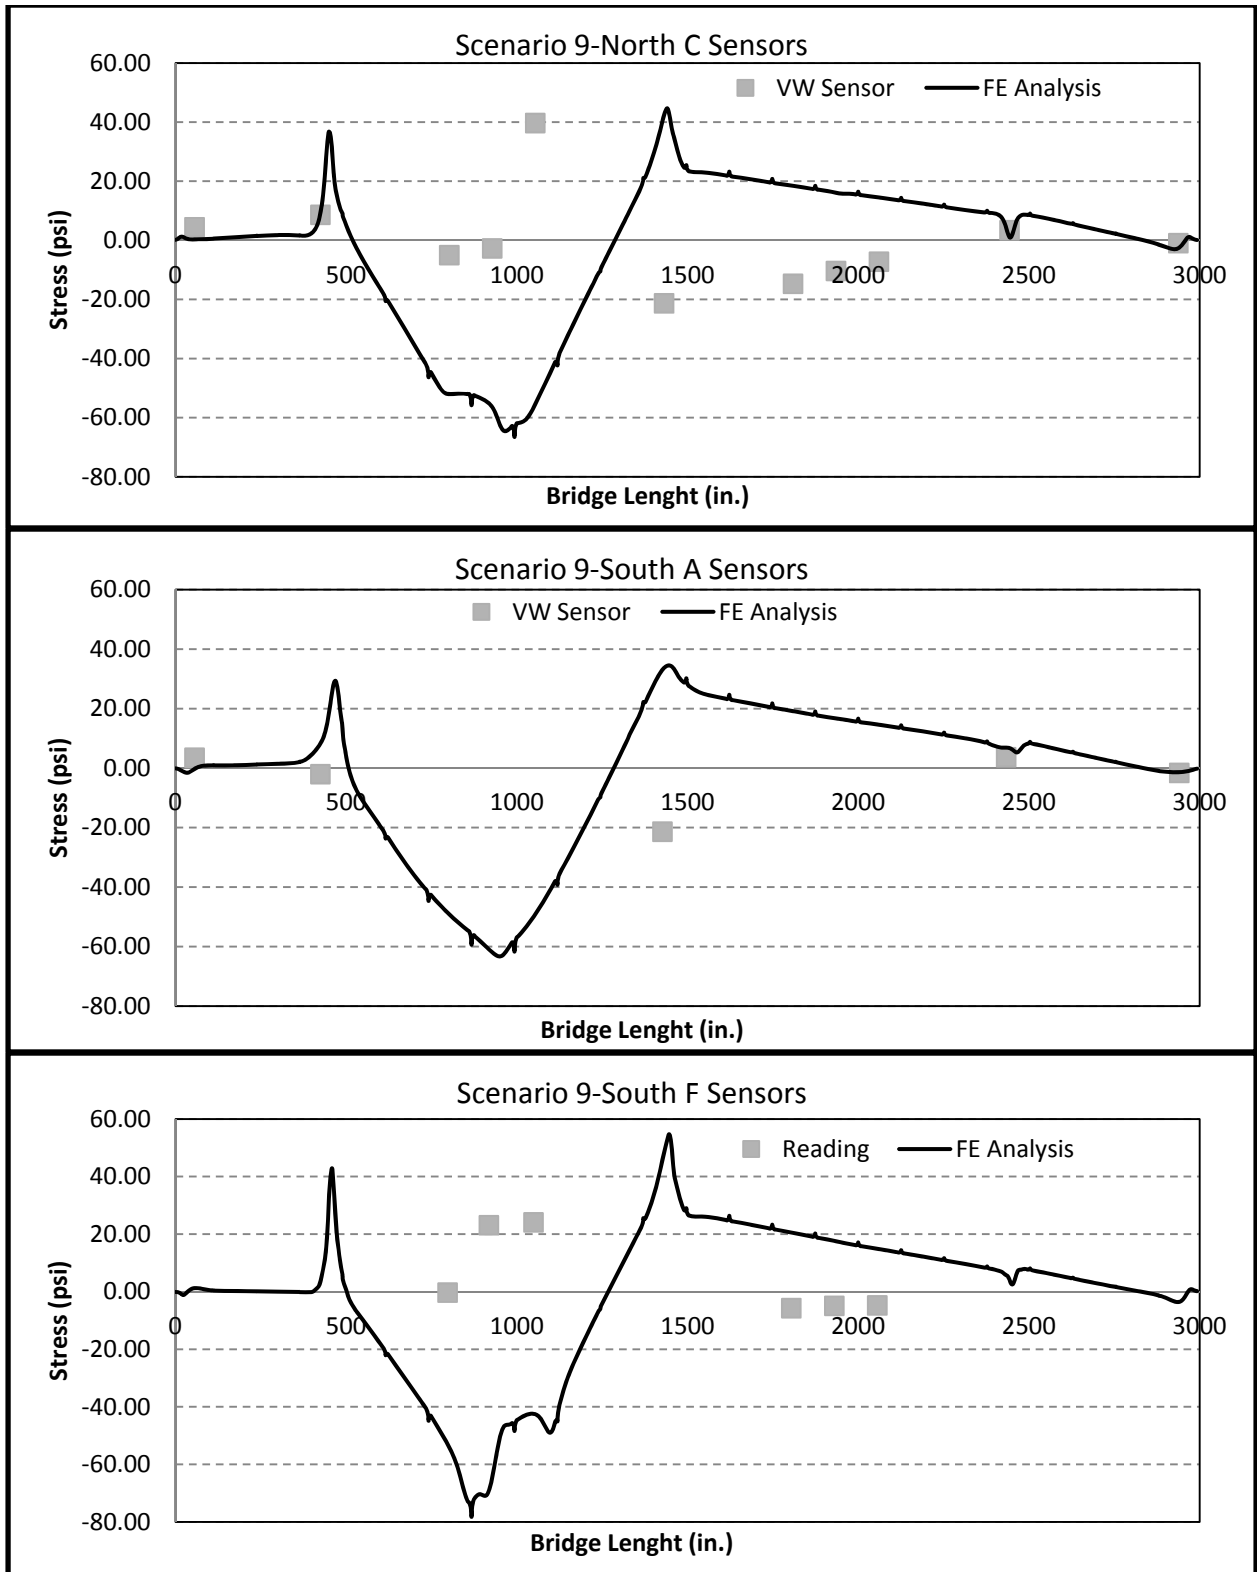
Figure B-8. Comparison of load test data and FE analysis results – Scenario 9

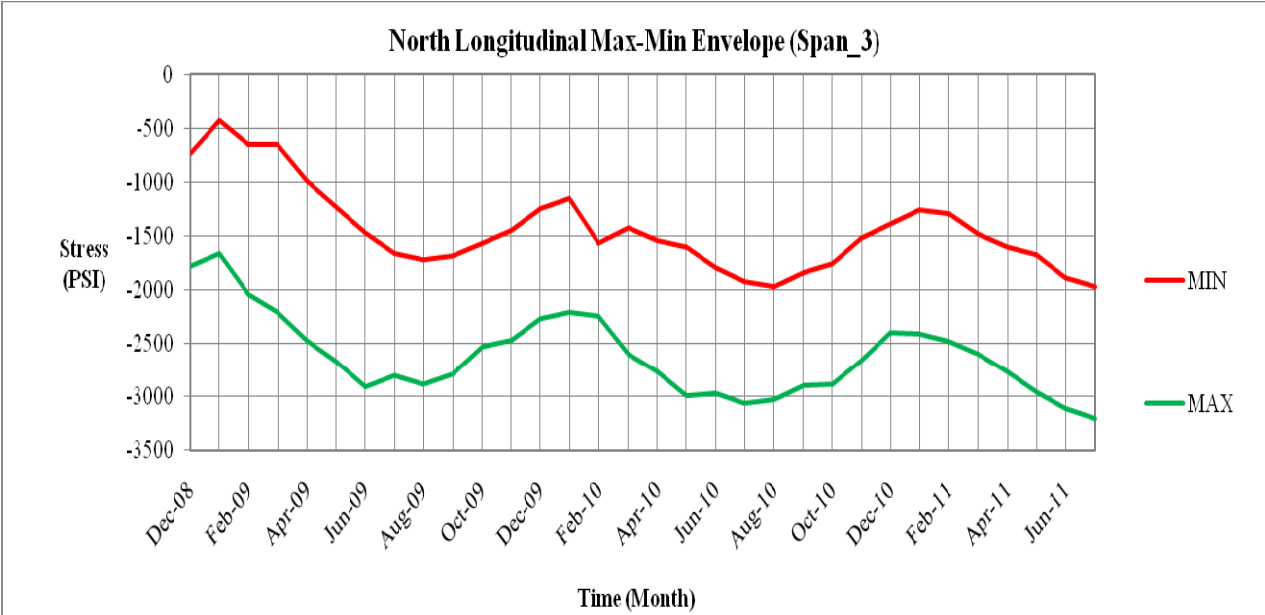
**Figure C-3. Three-year envelope for north span 3 in the longitudinal direction**

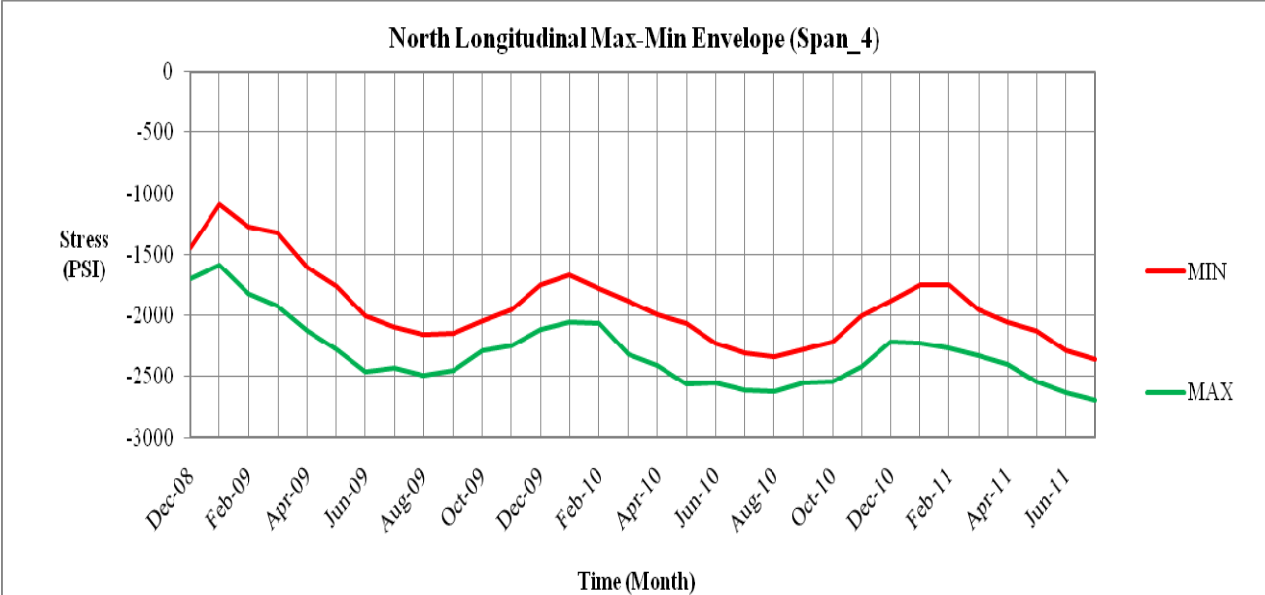
**Figure C-4. Three-year envelope for north span 4 in the longitudinal direction**

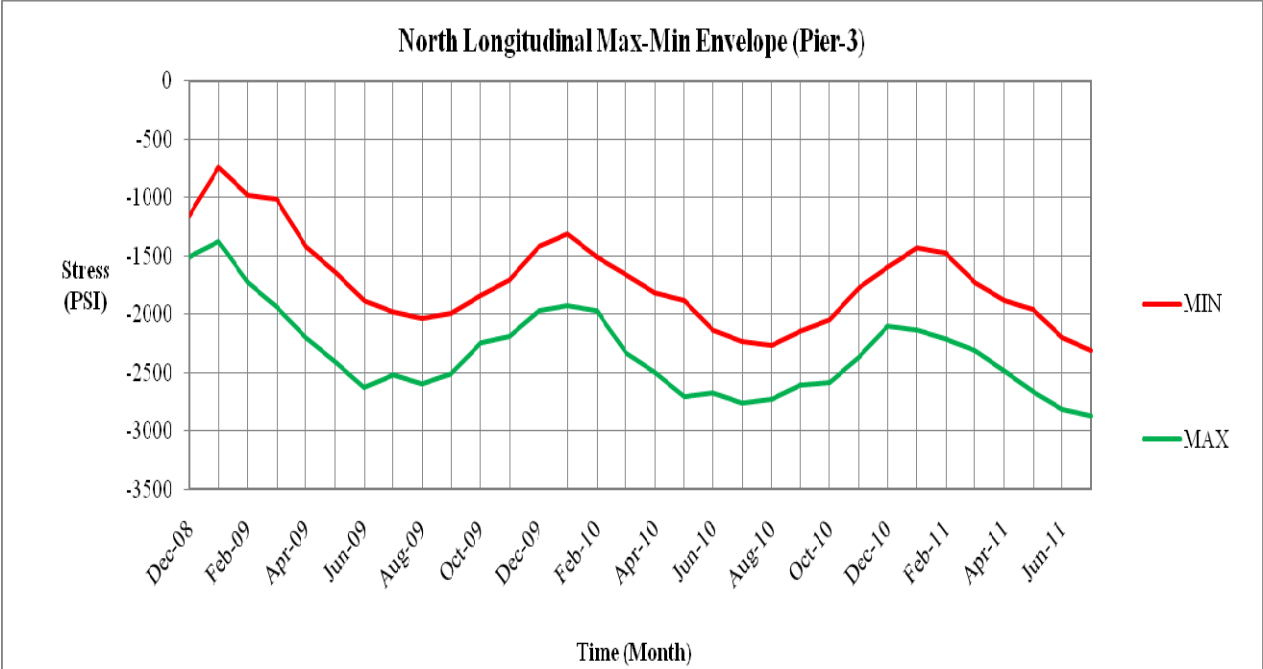
**Figure C-7. Three-year envelope for north pier 3 in the longitudinal direction**

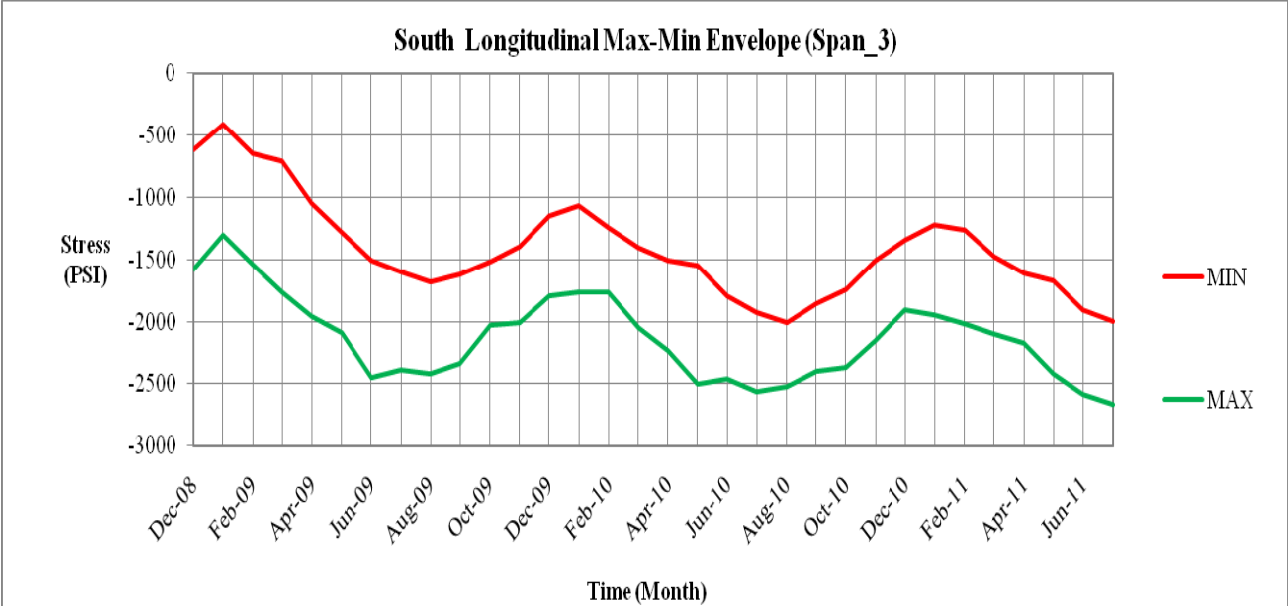
**Figure C-10. Three-year envelope for south span 3 in the longitudinal direction**

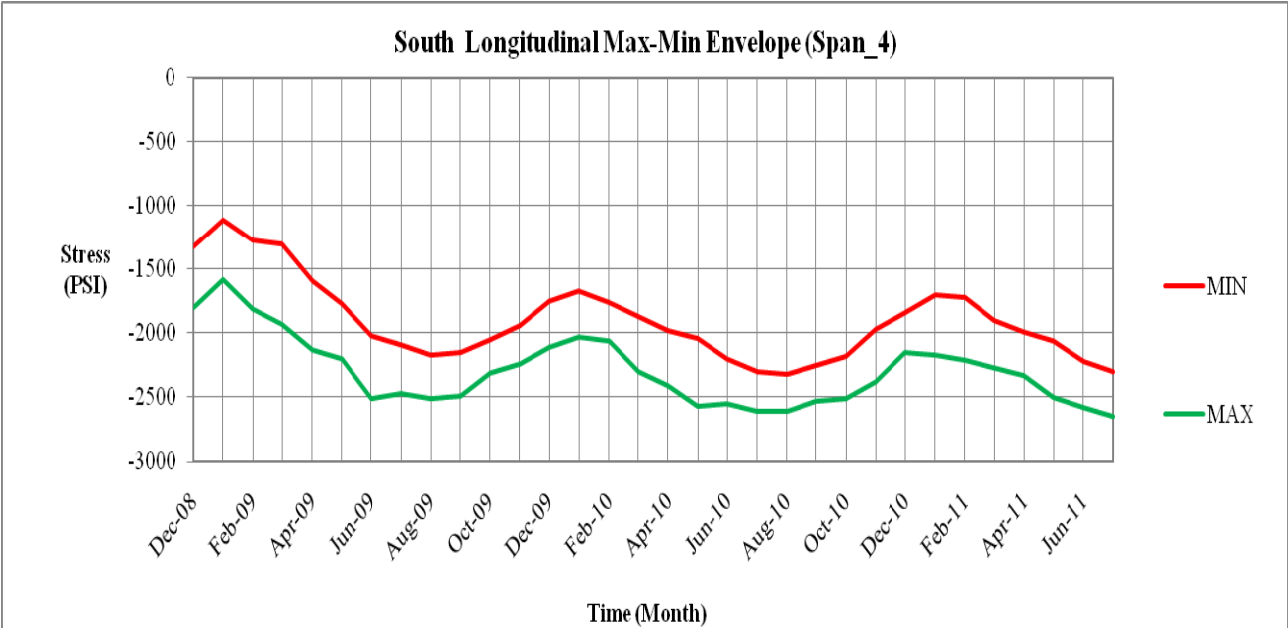
**Figure C-11. Three-year envelope for south span 4 in the longitudinal direction**

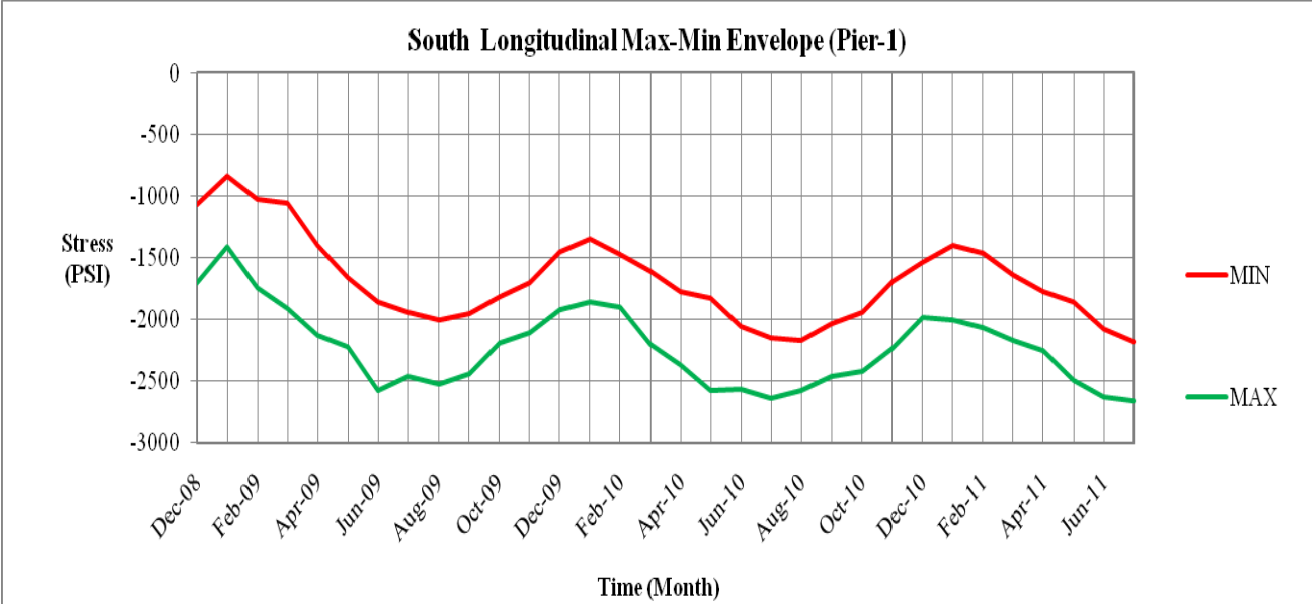
**Figure C-12. Three-year envelope for pier 1 in the longitudinal direction**

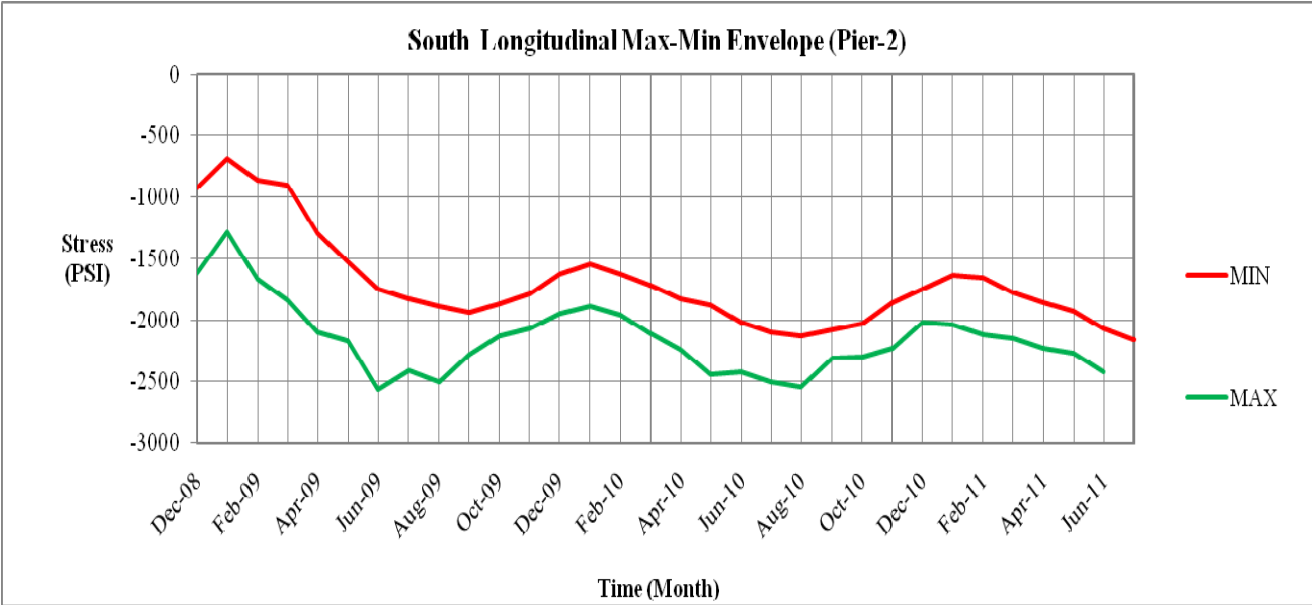
**Figure C-13. Three-year envelope for pier 2 in the longitudinal direction**

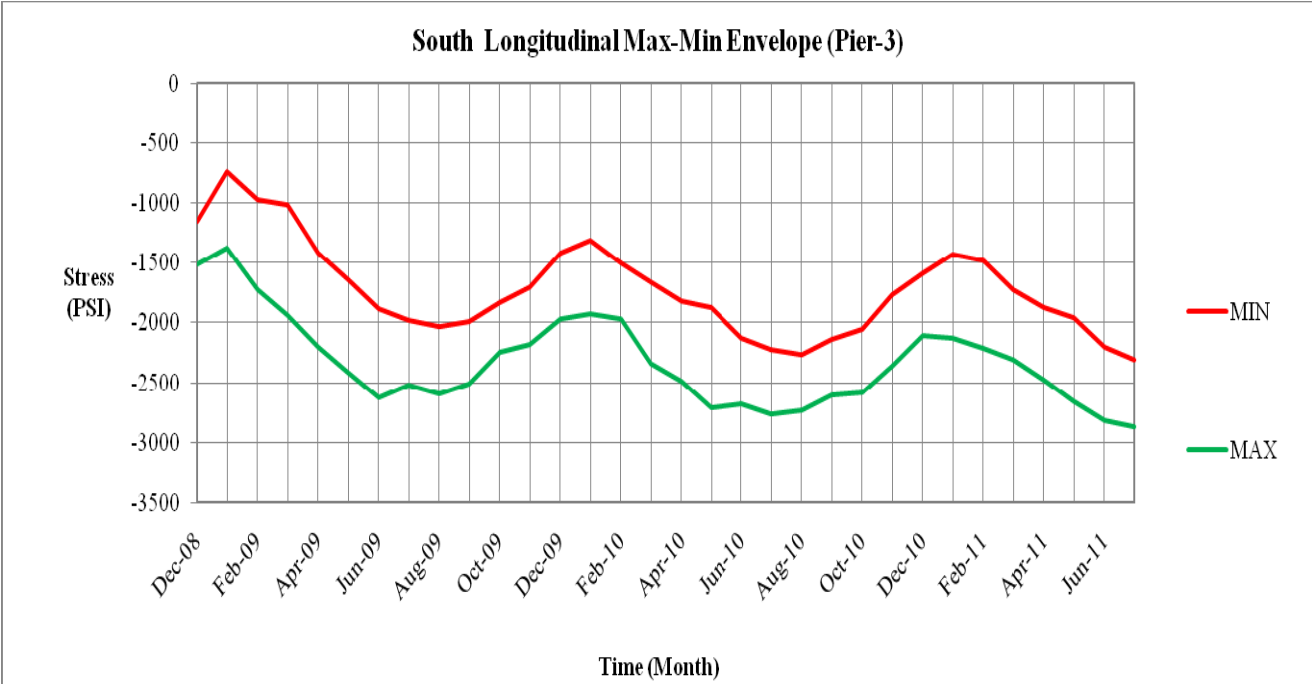
**Figure C-14. Three-year envelope for pier 3 in the longitudinal direction**

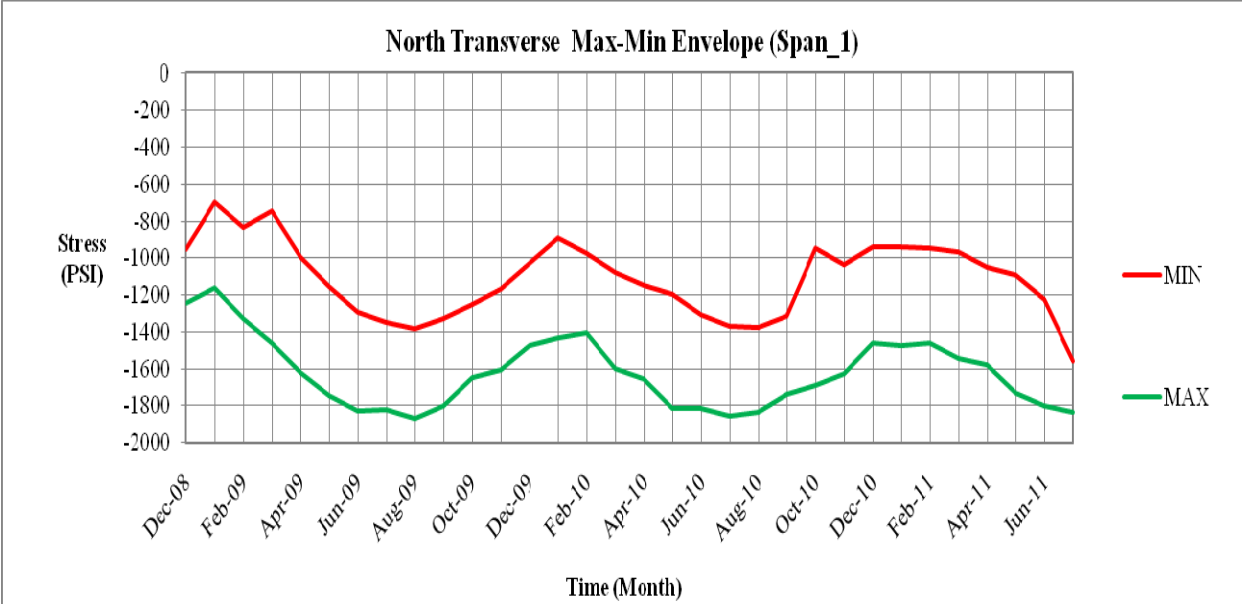
**Figure C-15. Three-year envelope for north span 1 in the transverse direction**

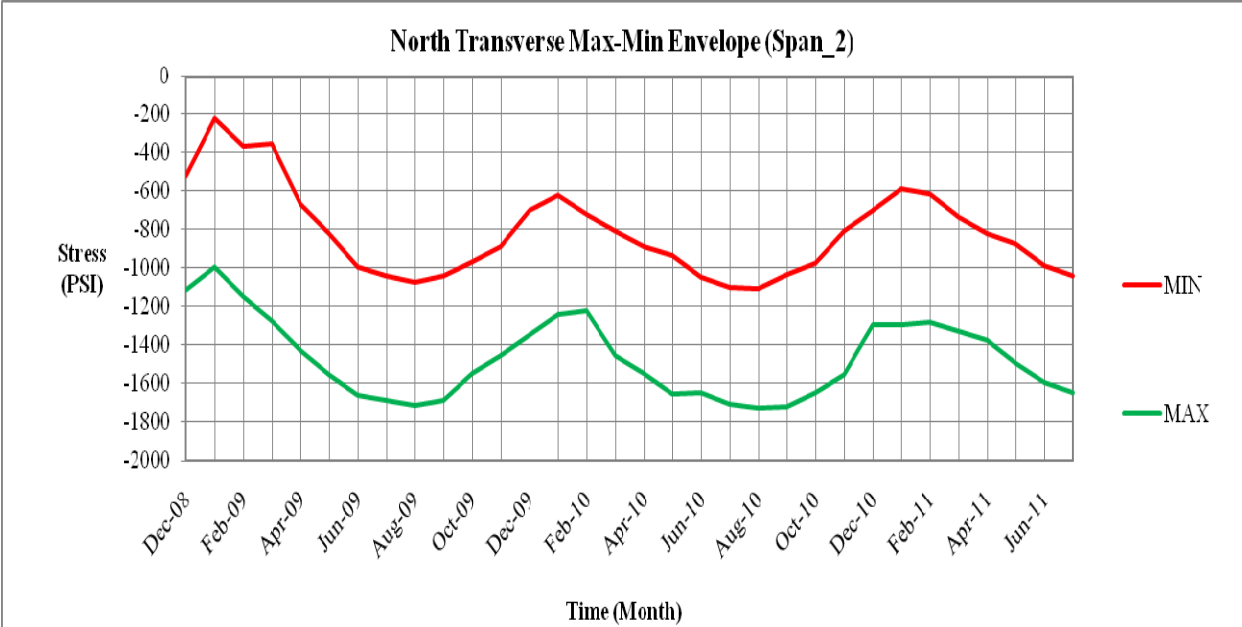
**Figure C-16. Three-year envelope for north span 2 in the transverse direction**

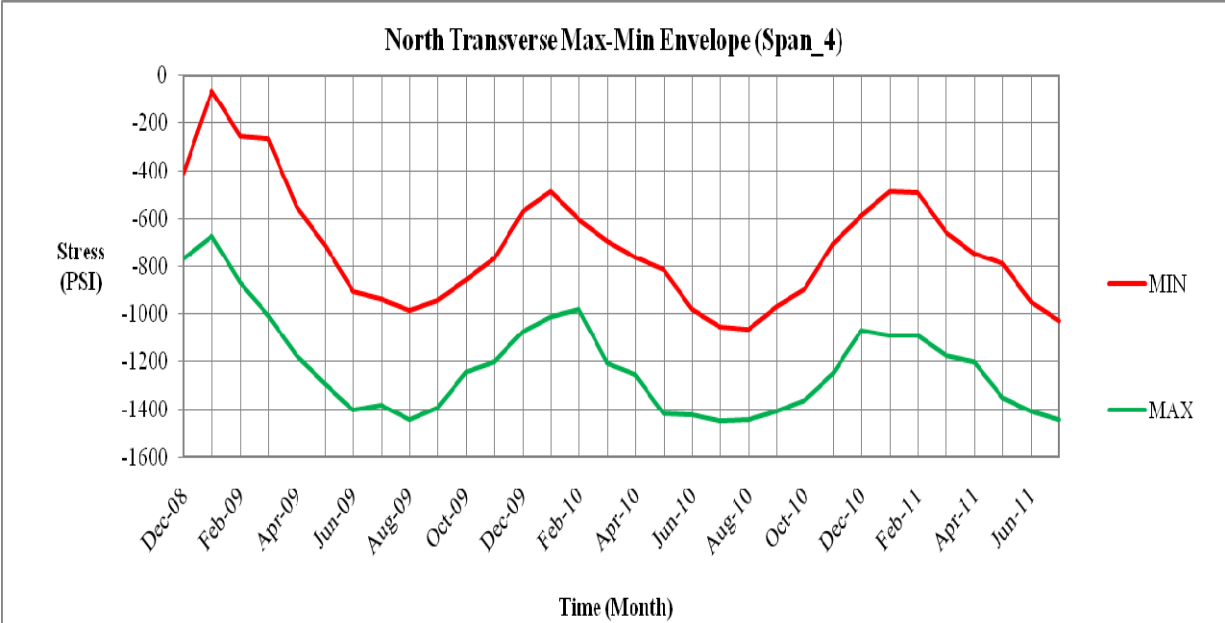
**Figure C-18. Three-year envelope for north span 4 in the transverse direction**

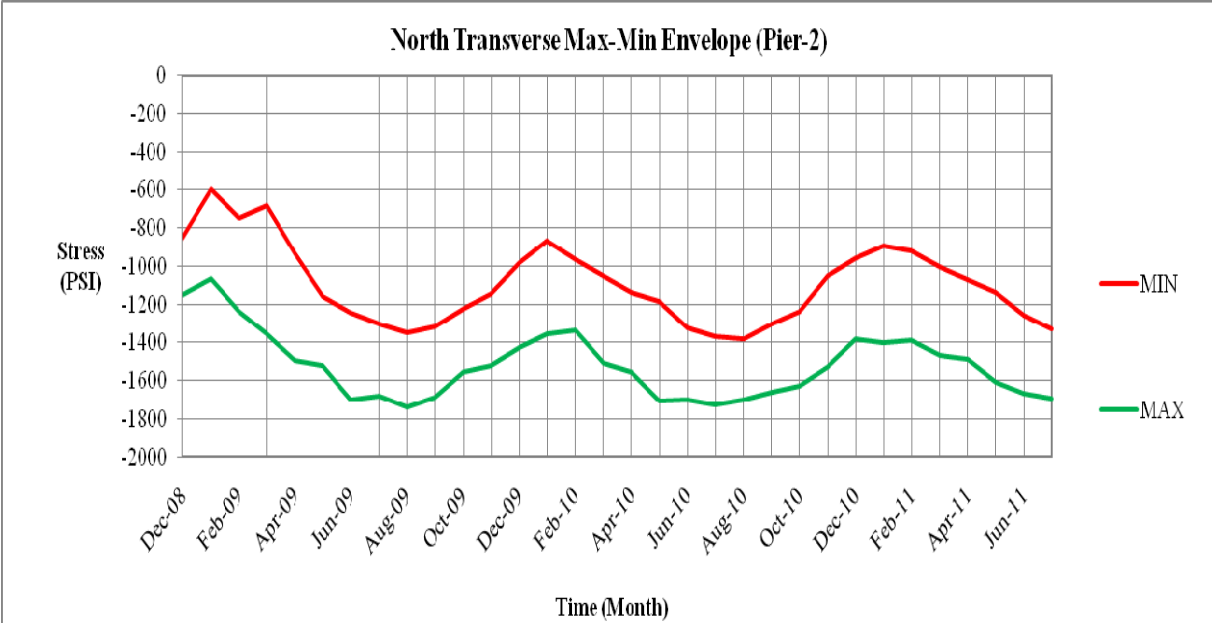
**Figure C-20. Three-year envelope for north pier 2 in the transverse direction**

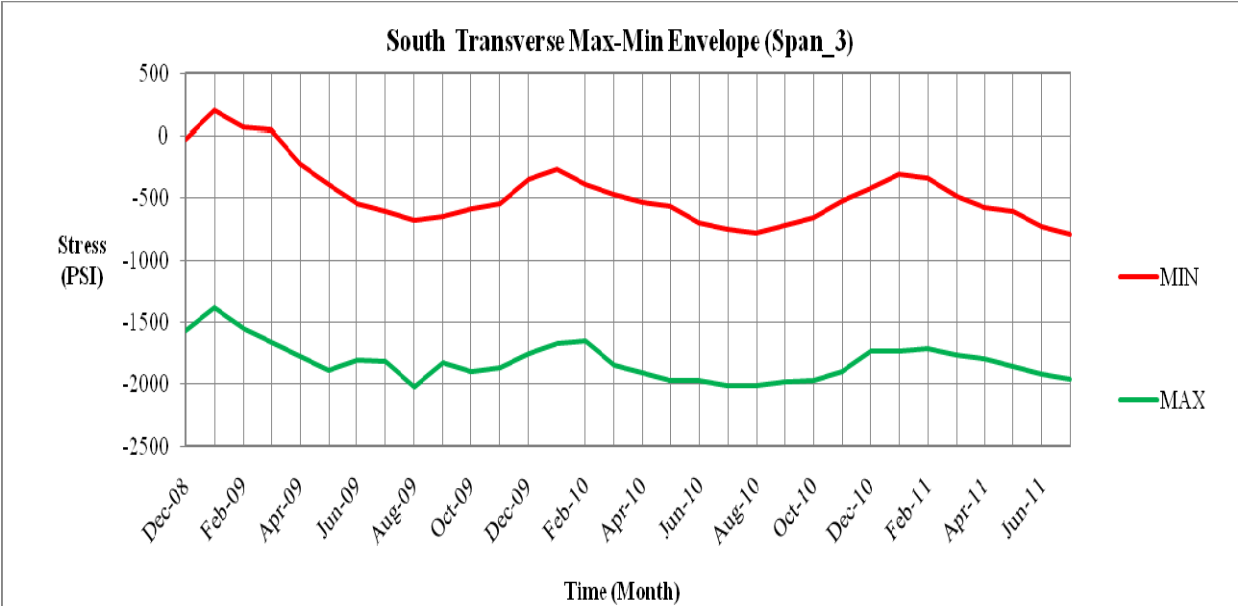
**Figure C-23. Three-year envelope for south span 3 in the transverse direction**

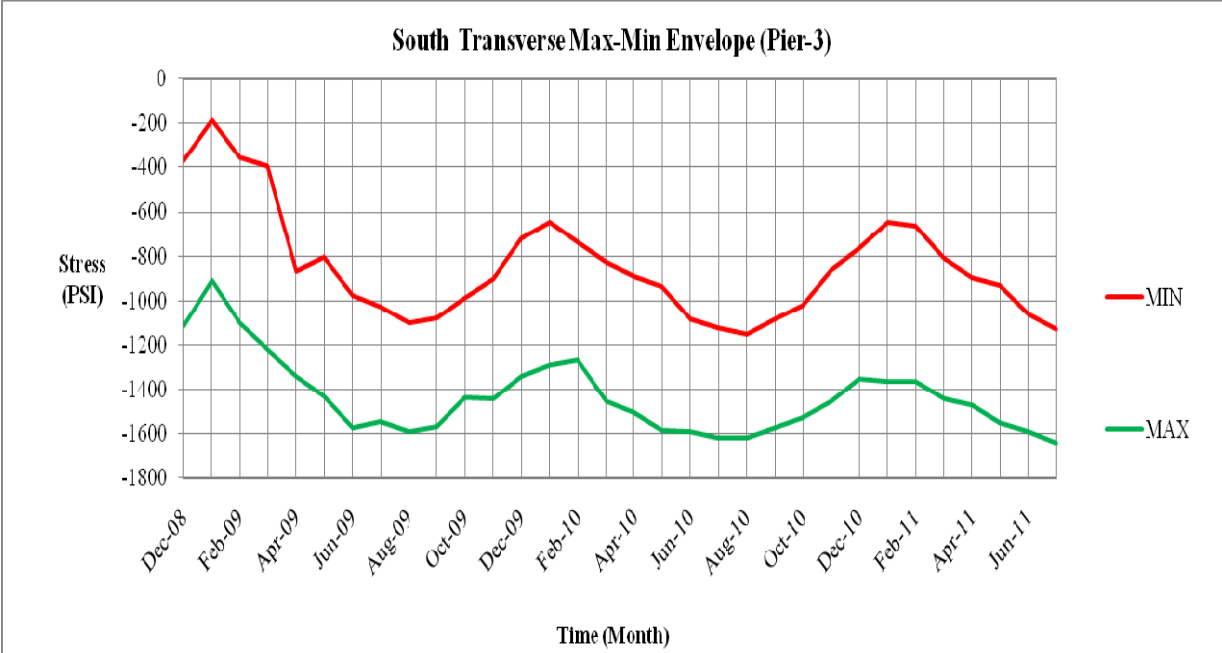
**Figure C-27. Three-year envelope for south pier 3 in the transverse direction**

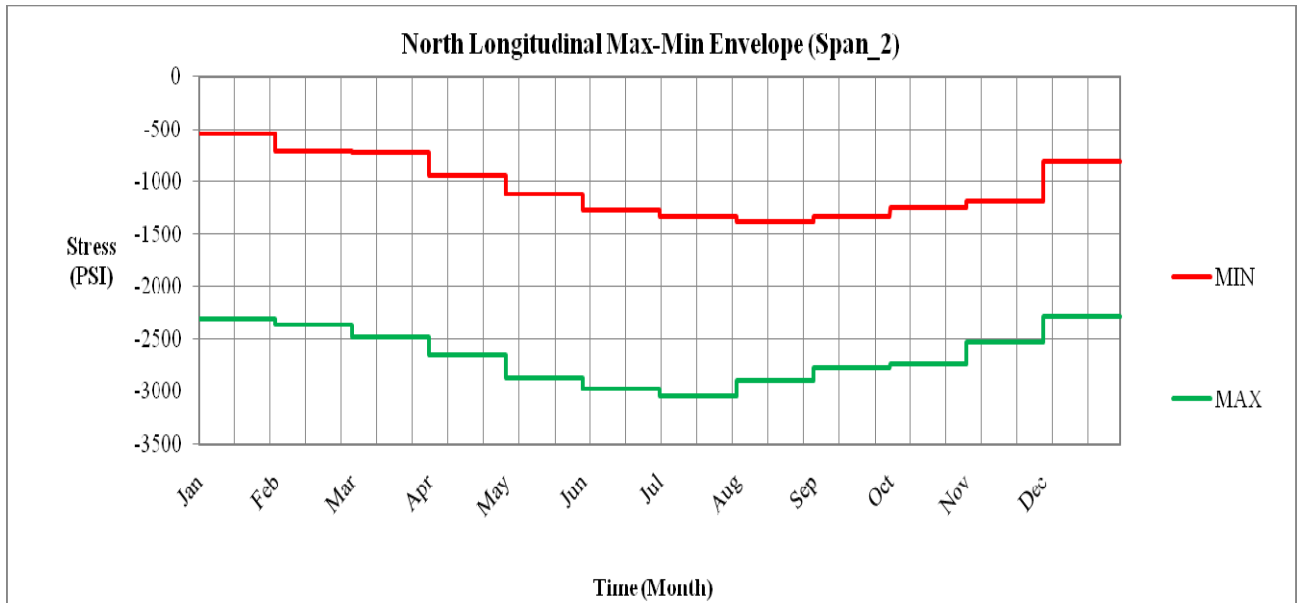
Figure D-2. One-year envelope for north span 2 in the longitudinal direction

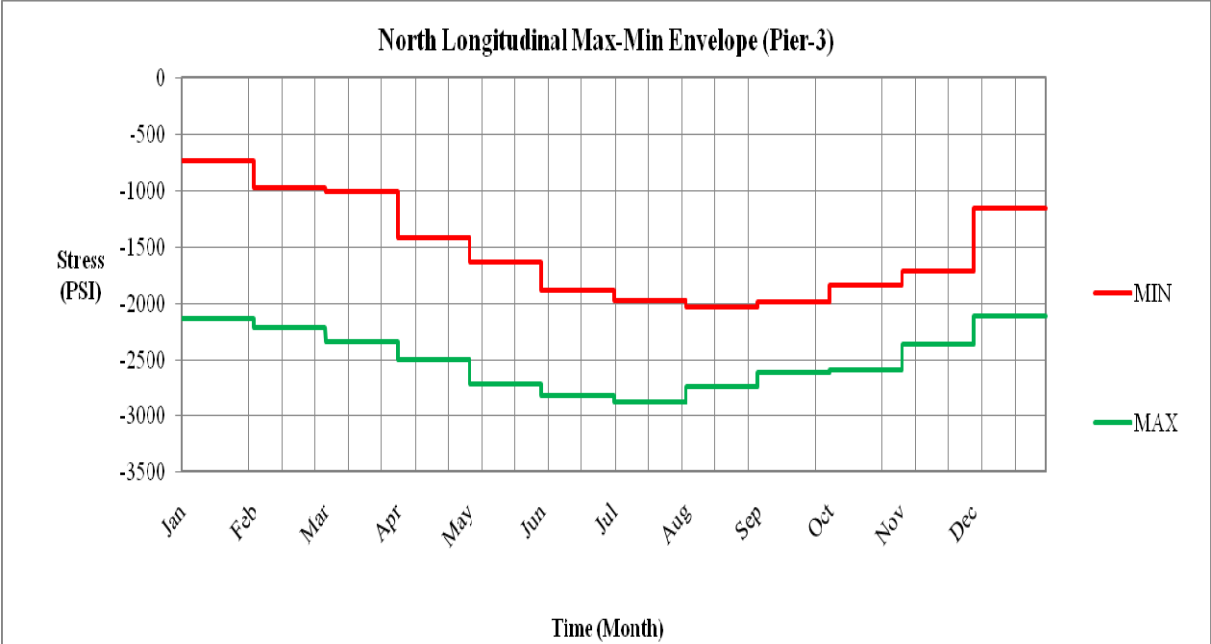
**Figure D-7. One-year envelope for north pier 3 in the longitudinal direction**

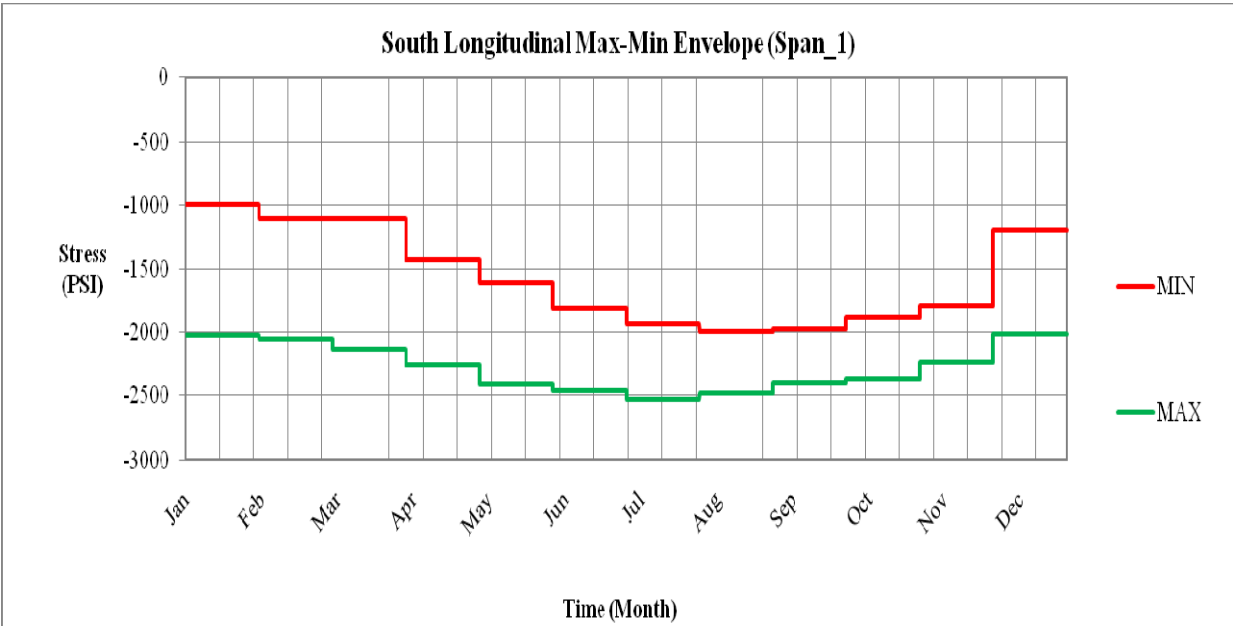
**Figure D-8. One-year envelope for south span 1 in the longitudinal direction**

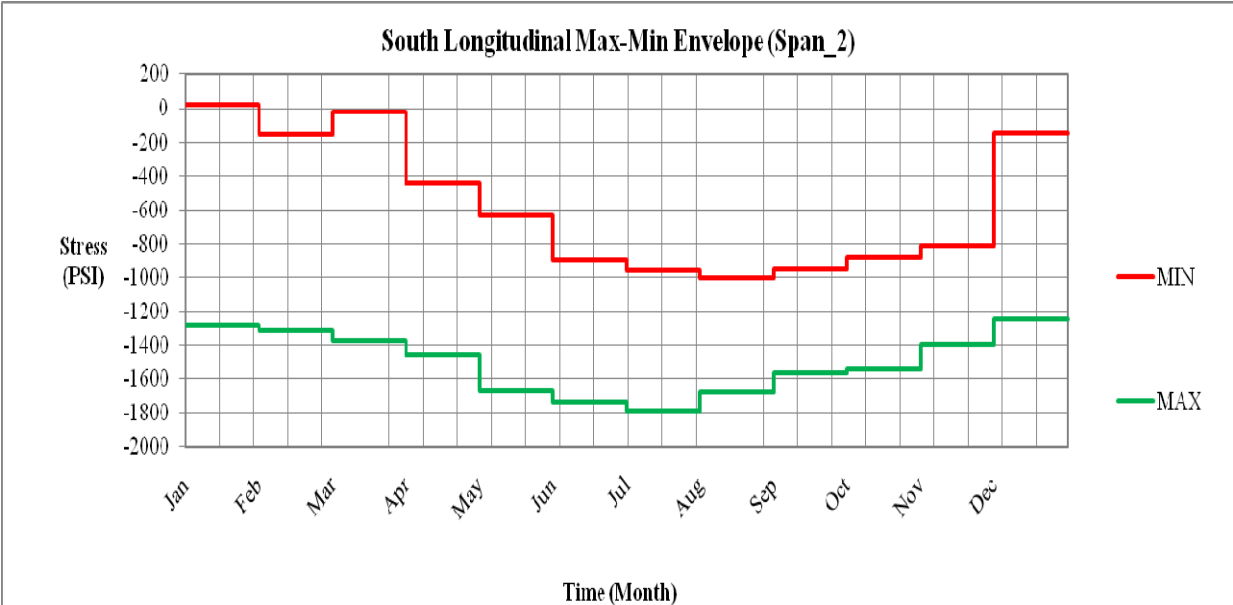
**Figure D-9. One-year envelope for south span 2 in the longitudinal direction**
