### **Development and Validation of a Sensor-Based Health Monitoring Model for the Parkview Bridge Deck**

**Sponsored by Michigan Department of Transportation**

Final Report

January 31, 2012

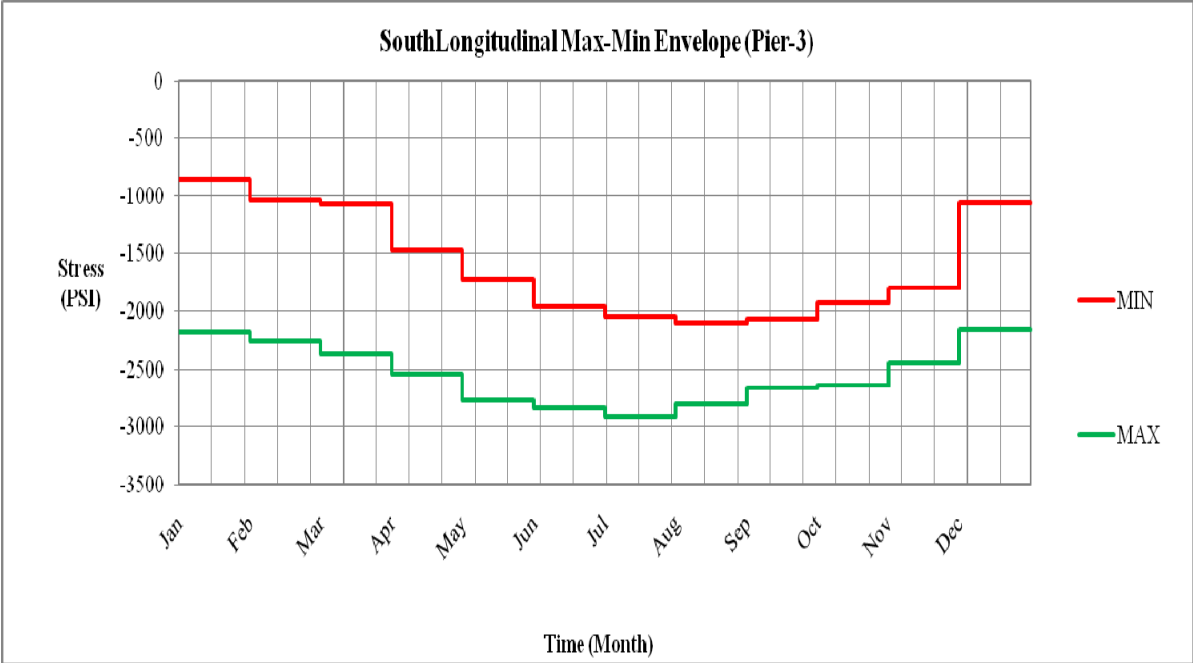
**Figure D-14. One-year envelope for pier 3 in the longitudinal direction**

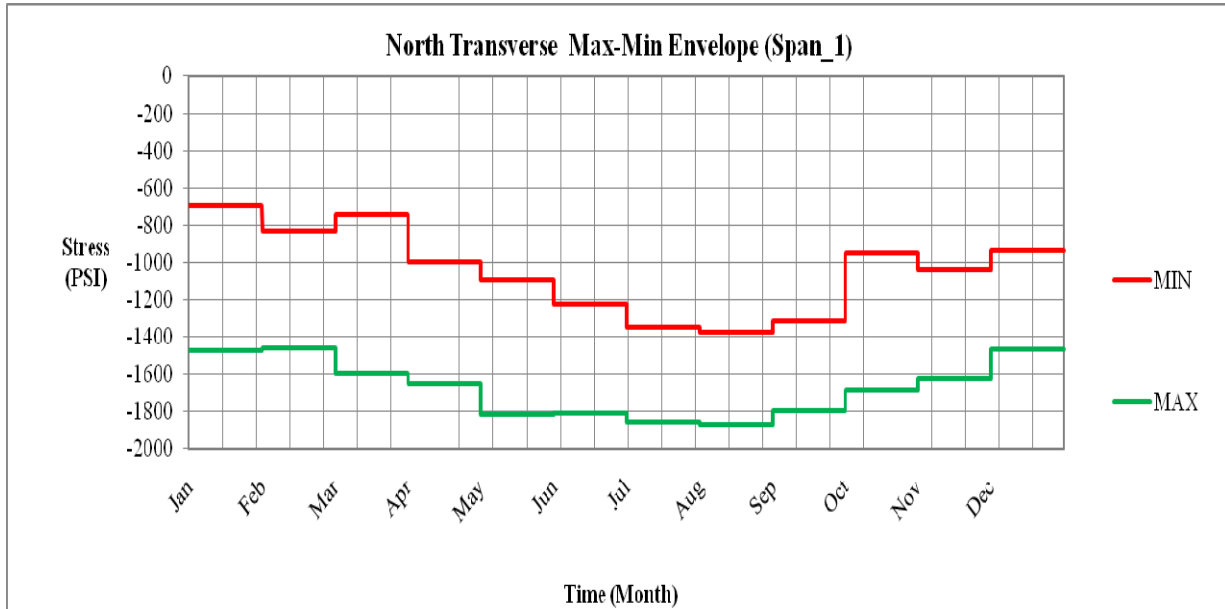
Figure D-15. One-year envelope for north span 1 in the transverse direction

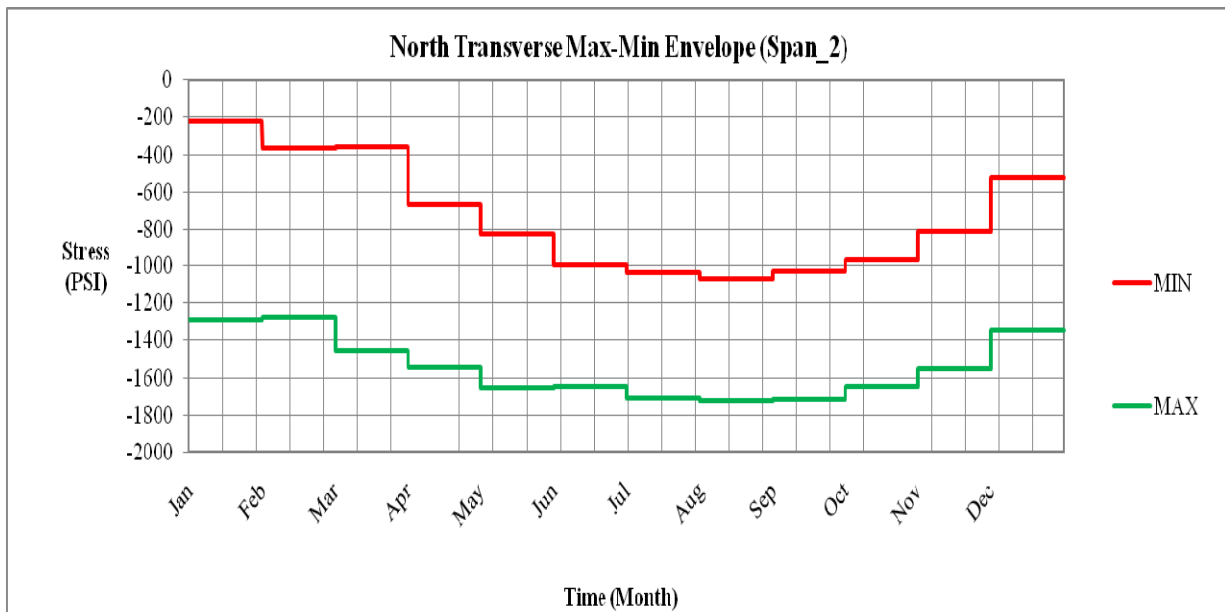
Figure D-16. One-year envelope for north span 2 in the transverse direction

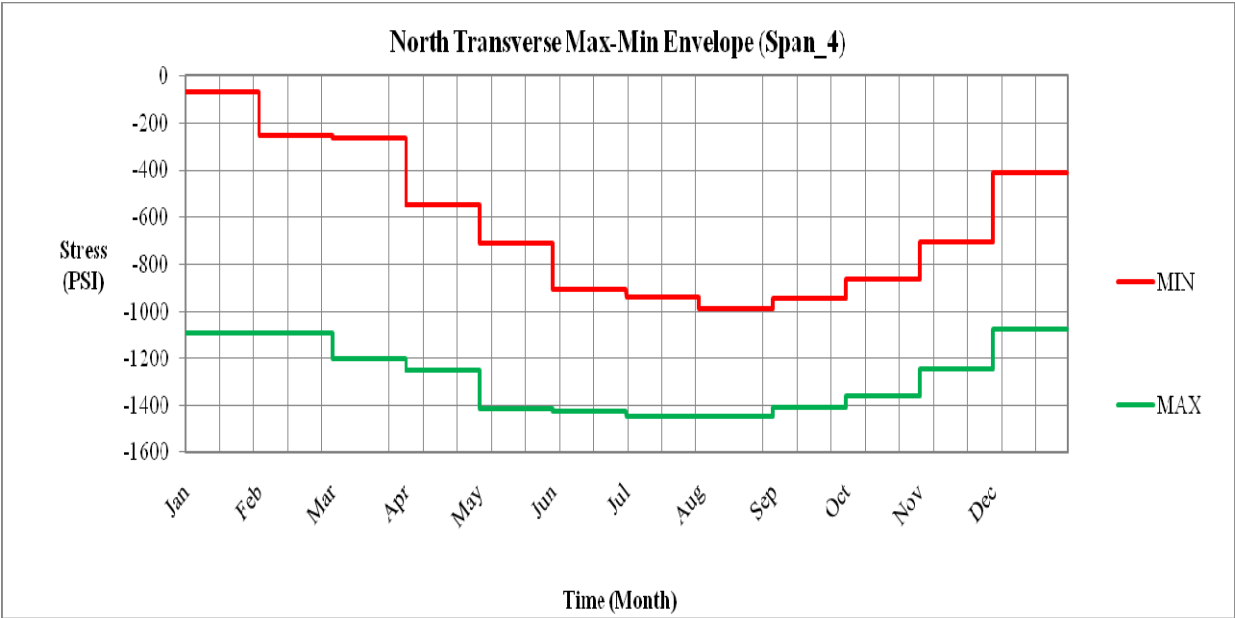
**Figure D-18. One-year envelope for north span 4 in the transverse direction**

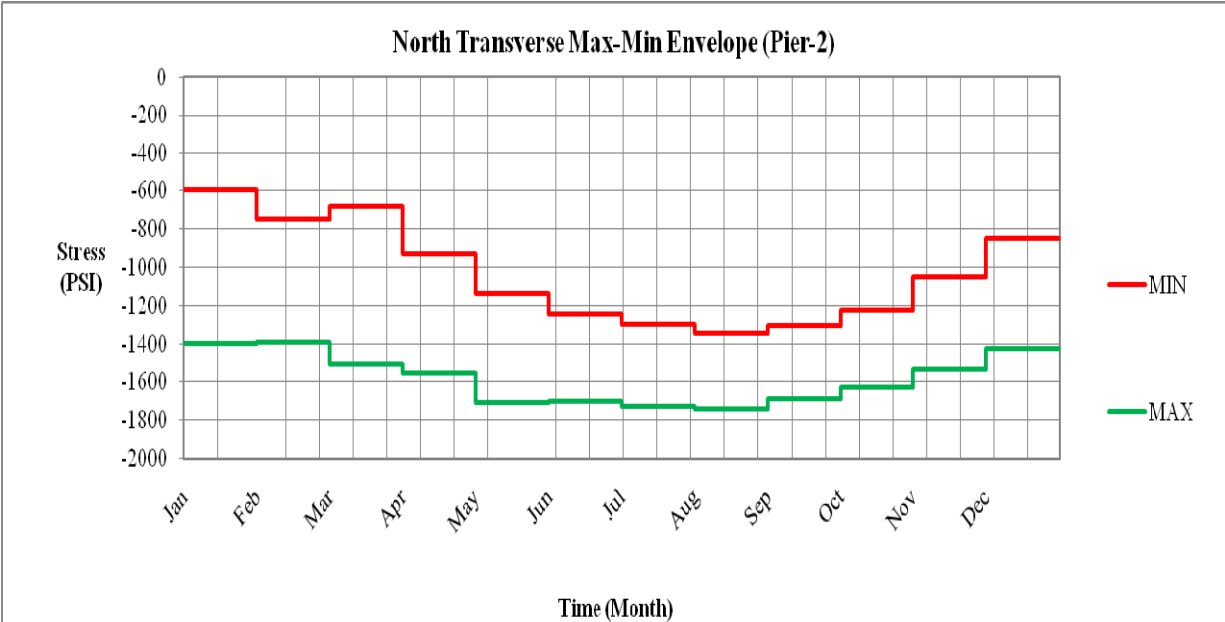
**Figure D-20. One-year envelope for north pier 2 in the transverse direction**

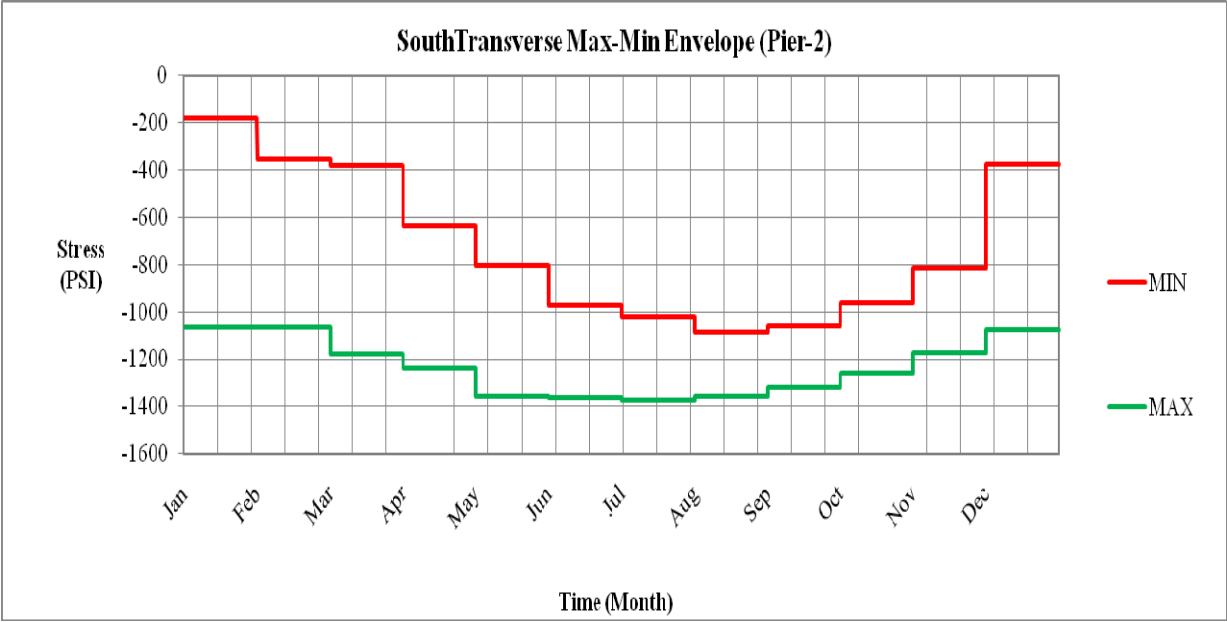
**Figure D-26. One-year envelope for south pier 2 in the transverse direction**

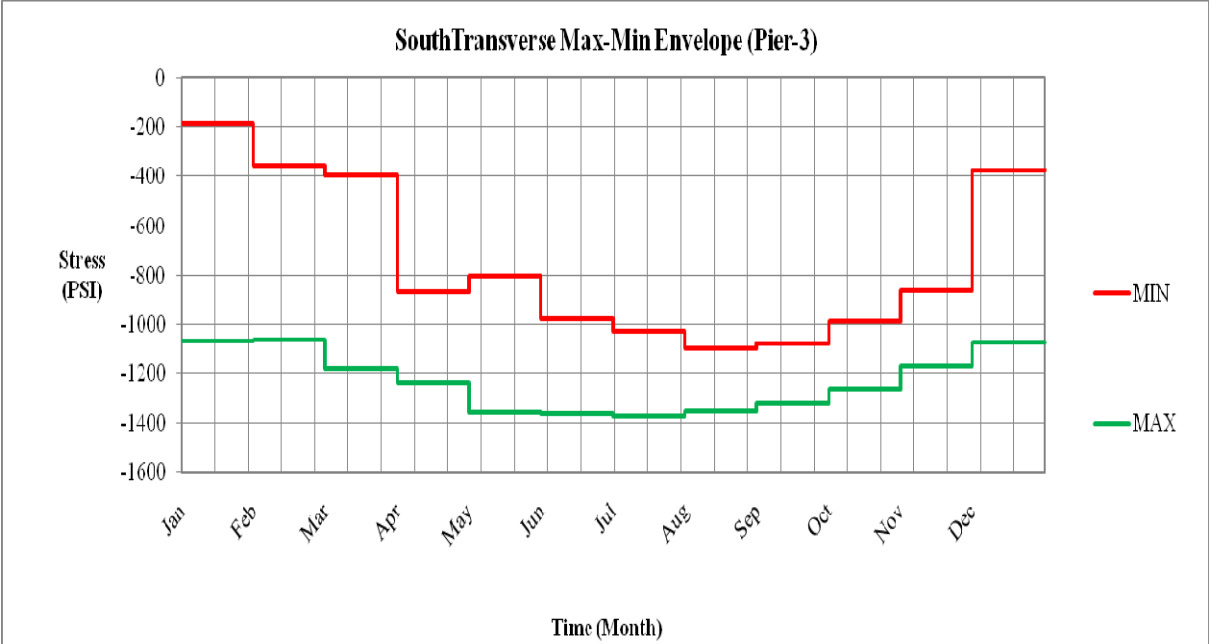
**Figure D-27. One-year envelope for south pier 3 in the transverse direction**

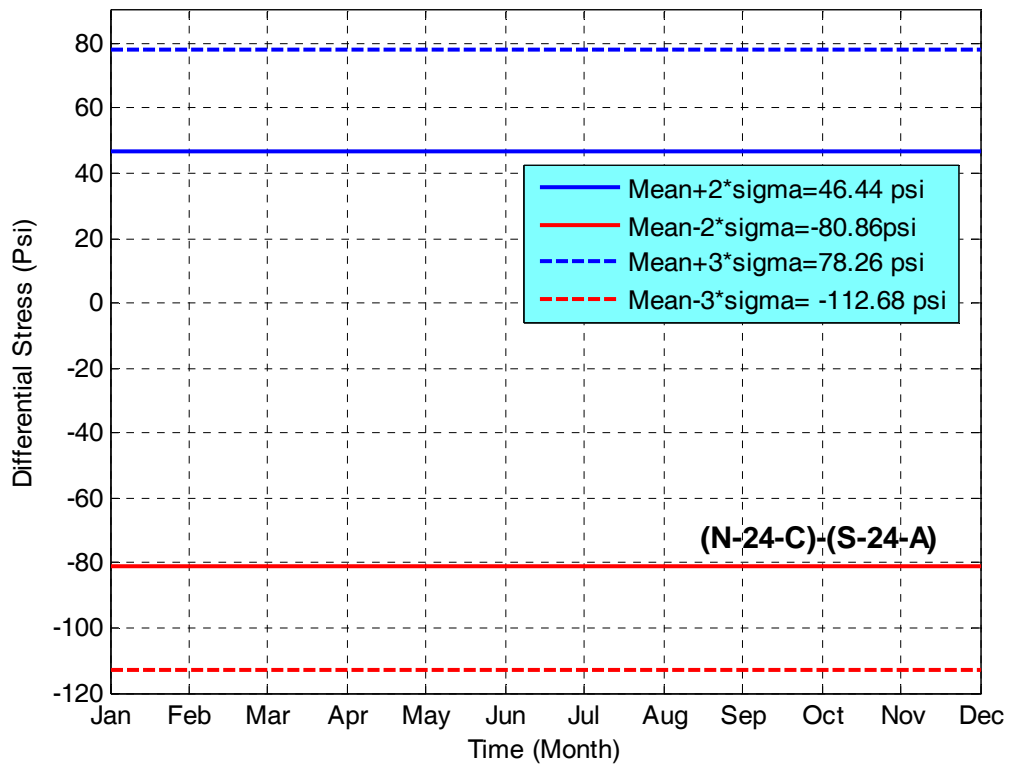
**Figure D-38. One-year differential stress envelope for the closure grout sensors between north span 4 and south span 4 (span 4)**
